## Embankment Criteria and Performance Report

# JOE POOL LAKE MOUNTAIN CREEK, TEXAS TRINITY RIVER BASIN

**SUBJECT: Joe Pool Lake, Texas, Embankment Criteria and Performance Report**

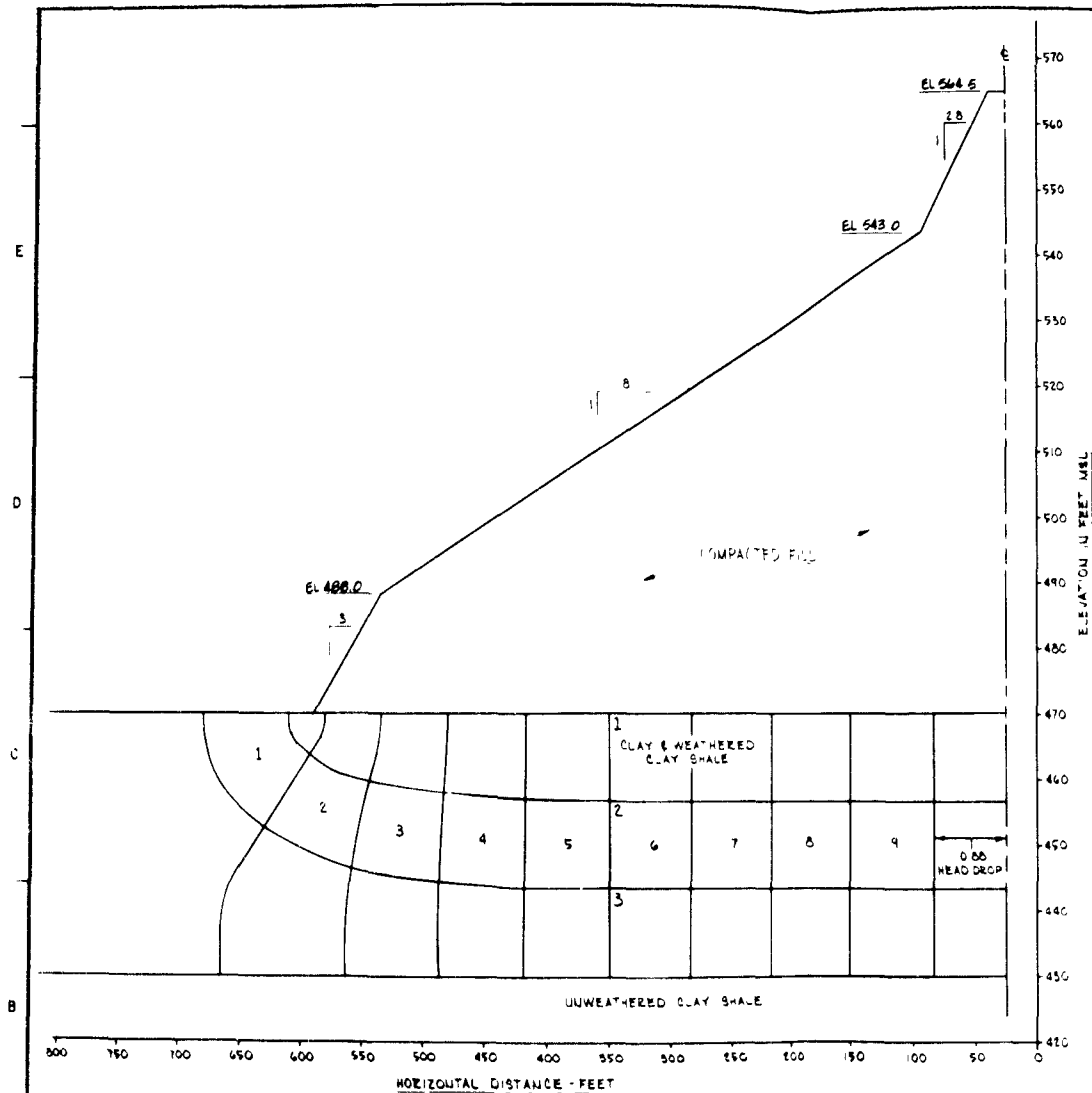
### FLOODPLAIN - APPROXIMATE STATION 46+00

NUMBER OF FLOW CHANNELS = 3  
 NUMBER OF HEAD DROPS = 19.8  
 SEEPAGE QUANTITY =  $1.6 \times 10^{-3}$  GAL/DAY PER FOOT OF DAM AT RESERVOIR POOL  
 EXT. GRADE ENT. WITH RESERVOIR AT LOWER ELEVATION POOL = 0.4  
 EXT. GRADE ENT. WITH RESERVOIR AT MAXIMUM DESIGN WATER SURFACE = 0.27

- 1 FLOWNETS ARE SYMMETRICAL ABOUT THE CENTERLINE
- 2 TRANSFORMED CROSS SECTIONS ARE SHOWN
- 3 A DEEP INSPECTION TRENCH IS DESIGNED BETWEEN APPROXIMATE STATIONS 6+50 AND 17+00 TO DETERMINE EXTENT OF SECONDARY PERMEABILITY IN THE JOINTED AND FRACTURED WEATHERED SHALE ZONE

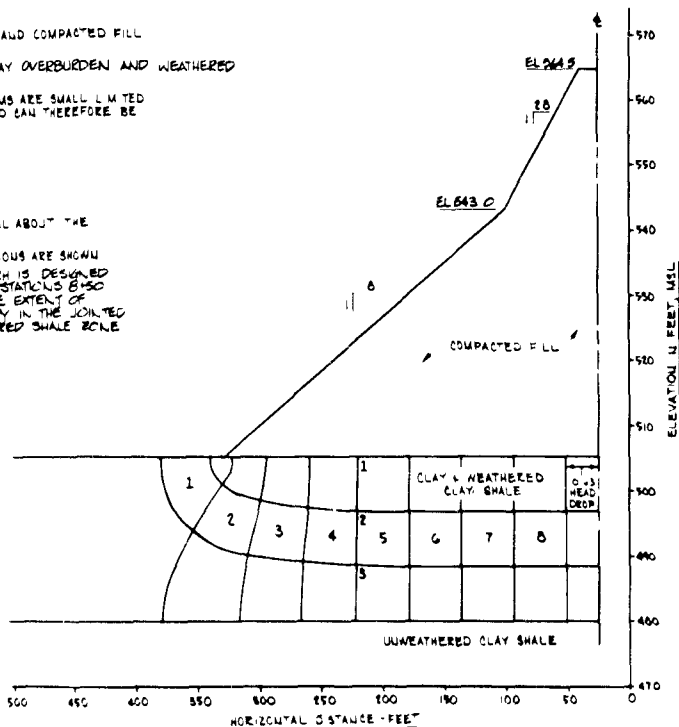
RIGHT ABUTMENT - APPROXIMATE STATION 12+60

NUMBER OF FLOW CHANNELS - 3  
 NUMBER OF HEAD DROPS - 73  
 SEEPAGE QUANTITY - 0.27 X 0.4 GAL/DAY  
 PER FOOT OF DAM AT CONSERVATION  
 EXT. GRADIENT WITH RESERVOIR AT  
 CONSERVATION POOL - 0.1  
 EXT. GRADIENT WITH RESERVOIR AT  
 MAXIMUM DESIGN WATER  
 SURFACE - 0.54

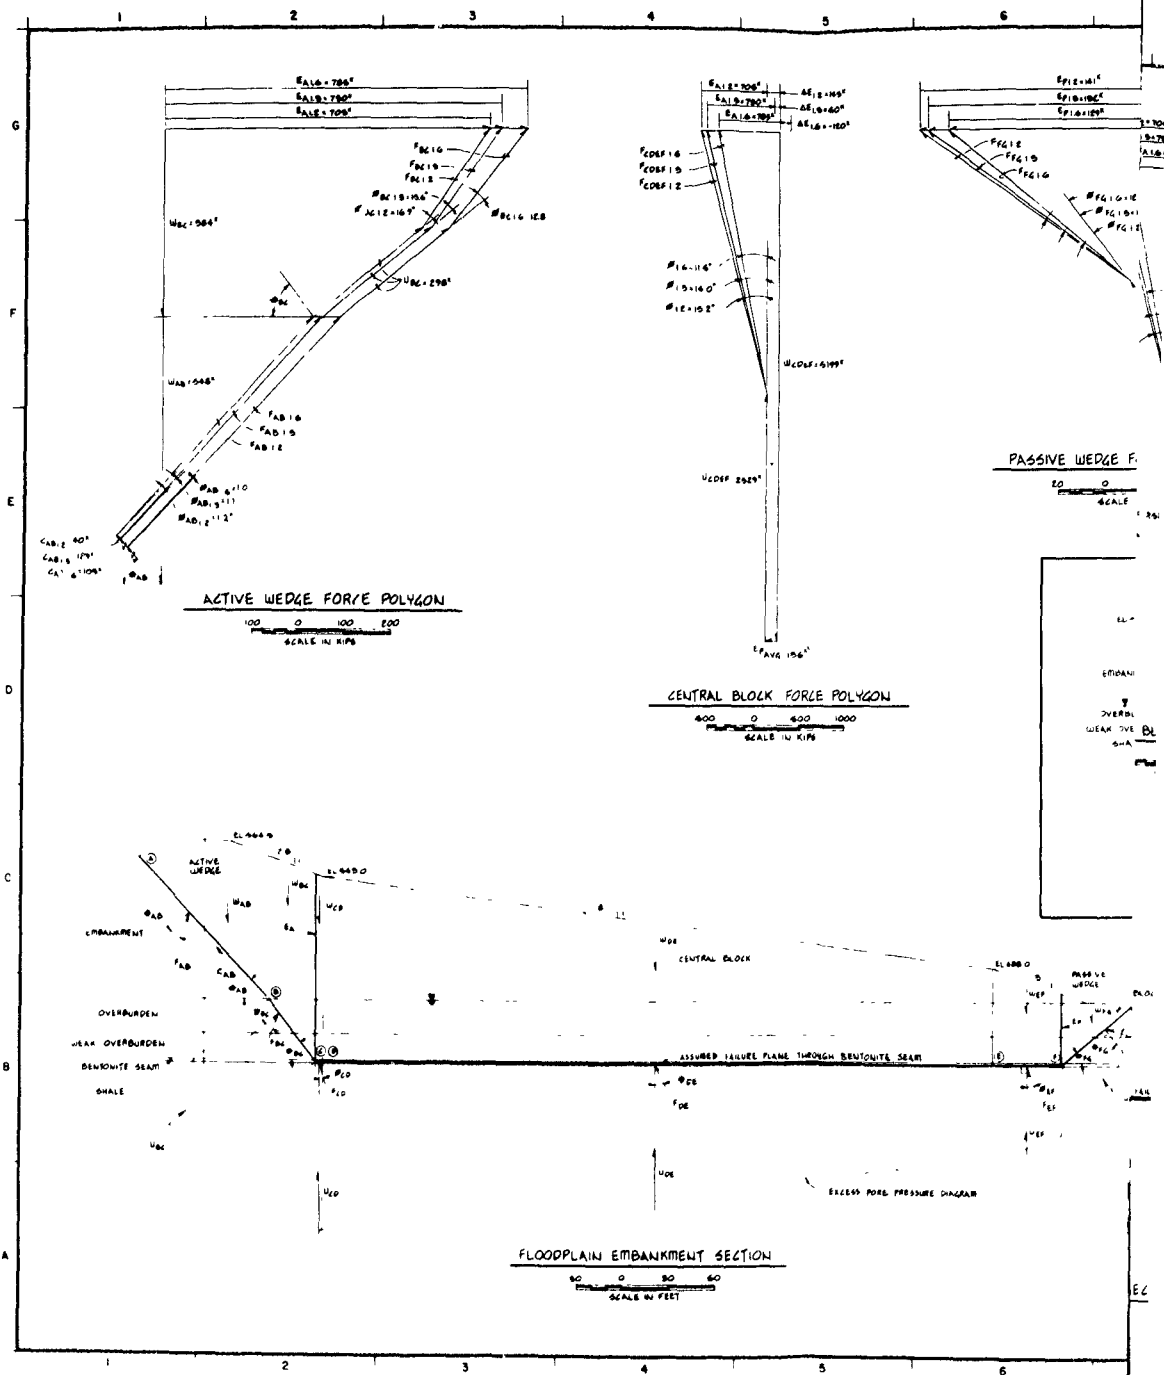
PLATE 55

TRIAL FACTOR OF SAFETY

THE MINIMUM FACTOR OF SAFETY CALCULATED USING COMPUTER METHODS IS 1.81. MANUAL CALCULATIONS FOR VERIFYING COMPUTER ACCURACY ARE PRESENTED ON THIS PLATE.

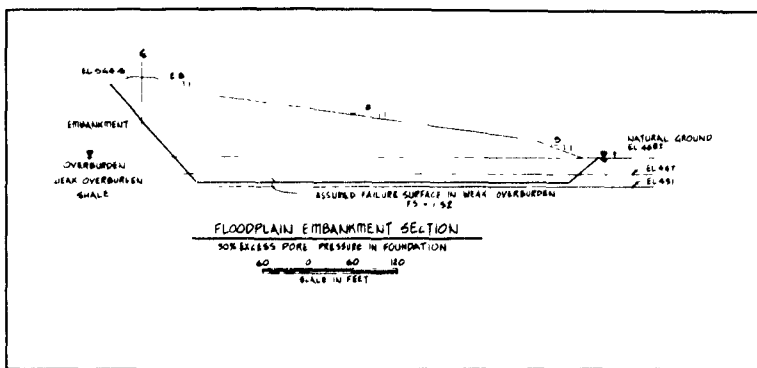
FLOODPLAIN EMBANKMENT SECTION

50% EXCESS PORE PRESSURE IN FOUNDATION

- SEE PLATE FOR ADOPTED SHEAR STRENGTHS AND UNIT WEIGHTS
- FOR SIMPLICITY THE ANALYSIS SHOWN ON THIS PLATE ASSUMED THE SAND AND GRAVEL STRATA VERTICALLY ASSURED PRESENT AT THE TOP OF PRIMARY SHALE IN THE FLOODPLAIN
- THE ANALYSES WERE CONDUCTED ASSUMING 50% EXCESS PORE PRESSURE IN THE FOUNDATION, 5% STRENGTH IN THE FOUNDATION AND 0% STRENGTH IN THE EMBANKMENT

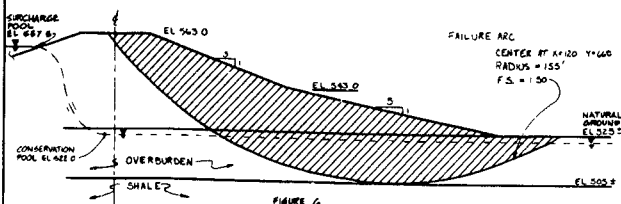
FIGURE 6  
STEADY SEEPAGE CONDITIONS WITH  
FAILURE ASSUMED THROUGH FOUNDATION  
FS = 150 BY COMPUTER METHODS  
MANUAL CALCULATIONS WERE NOT  
PERFORMED

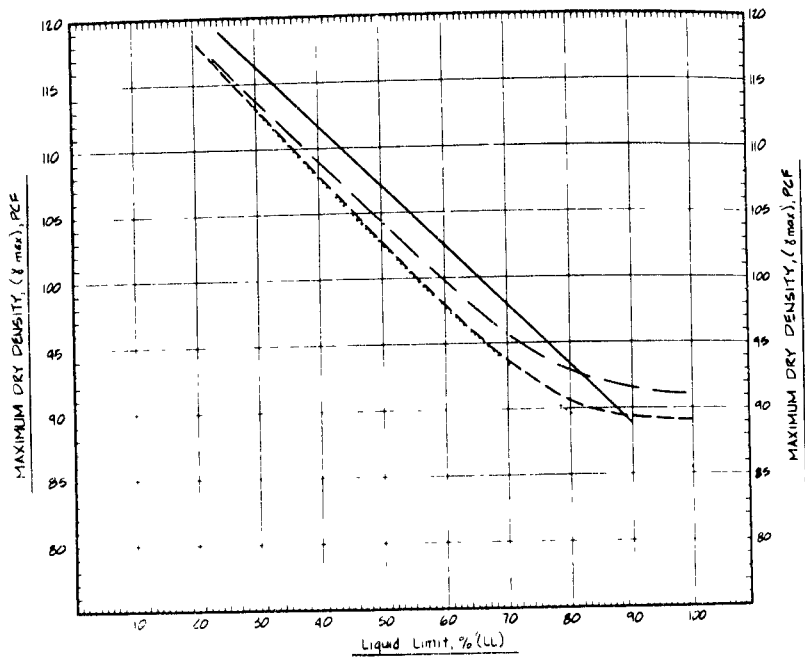
LIQUID LIMIT vs MAXIMUM DRY DENSITY

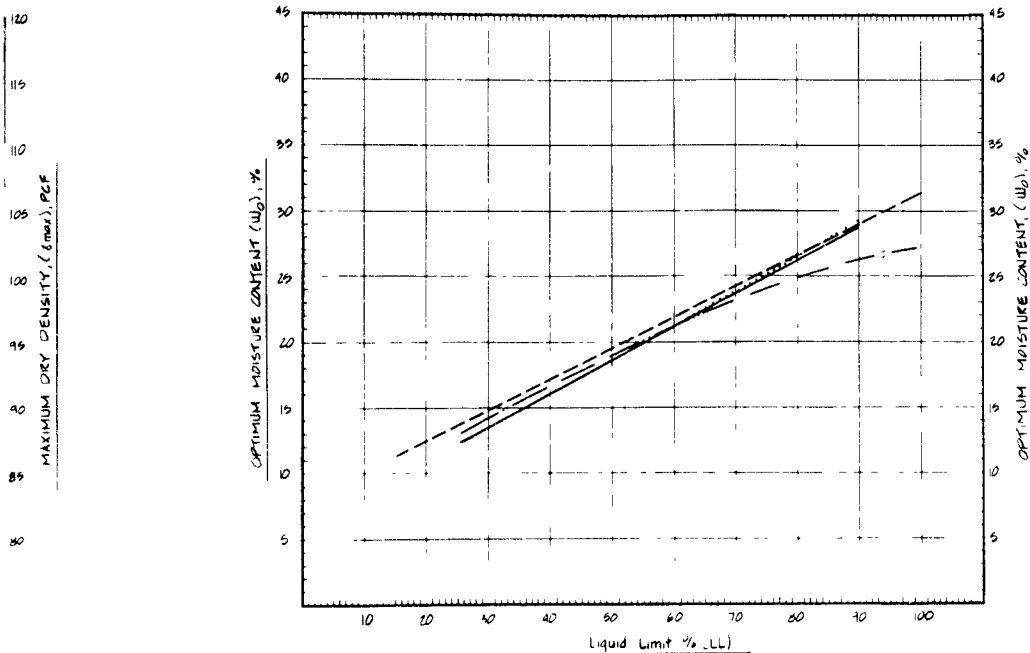
LIQUID LIMIT vs OPTIMUM MOISTURE CONTENT

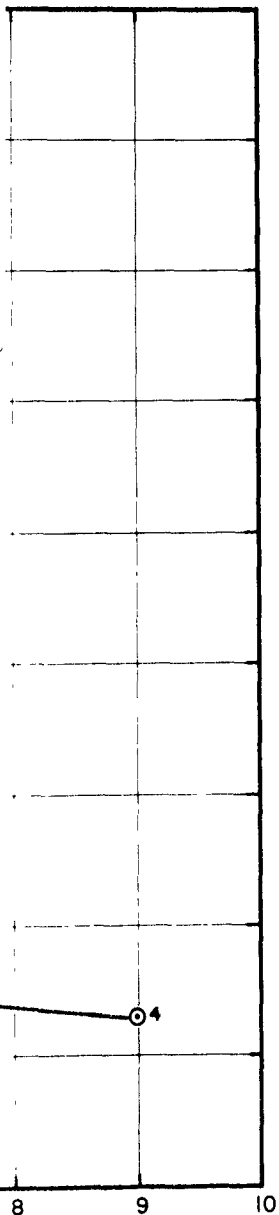
JOE POOL LAKE, MOUNTAIN CREEK  
PERCENT OF M.C. TESTS FAILED  
VS  
SPECIFIED "WINDOW" OF M.C.  
JOE POOL LAKE

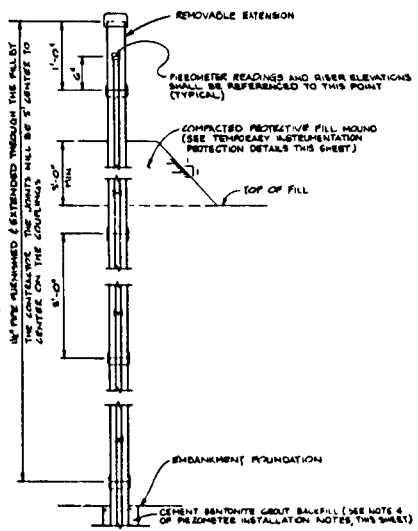
**EMANKMENT FOUNDATION  
POROUS PLASTIC TIP PIEZOMETER  
EXTENSION DETAIL 'A'  
INSTALLATION WITHIN LIMITS  
OF EMANKMENT**  
NOT TO SCALE

\* SIMILAR FOR EXTENSION OF  
SETTLEMENT PLATES AND DEEP  
SETTLEMENT PLATES

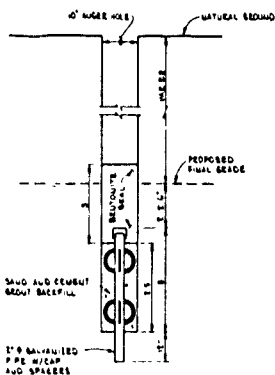
**HEAVE POINT DETAIL**  
UTS
