# A TRIDENT SCHOLAR PROJECT REPORT

**A METHOD TO IMPROVE POST IMPACT COMPRESSIVE  
STRENGTH IN GRAPHITE/EPOXY COMPOSITE MATERIALS  
AFTER LOW TEMPERATURE IMPACT**

**A Trident Scholar Project Report**

**Midshipman Robert C. Dunn, Class of 1991**

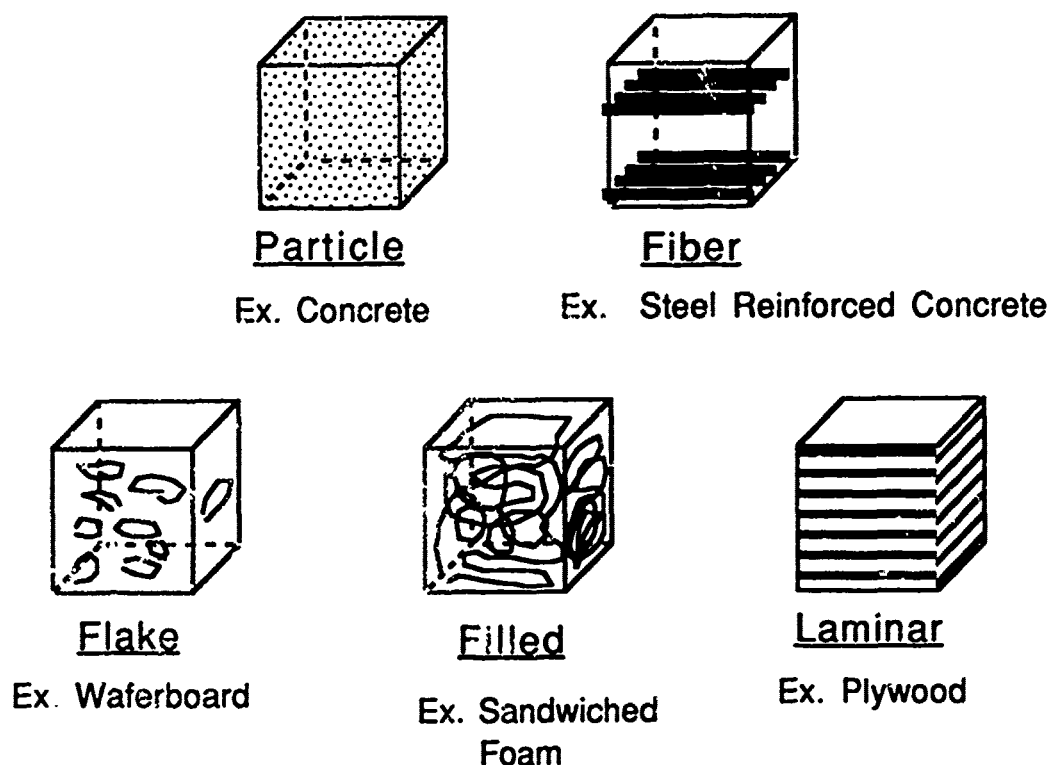
In order to understand fully the advantages of composite materials and the benefits of this project, it is necessary to explain some terms relating to composite materials. As described by Schwartz <sup>4</sup>, "A composite material is a materials system composed of a mixture or combination of two or more macroconstituents differing in form and/or material composition that are essentially insoluble in each other." In reinforced concrete the first constituent is the load bearing base material, cement, which is relatively weak under tension. The second constituent is the reinforcing material, such as steel mesh, which improves the tensile strength of the composite. There are five main types of composite materials, classified by the form that the reinforcing constituent takes. Figure 1 shows each class of composite material, with an example of each.

**Figure 1 - Classes of Composite Materials**

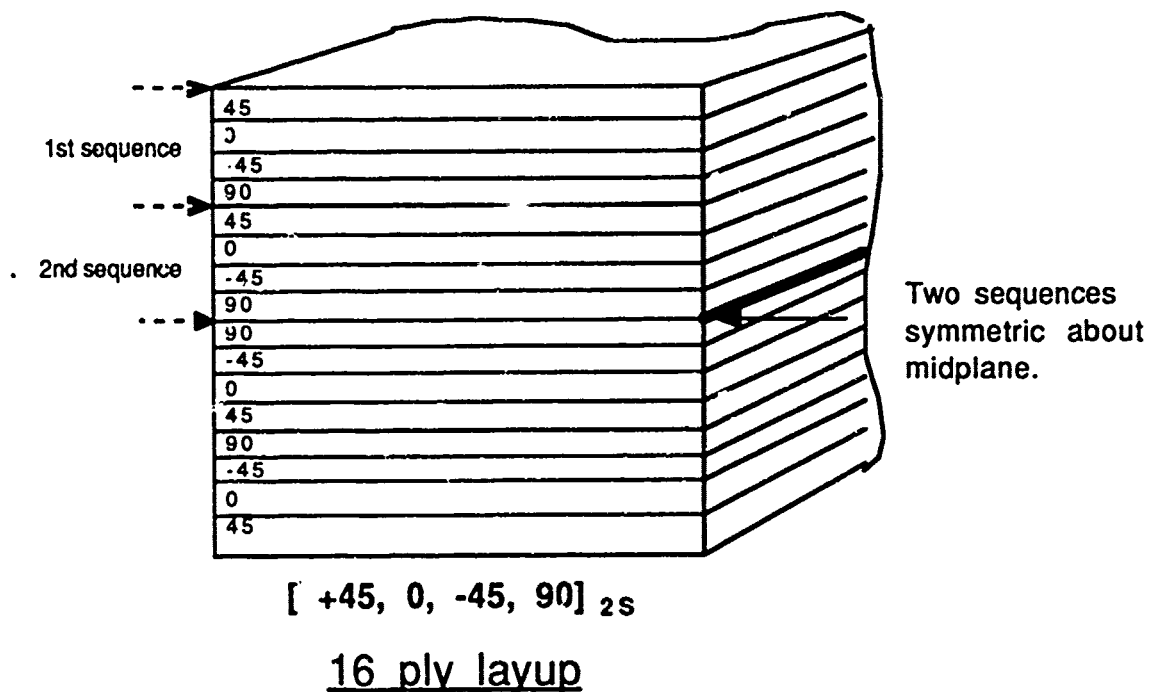
sequence is repeated two times, as indicated by the subscript 2. The sequence then reverses and continues to the 16<sup>th</sup> ply. This creates a symmetric layup, designated by the subscript "S" after the bracketed sequence, about the midplane of the panel. Figure 2 shows an example of this technique on a 16 ply panel, to achieve quasi-isotropic properties.

**Figure 2 - An Example Stacking Pattern to Achieve a Quasi-Isotropic Panel**

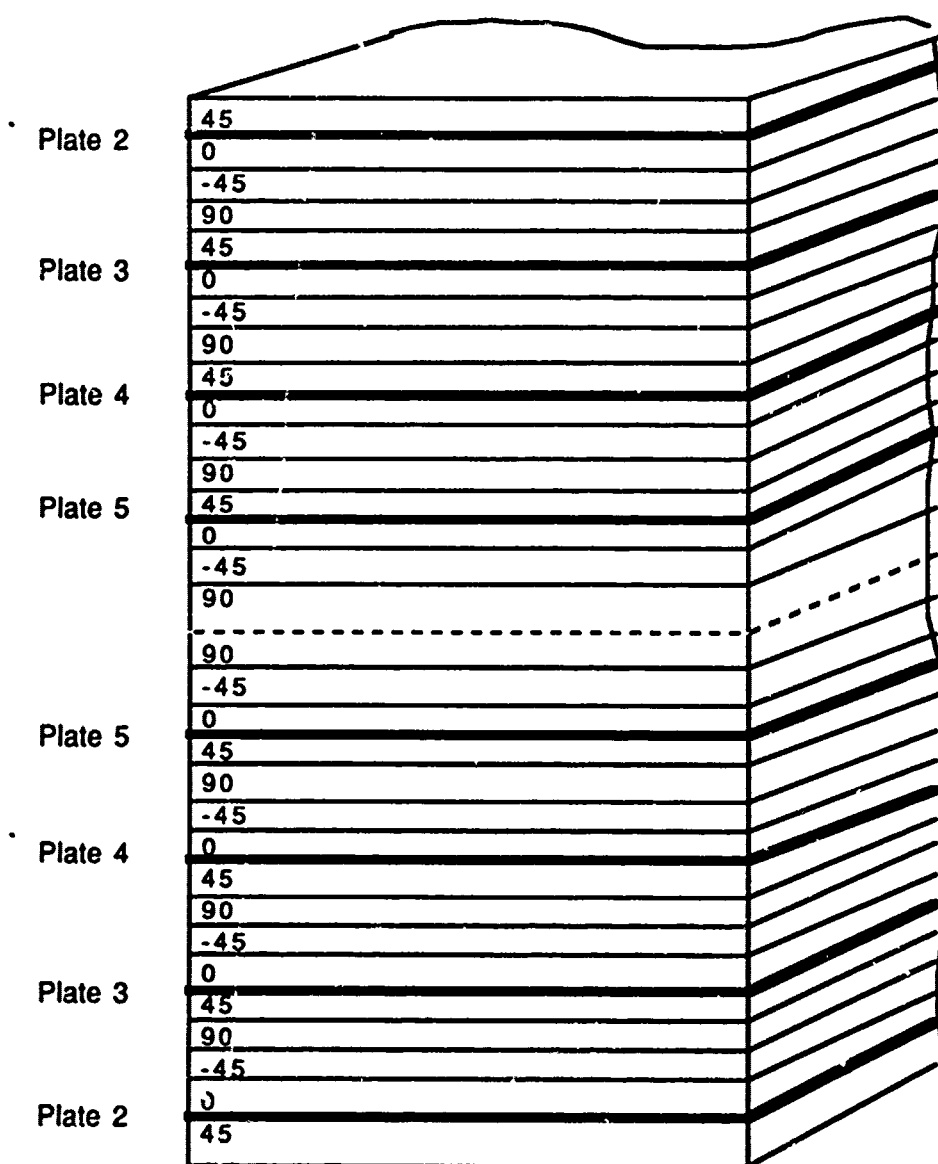
One of the panels was unmodified, and served as the control panel. The other four panels were modified by adding an interleaf of FM300, a tough thermoset, over the first zero degree plies in the first modified panel. The second modified panel contained FM300 interleaves over the second zero degree plies. This was repeated for the third and fourth zero degree plies in the last two modified panels. Since uniaxial force is applied along the zero degree fiber direction, these locations were chosen because the zero degree plies contribute the most to the compressive strength in the compression after impact (CAI) test. It was hoped that the placement of the FM300 over these plies would help protect them and increase their structural integrity. The location was varied in each of the four panels in order to determine the optimum placement of the interleaves. The location of the interleaves in the modified panels is shown in Figure 4. Plate 1, which is not shown, is the unmodified control plate. Plates 2-5 are the modified panels with the interleaves located as indicated in Figure 4.

**Figure 4 - Placement of FM300 Interleaves in Modified Plates**

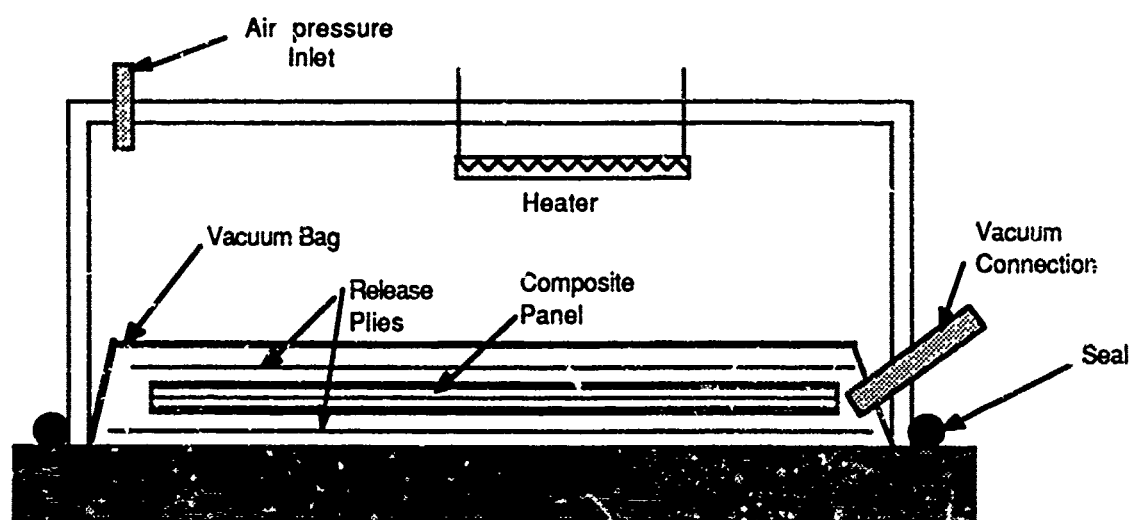
The panels were constructed from 32 layers of prepreg tape, with approximately 62% fiber volume. After the panels were laid up, they were cured in an autoclave, as shown in Figure 5, to achieve their maximum strength. An autoclave uses high temperature and pressure to cure the epoxy matrix. The uncured panel is covered with release plies and placed between two platens. The platens are covered with a vacuum bag and the edges are sealed to maintain the vacuum when it is applied. When a vacuum is applied to the vacuum bag, it collapses to apply pressure, via the platens, on the panel. The vacuum also helps remove any air that would be trapped, causing voids in the panel. The air inlet introduces high pressure air on the outside of the vacuum bag to increase the pressure on the panel. Heat is added to cure the epoxy. A schematic of the cure cycle for the autoclave is indicated in Figure 6.

**Figure 5 - Schematic of an Autoclave For Composite Panel Production**

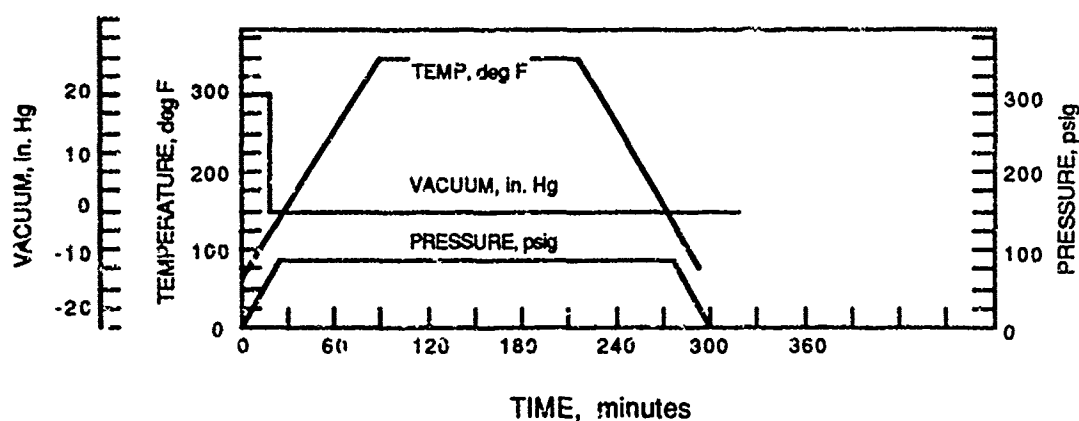
1. Panel is enclosed in a vacuum bag and placed in the autoclave.
2. Header vacuum of 20 inches Hg is applied to vacuum bag.
3. Autoclave is pressurized to 90 psig.
4. Panel is heated at 5 deg F per minute to 355 F.
5. Vacuum bag is vented when pressure reaches 20 psig.
6. Panel is held at 355 F for 130 minutes.
7. Panel is cooled at a rate of 5 deg F per minute to 140 F.
8. When panel cools below 140 F, autoclave pressure can be vented and panel can be removed.

**Figure 6 - Typical Cure Cycle For Composite Panel Production**

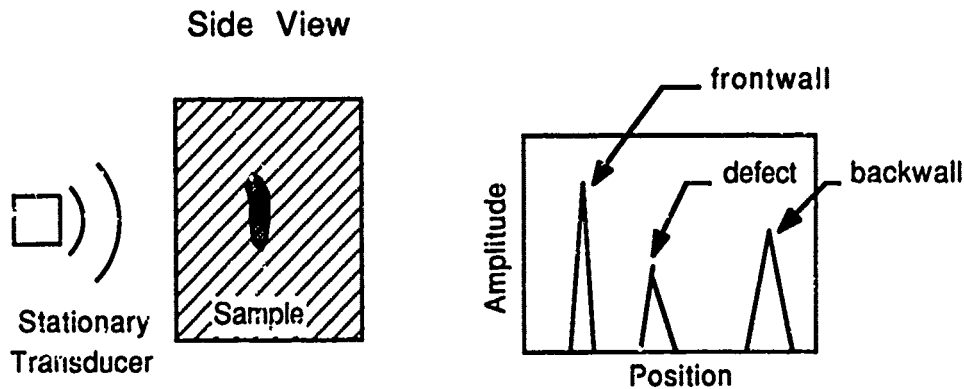
**Figure 7 - A-scan Representation of Ultrasonic Data**

As Figure 7 shows, in the A-scan representation, the reflections are shown as a series of peaks from a baseline noise level. The amplitude of the peak roughly corresponds with the defect size, in that larger defects will have a larger amplitude than smaller ones. The location of an echo with respect to the large front and back wall echoes gives its relative position within the specimen, thus a defect echo appearing halfway between the front and back wall echoes would be located near the midplane of the panel. One major drawback for the A-scan is that it only represents the portion of the specimen directly underneath the current position of the transducer.

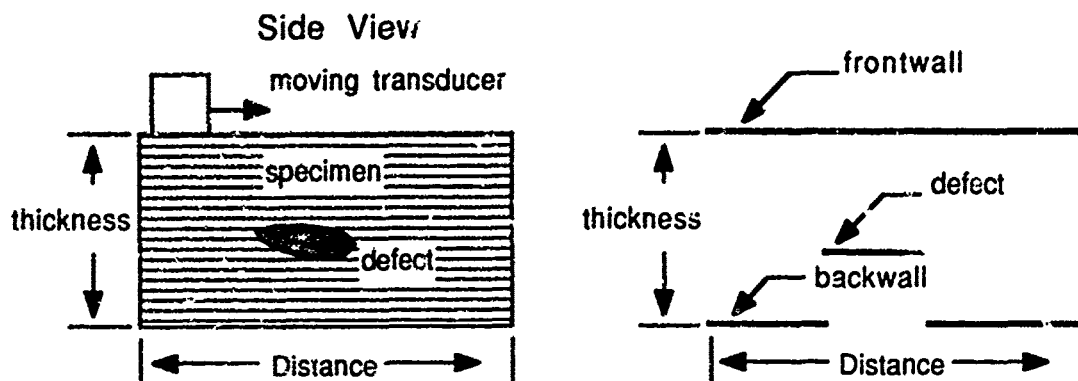
**Figure 8 - B-scan Representation of Ultrasonic Data**

Figure 8 shows the B-scan representation for ultrasonic data. This method uses a transducer moving in a line at a constant rate across the specimen. As the wall and defect echoes are received, they are shown as a series of lines. The pattern of the lines indicate the relative length and depth of defects. This representation can be compared to what the specimen would look like if it were cut along the path of transducer movement and visually inspected. The drawback of the B-scan is that it only gives the relative length and location of defects within one thin slice of the specimen.

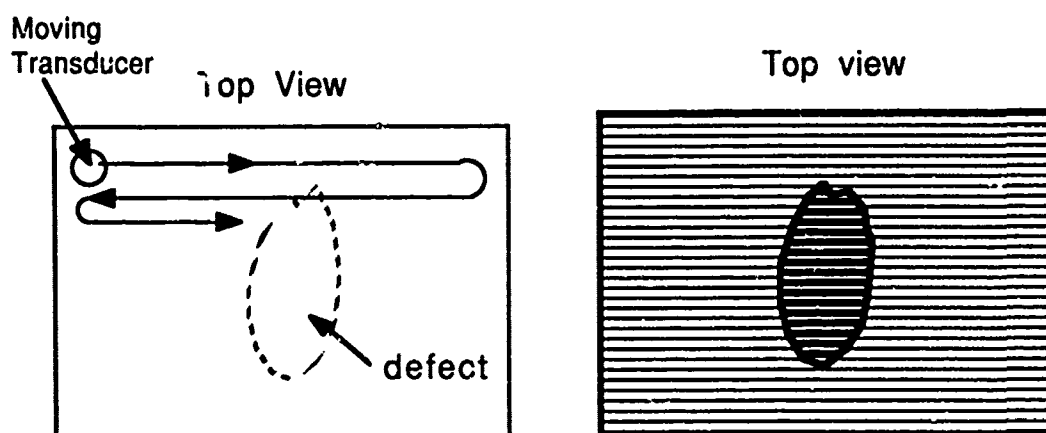
**Figure 9 - C-scan Representation of Ultrasonic Data**

Figure 9 shows a C-scan representation of the ultrasonic data. This method integrates a series of transducer passes, giving a plan view of defect location and size within the specimen. C-scan data can be collected in two different ways. The first method uses only one transducer, and is termed the pulse-echo method. The single transducer produces an ultrasonic sound pulse then pauses to collect the echoes. The pulse repetition frequency of the transducer is adjusted to ensure that the transducer does not pulse again until the back wall specimen is received. An added benefit for this method is that since the sound velocity in the specimen is known, as well as the time intervals in which the defect reflections are received, the defect depth can be calculated by the signal processor. This feature allows a "time of flight" representation which is a plan view as before, but defects are shaded differently according to their depth within the

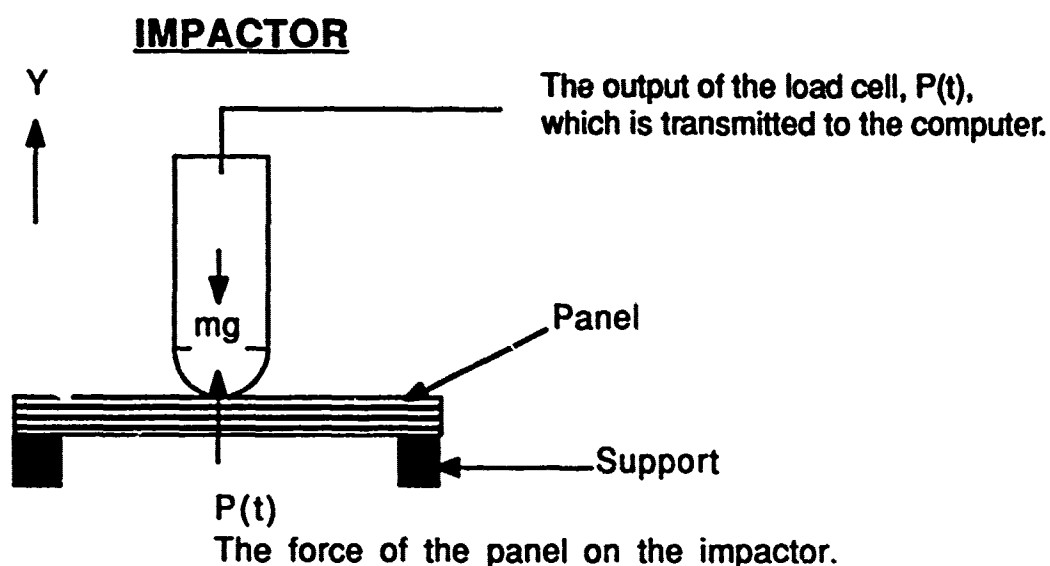
In order to characterize the impact toughness of the panels, an instrumented falling dart impact test was chosen. This test utilizes an spherical tipped dart containing a load cell to measure the impact force from the panel on the dart as a function of time. This force-time curve is integrated by computer to produce an absorbed energy versus time curve. Figure 12 shows the impactor. The mathematical analysis for the impact response is as follows: <sup>18</sup>

**Figure 12 - Forces Acting on the Instrumented Impactor.**

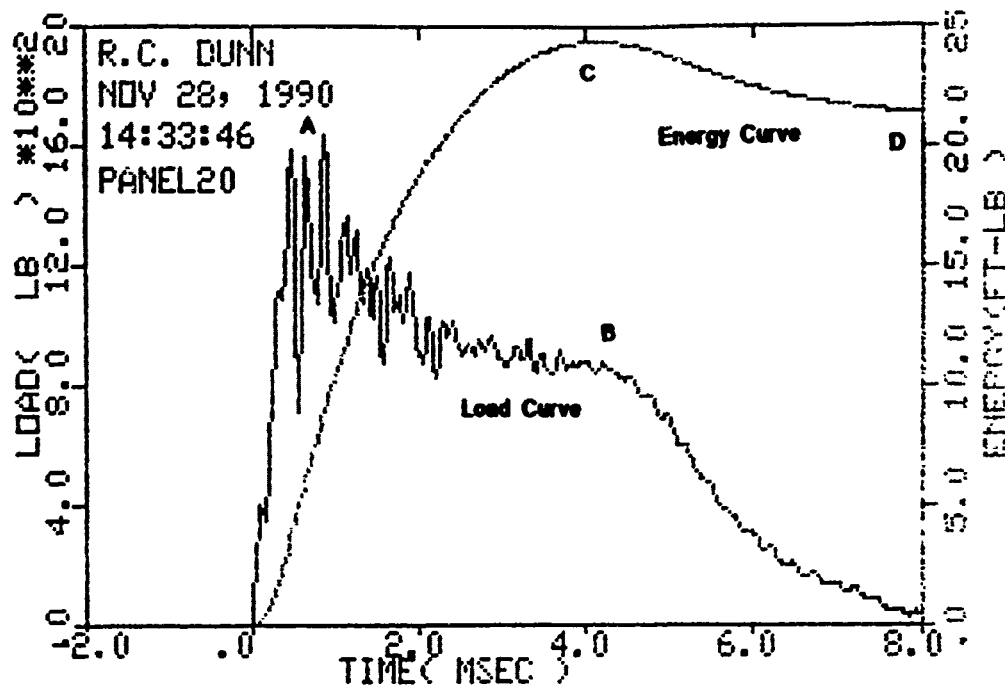
- meaning of the the area under the force-time curve is the variation in momentum ( $m \, dV$ ) of the striker due to impact.<sup>19</sup> A typical force-time curve and its associated energy-time curve is shown in Figure 13. Significant points on both curves are labeled and described beneath the figure.

Point A: Maximum load

Points A to B: Fiber breakage, matrix cracking, and debonding

Point D: Absorbed impact energy (Damage)

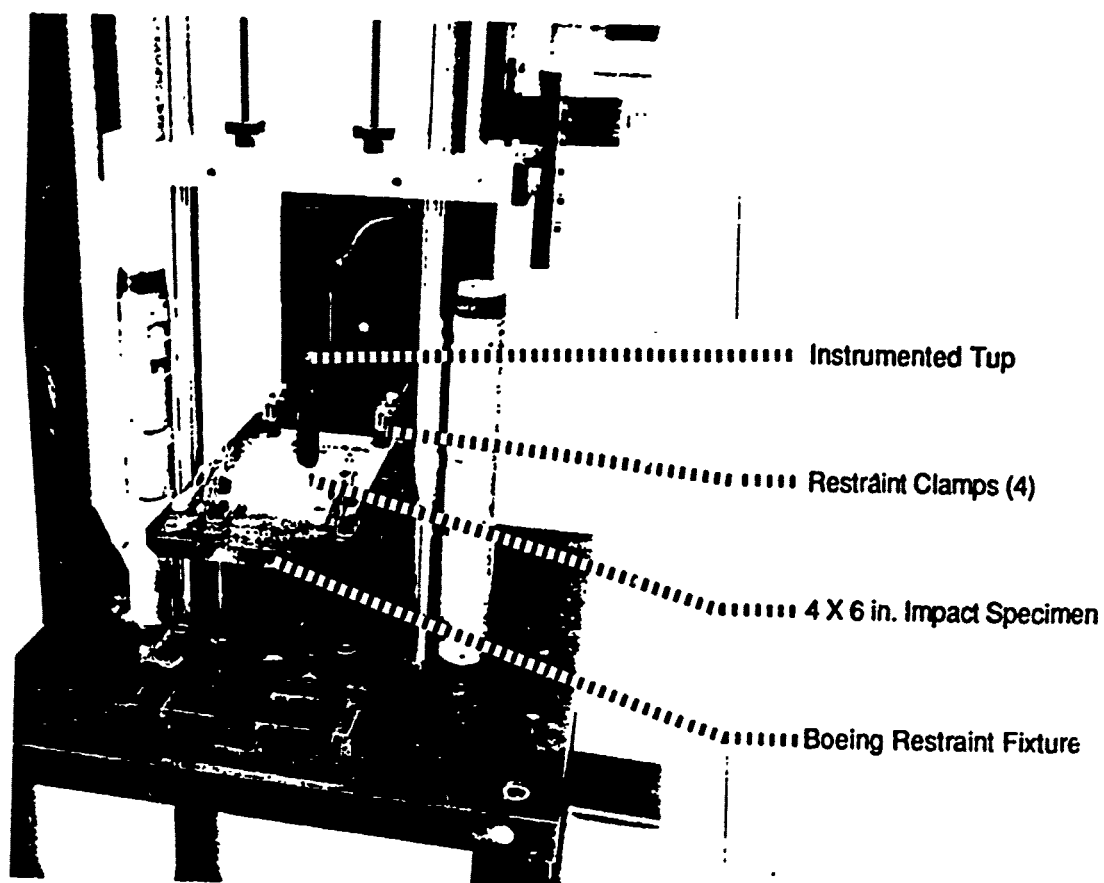
Each of the five different plates used in this study were cut into six 4 X 6 inch impact specimens. All six specimens from each plate were impact tested on a Dynatup model 8200 drop weight impact tower with a 0.625 in diameter spherical tip impactor as shown in Figure 14. The weight of the impactor system was 10.86 lbs. The average specimen thickness was 0.188 in, which translated into average drop heights of 25.9 in. The drop height for the impactor was adjusted slightly on each test to ensure the desired 1500 in.-lbs/in impact energy was obtained. The impactor is attached to a frame that slides on the vertical rails shown in the figure. This figure also shows how the specimen was constrained at each corner over a 3 X 5 inch cutout by a Boeing restraint fixture.

**Figure 14 - Impact Tower and Instrumented Impactor**

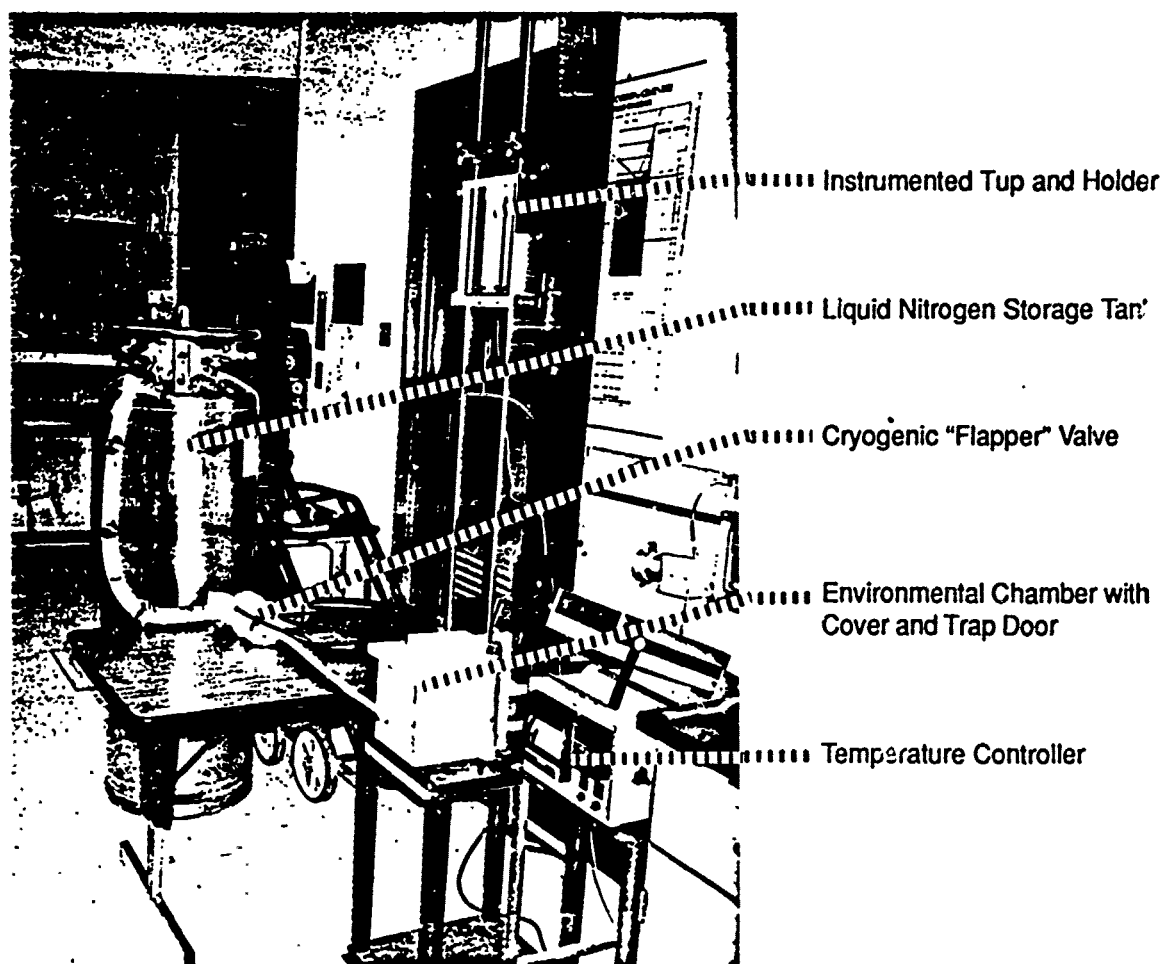
After the panel was placed in the impact restraint, the cover for the chamber was replaced and the panels were subjected to a single impact energy of 1500 in-lbs/in at -67 F. Repeated impacts, due to rebounding, were avoided by the use of a trigger and ratchet assembly to catch the impactor when it rebounded.

Figure 15 - Environmental Chamber

Before discussion of the impact results, it is noted that the design and performance for the environmental chamber were more than adequate. The use of a proportional integral and derivative (PID) controller allowed the temperature to be rapidly lowered into the test range of -67 F. Once the chamber reached this subambient temperature, the PID controller cycled the LN<sub>2</sub> cryogenic valve to maintain this temperature +/- 2 deg F.

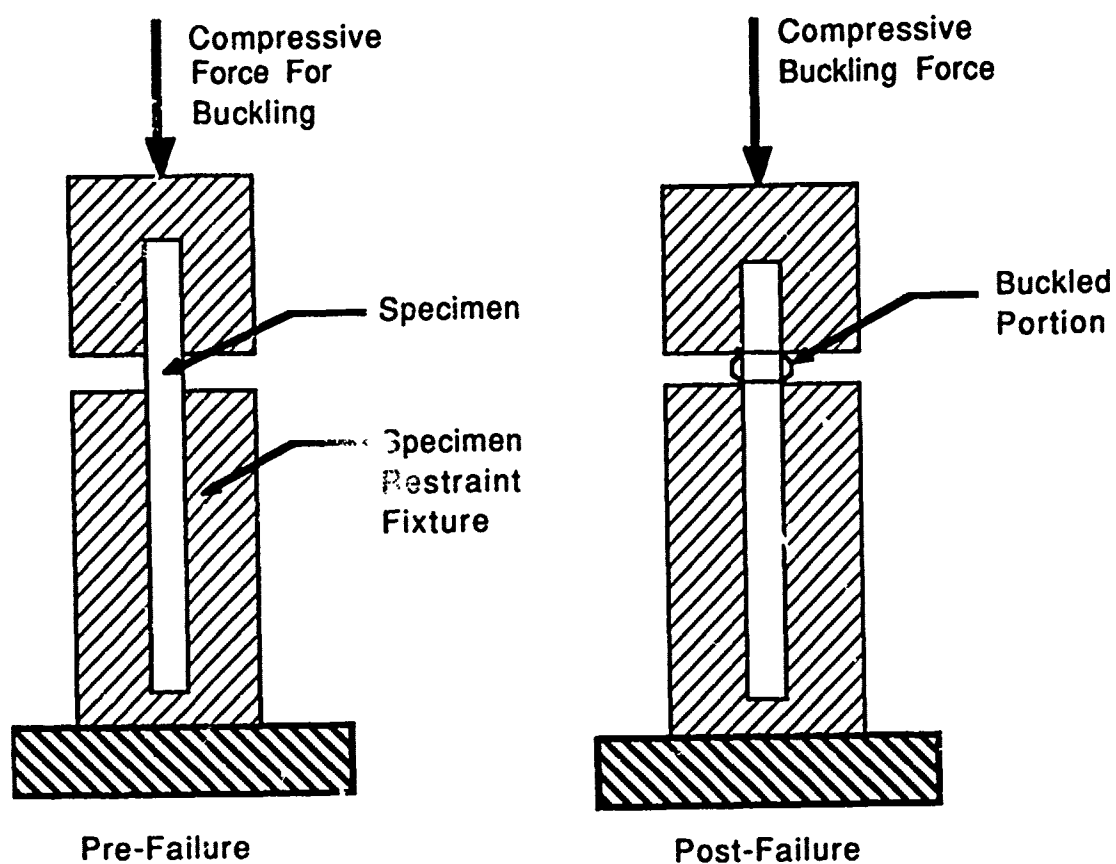
Due to the unavailability of a compression restraint fixture, four of the six impacted specimens from each of the five plates were sent to Hercules Aerospace in Magna, Utah, where the CAI test was performed. This test is conducted because composite materials on the upper wing surfaces of aircraft, prone to damage from accidental tool drops, are subjected to uniaxial compression during flight. The test utilizes a fixture which constrains the edges of the specimen, except along a short length as shown in Figure 16. The panel is placed in uniaxial compression, along the zero degree ply axis, until buckling is detected by the strain gages in the unrestrained region of the panel. This buckling load is divided by the cross sectional area of the specimen to obtain the compressive strength. The results of this test are expressed in the pounds per square inch of cross sectional area required to cause buckling. A typical plot of the load versus deflection output is shown in Figure 17 below.

**Figure 16 - Compression After Impact Test**

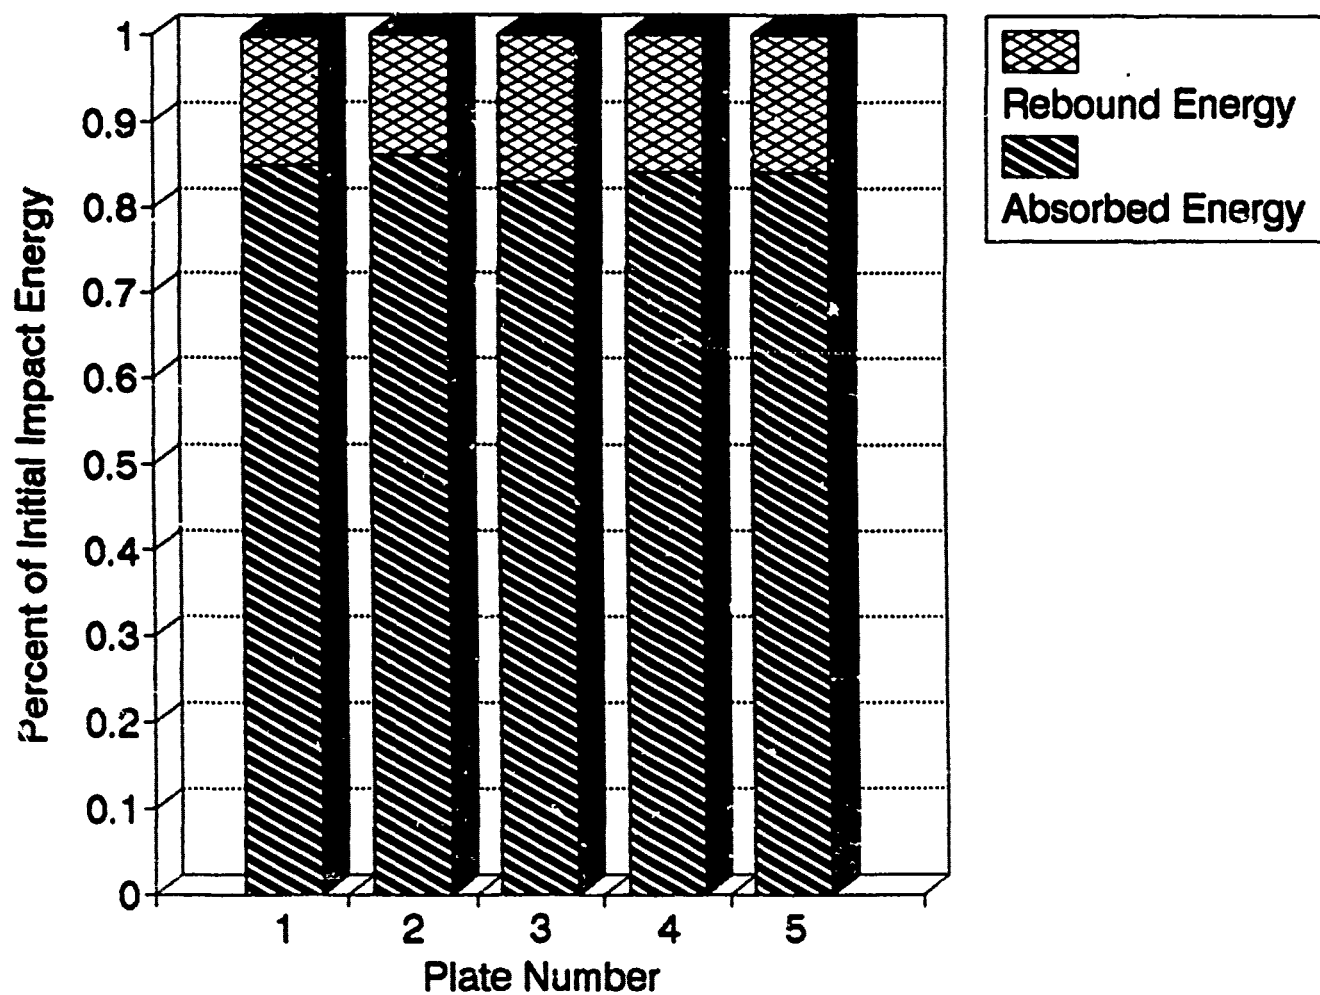
The average results from the instrumented impact testing of six specimens from each of the five plates are summarized in Figure 18. These show that the initial impact energy varied slightly to maintain the desired impact energy of 1500 in.-lbs/in. thickness. The increased specimen thickness of the modified panels, due to the two plies of FM300, required greater initial impact energies to attain 1500 in.-lbs/in. impact energy. Notice in the energy-time curve, Figure 13, the areas listed as the energy returned to the impactor, due to rebounding, and the energy absorbed in the specimen as damage. As previously stated, this can be compared to dropping a weight on a spring and compressing it beyond its elastic limit. The weight will not rebound off the spring with its same initial kinetic energy. The permanent deformation in the spring is analogous to the energy absorbed as damage in the composite panel. The normalized energy values listed in Figure 19 are essentially identical. This

indicates that this test did not detect any improvement, or degradation, in impact toughness due to the addition of the interleafs. The introduction of the interleafs was to minimize the amount of damage retained in the specimen as permanent damage. The above results indicate that this was not achieved.

**Figure 19 - Instrumented Impact Absorbed Energy Results**

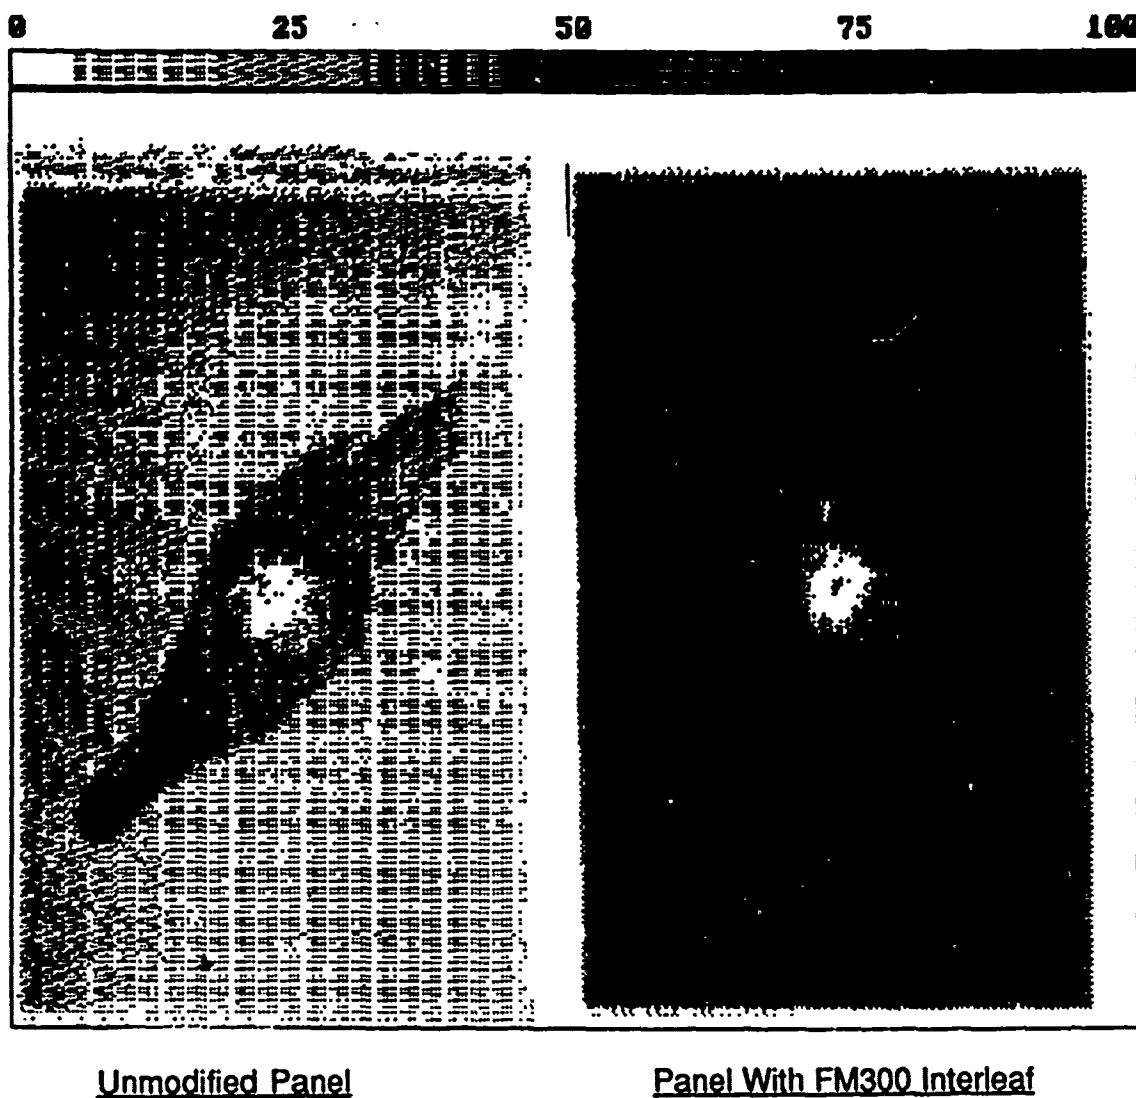
The comparison of the post impact C-scan inspections of the panels, shown in Figure 20, indicates a decrease in damage area in the interleaved panels. The increased impact toughness of the FM300 interleaves helped absorb a portion of the impact energy, thus preventing damage. The decreased damage area in the modified plates is important for two reasons. As the technology becomes available to completely repair the impact damaged areas, a smaller damage area would be less expensive to repair and require less downtime for the aircraft. The second reason is the decreased damage area would be less susceptible to fatigue failure before it was repaired. Although the effects vary from panel to panel, there appears to be a slight advantage when the interleaf is located over the first zero degree ply for the greatest reduction in impact damage area.

**Figure 20 - C-scan Comparison of Damage Area.**

- (3) There was no optimum interleaf location found that increased the post impact compressive strength.
- (4) The interleaves did decrease the damage area compared to the unmodified panels, as characterized by C-scan inspections

- (5) There was an optimum location for the interleaves that yielded the greatest reduction in impact damage area.
- (6) The low temperature impact of unmodified IM6/3501-6 did not produce the predicted decrease in post impact compressive strength when compared to room temperature impact of identical specimens.

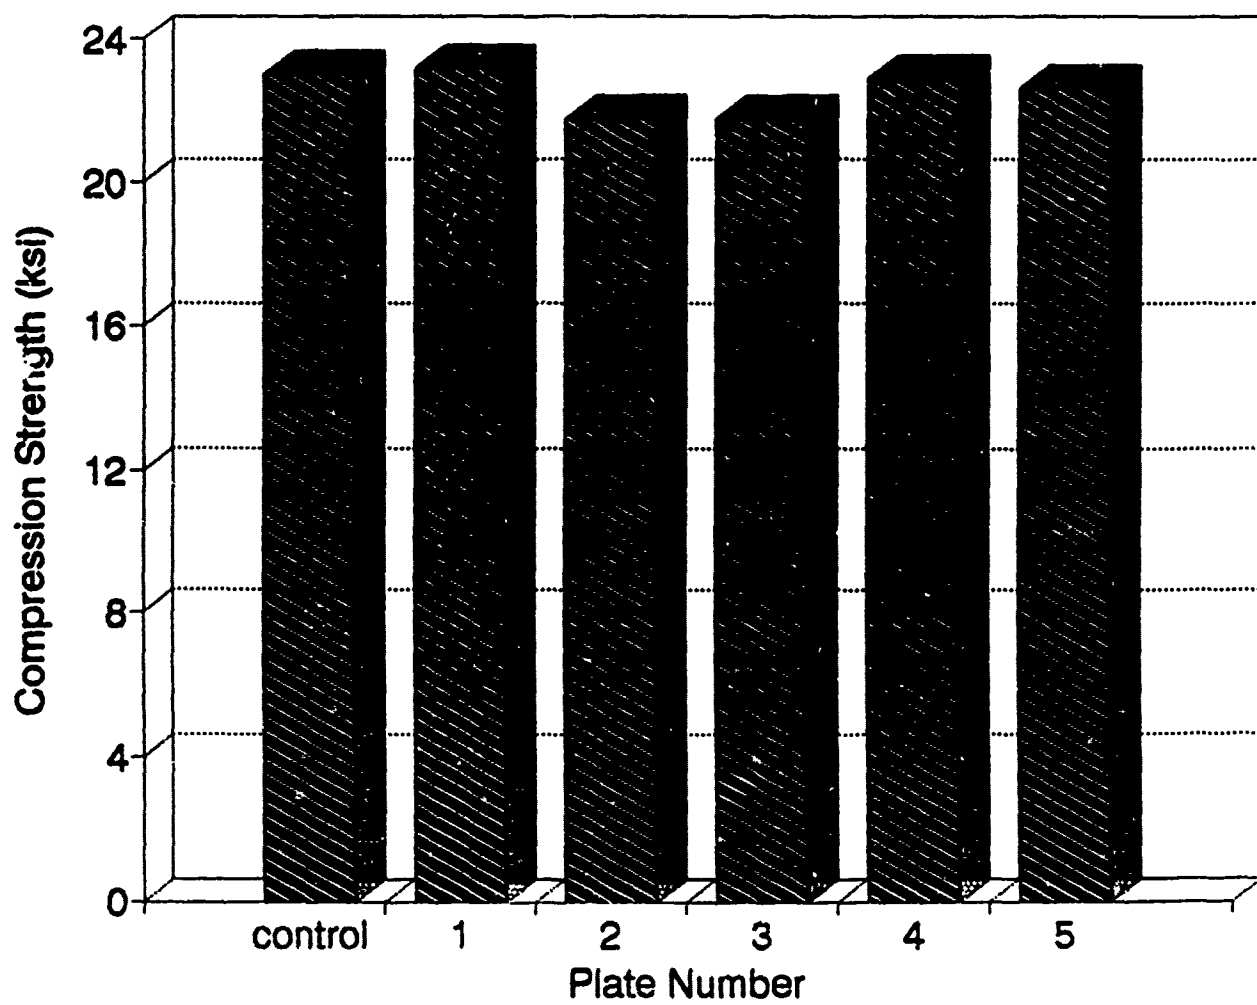
The compression after impact test results, Figure 21, show that the failure loads of the unmodified panels were within the normal range for IM6/3501-6 materials, as indicated by the room temperature data

for the unmodified configuration, listed as the control panel. The average thickness of 0.1767 inch is also within the normal range for panels constructed of  $145 \text{ gm/m}^2$  prepreg material. An interesting note is that the unmodified IM6/3501-6 system had the same post impact compressive strength regardless of impact temperature. This suggests that the unmodified IM6/3501-6 system appears to be relatively unaffected by low temperature embrittlement. The average CAI strengths of the interleaved panels were slightly lower than the unmodified panel. The average buckling loads for each of the panels were relatively constant, so when the additional thickness of the interleaves was subtracted, the CAI strength of the modified panels were identical to the unmodified panels. No optimum interleaf location was found that maximized the post impact compressive strength since the interleaves actually tended to slightly decrease the post impact compressive strength of the panels.

**Figure 21 - Compression After Impact Test Results**

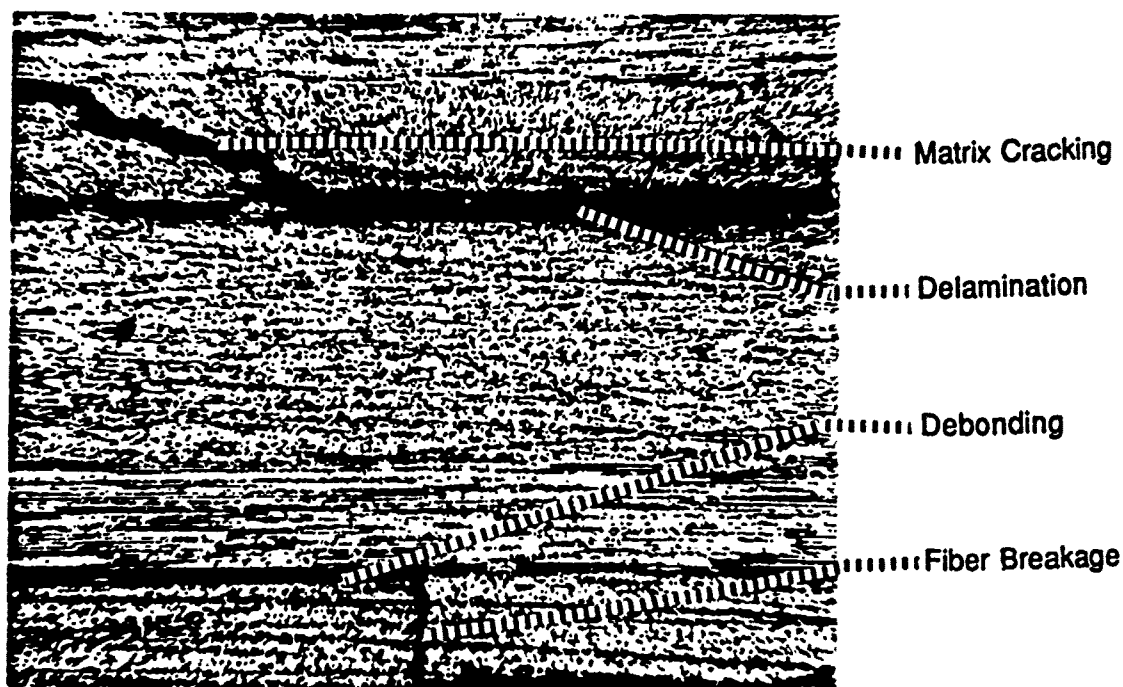
Representative fracture damage found in the impact damaged specimens is shown in Figure 22. The fractographic analysis indicated a large amount of delamination, debonding, fiber breakage, and matrix cracking in the impact damaged area. There was no clear localized pattern of delamination or debonding near the interleaf, which would indicate poor bonding between the interleaf and the epoxy matrix. The impact energy caused a large amount of fiber breakage and matrix cracking as shown in Figure 22.

Post Impact Specimen @ 100X

**Figure 22 - Representative Damage Types in Post Impact Specimen**

- (8) Fractographic analysis of the subambient temperature impact specimens does not indicate any clear reasons why the FM300 interleaves do not reduce the impact damage to a greater extent.
