TECHNICAL REPORT GL-91-23

## A STUDY OF EMBANKMENT PERFORMANCE DURING OVERTOPPING

Paul A. Gilbert, S. Paul Miller

Geotechnical Laboratory

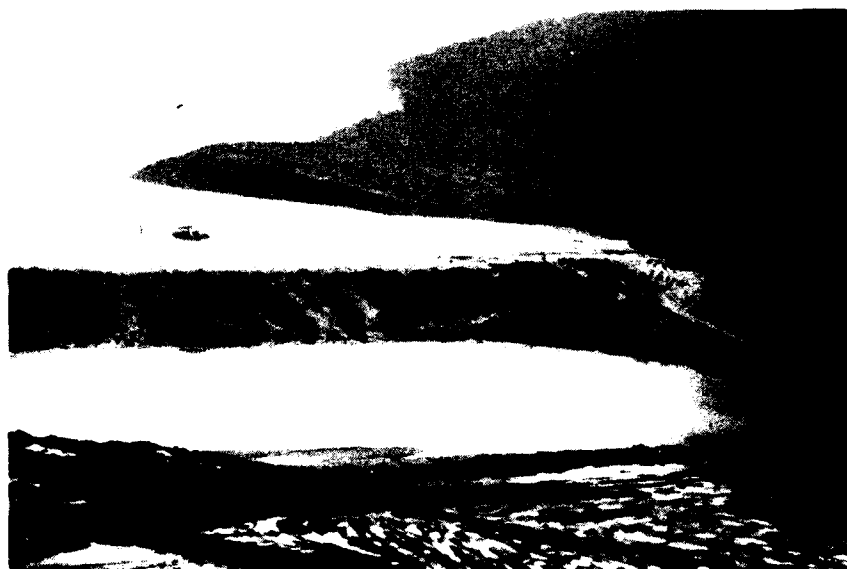
Figure 2. Notch area of Clarence Cannon cofferdam during initial overtopping

12. Damage. Overtopping flow was primarily contained in the notch area, with breaching in the center of the notch occurring after 20 hr of overtopping. Maximum depth (5 ft) was reached about this time. Limited flow over other areas of the cofferdam occurred for a few hours prior to notch breaching. The partially complete earth embankment, with very shallow slopes, allowed spread of the flow over a crest length of 850 ft. Apparently, the main embankment sustained very little damage until about 8 hr after notch breaching. At this time erosion reached the horizontal drainage blanket at the downstream main embankment toe and started removing the granular blanket

materials from beneath the central portion of the downstream slope. Undercutting of the overlying cohesive fill by removal of the drainage blanket continued for 8 or 10 hr until the chimney drain was reached. The chimney drain was removed from the left abutment to the concrete dam section without appreciable damage to the upstream portion of the main embankment. The chimney drain and 30 to 40 percent of the downstream embankment fill were lost.

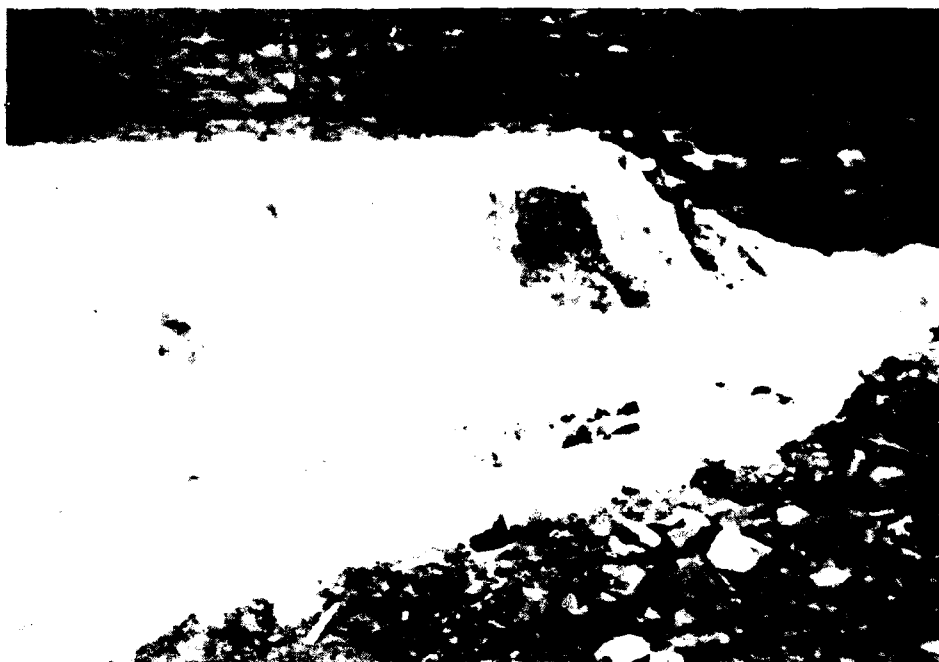
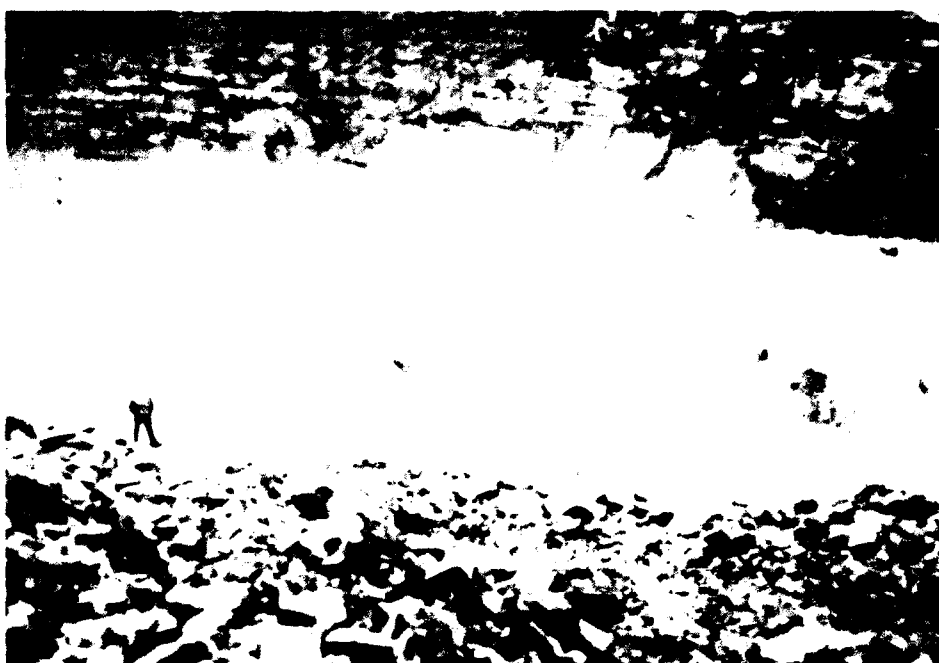
a. Early erosion

b. Terminal erosion

Figure 7. Breaching erosion of R. D. Bailey cofferdam

21. Damage. Breaching reached the upstream slope 4 hr after the start of overtopping, about the same time as maximum depth of overtopping. Figures 7a and 7b show notch erosion as breaching moved upstream. Subsequent lateral and downward erosion enlarged the breach to a width of 70 ft and to a level within 5 ft of the foundation (Figures 8 and 9). Once the water elevation started dropping between the diversion structure and the permanent cofferdam, erosion of the berm downstream of the cells was noted (Figure 10). This erosion continued for about an hour, and stabilized at a level 30 ft below the sheet pile cell elevation.

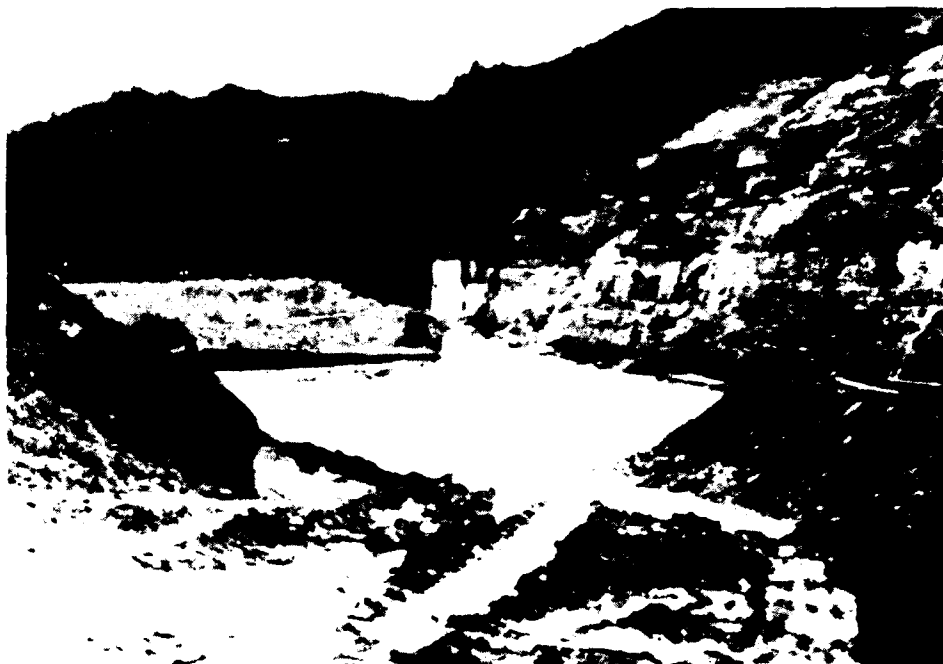
Figure 8. Breach of R. D. Bailey cofferdam looking upstream

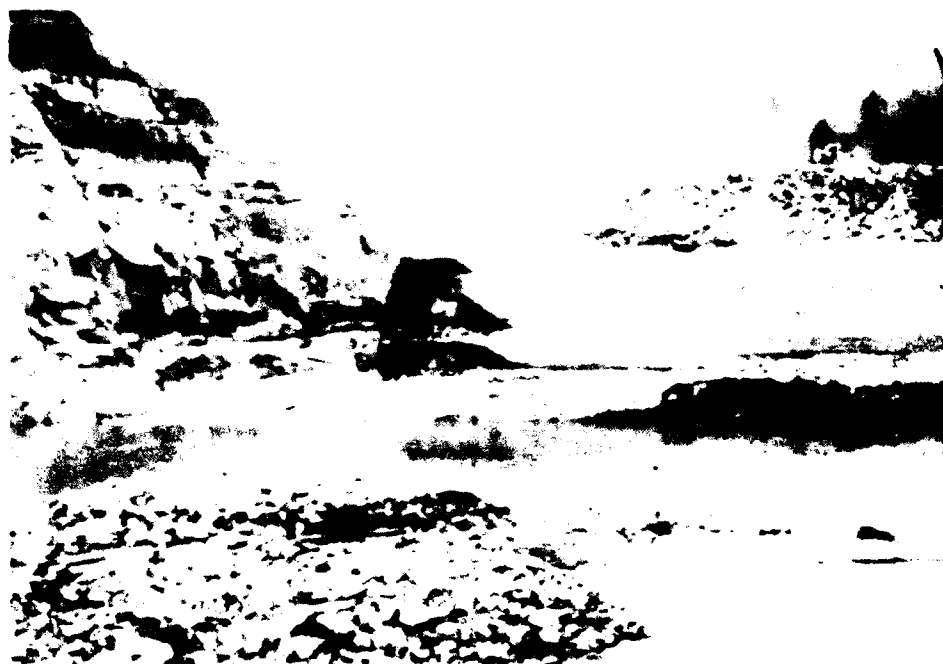
Figure 9. Breach of R. D. Bailey cofferdam looking downstream

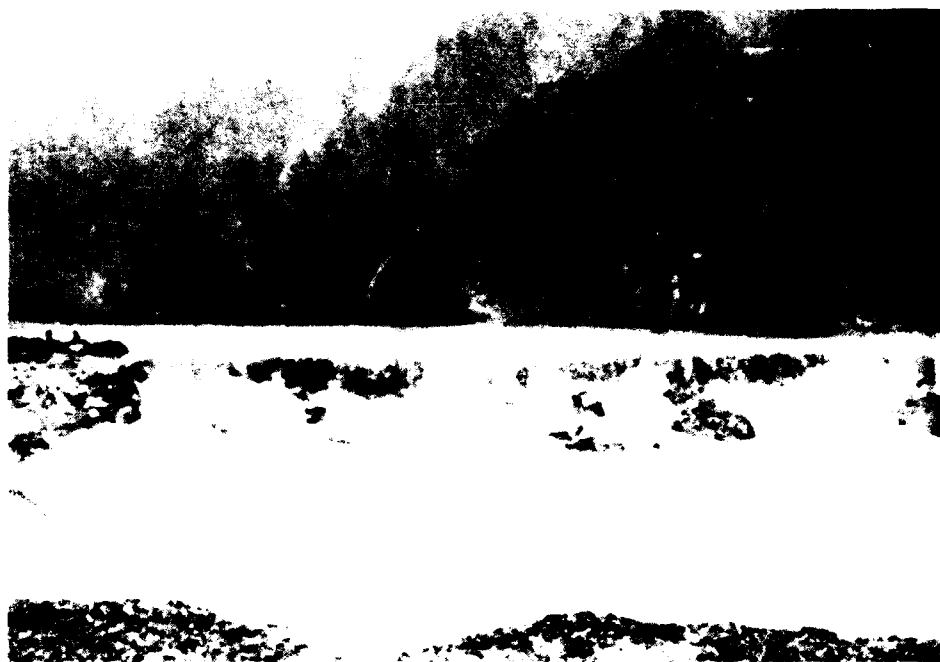
Figure 10. Berm erosion on downstream side of cellular cofferdam at R. D. Bailey Dam

22. The downstream berm of the diversion structure had been repaired to a 1V on 3H slope with a downstream toe of derrick stone (2- to 4-ft size), when a second overtopping occurred on 20 March 1975. This overtopping lasted for 15 hr, with a maximum depth of 2.5 ft, and caused erosion of the berm to the same level as the 14 March overtopping. Following this event, the berm

was restored to the 1V on 3H slope, with a splash pad at an elevation 15 ft below the structure crest. Twelve inches of concrete was placed over the berm with reinforced concrete on the splash pad. On 30 March 1974, a third overtopping, lasting 24 hr, with a maximum crest of 3 ft caused minimal damage to the berm area. The permanent cofferdam breach was left open during the 20 and 30 March events.

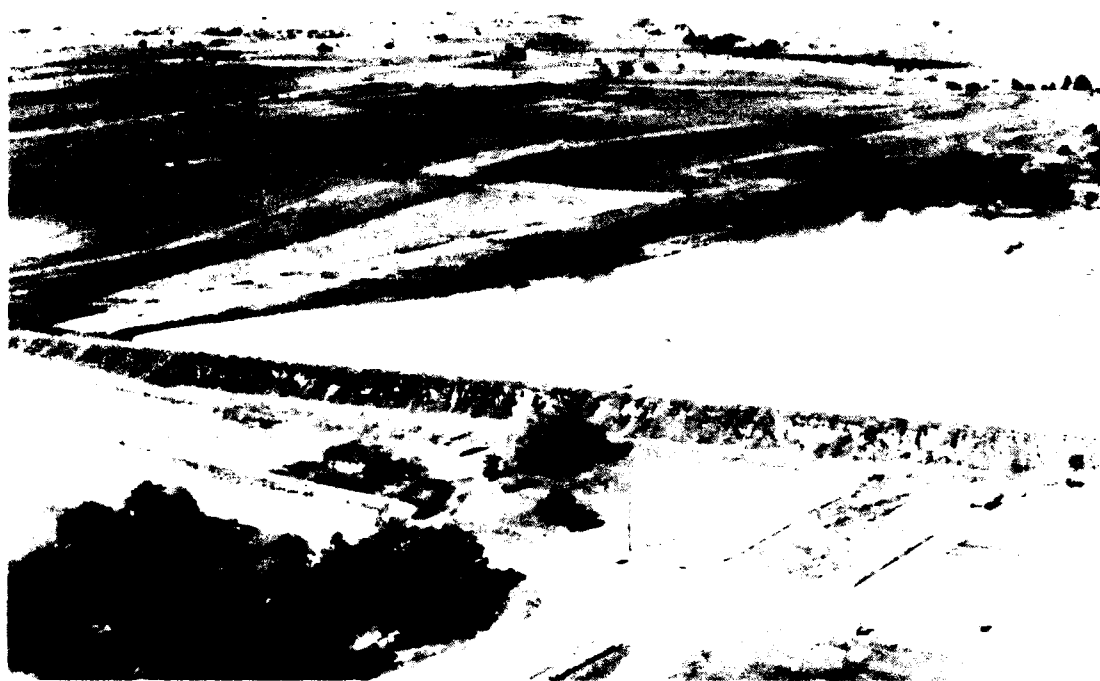
Figure 11. General view of Elm Fork Structure 9

26. Damage. Figure 11 is a general view of the damaged embankment; Figures 12a and 12b provide a closer view of the damaged downstream slope. The overtopping caused gullies or rills up to 5 ft in depth in the downstream slope. Apparently the overtopping lasted long enough to strip the vegetative topsoil and root structure from the compacted embankment layers along most of the embankment.

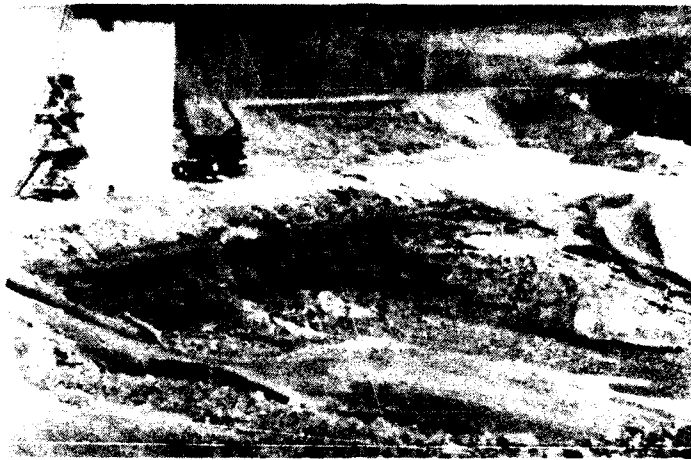
a. View from right abutment

b. Overtopping damage

c. General view of overtopping

Figure 16. B. Everett Jordan cofferdam

51. Damage. Figure 16c, a general view of the construction site during overtopping, shows the partially complete inlet works and cofferdam. The cofferdam suffered a general erosion of the downstream slope with a sharp drop of the crest (Figures 16a and 16b). Because it served as a roadway, the upper center part of the crest was probably better compacted than the near surface soil on the downstream slope. Relief was provided by a crude spillway quickly cut in the left abutment seen at the right edge of Figures 16a and 16b and just at the left end of the cofferdam in Figure 16c.
