Technical Report ARFSD-TR-92002

**M198 TOWED HOWITZER PRODUCT IMPROVEMENT PROGRAM  
(PIP) OVERVIEW**

**U.S. ARMY ARMAMENT RESEARCH, DEVELOPMENT AND  
ENGINEERING CENTER**

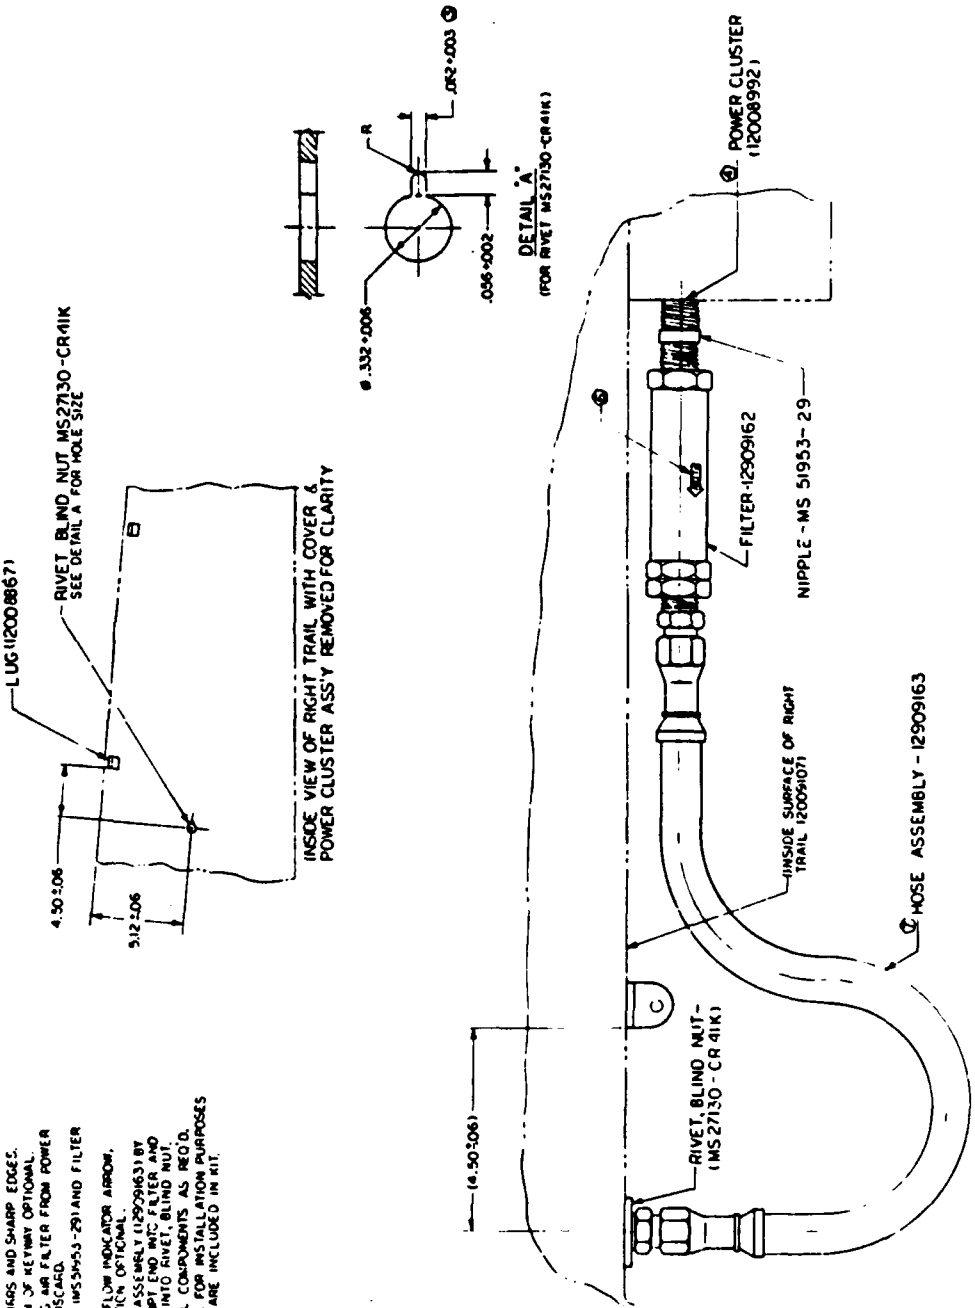
Figure 2. Snorkel system

INSTALLATION DETAIL

Incorporated into the present M198 master cylinder assembly is a carbon steel filter breather which allows the master cylinder's air side of the assembly to breathe from the environment when the weapon's brakes are applied or released. The breather is equipped with a metal filter that has 40 micron rating. The purpose of the breather assembly is to prevent moisture build-up in the assembly. The problem with the present system is that when the brakes are released a vacuum is created and water and/or foreign matter is taken into the air side of the cylinder, depending on what environment is being experienced at the present time. This is undesirable because water in the air housing could lead to corrosion, and the intake of foreign matter could cause undesirable functioning of the assembly.

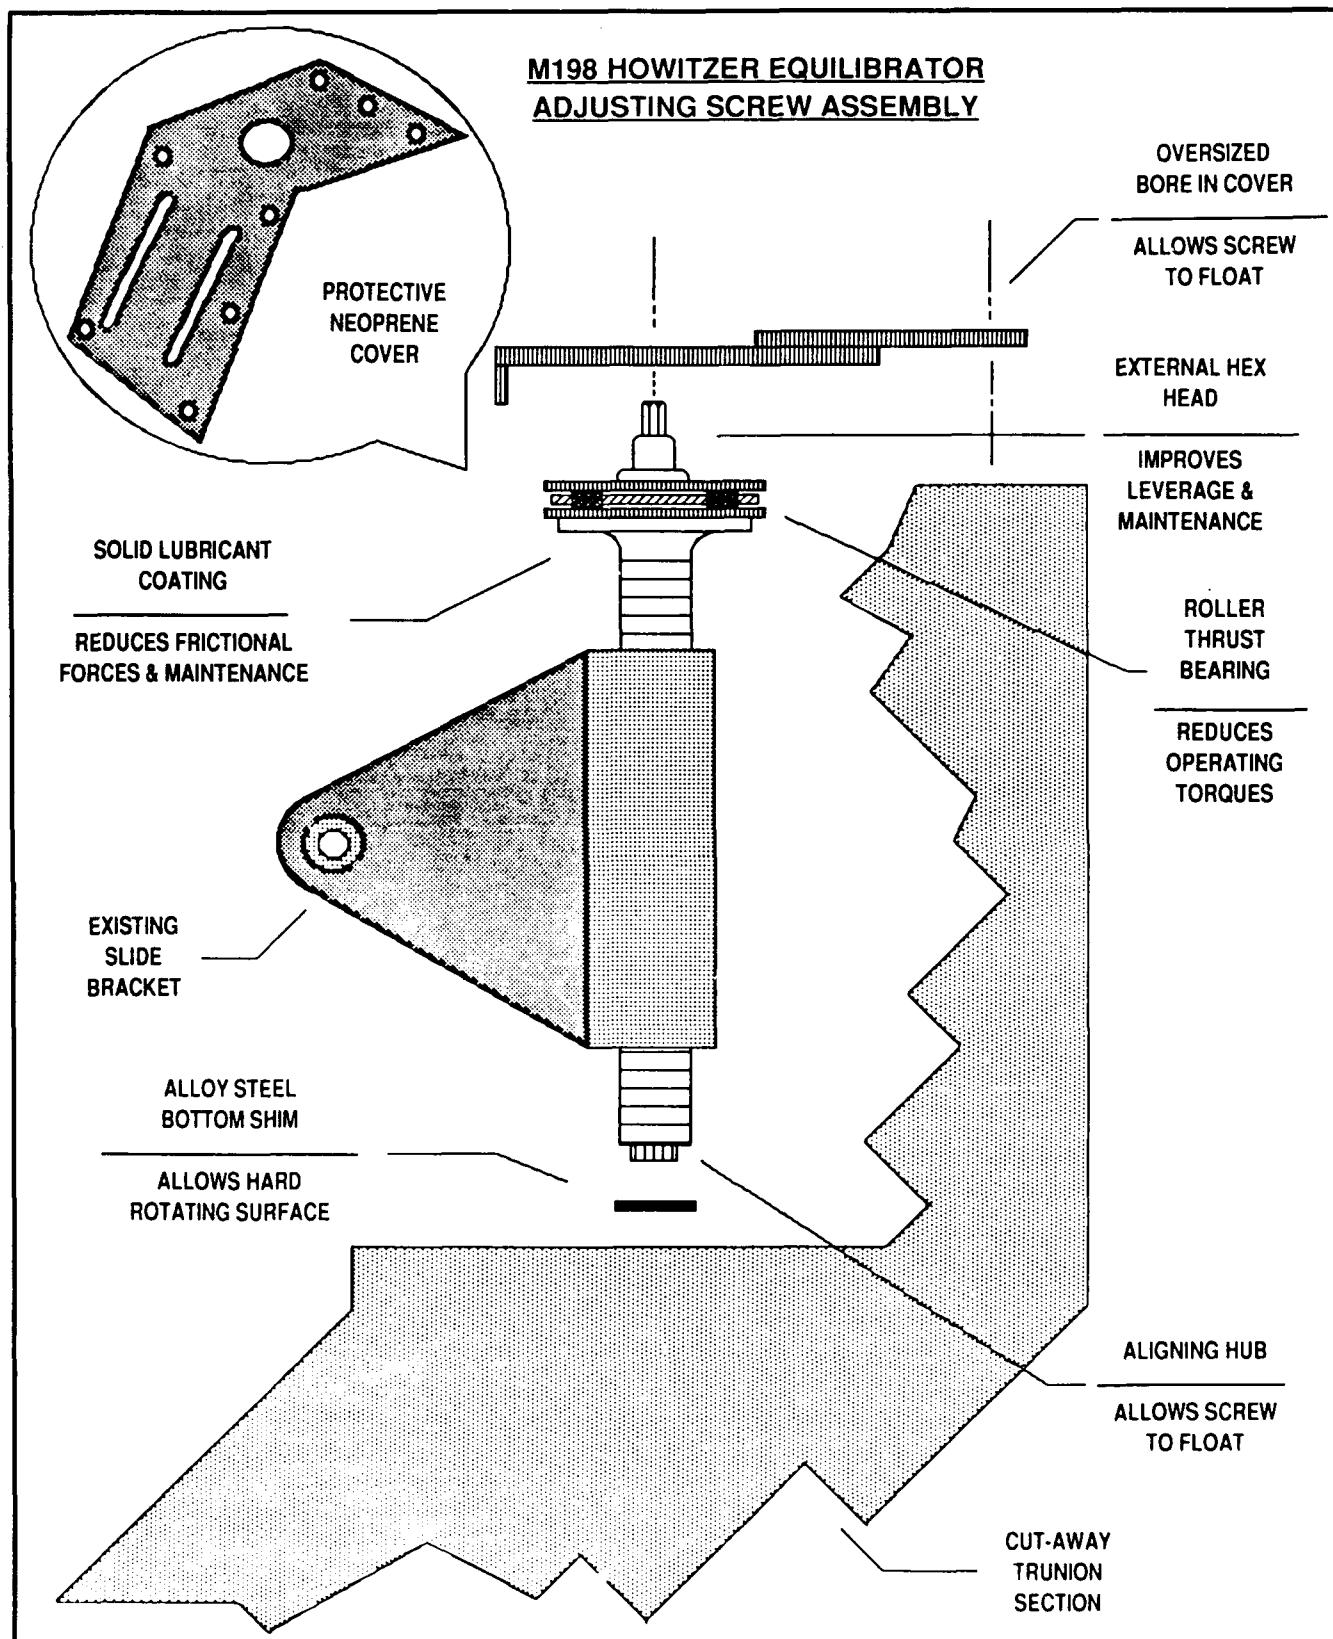
Figure 8. Equibrator adjusting screw assembly

# **M198 HOWITZER EQUILIBRATOR ADJUSTING SCREW ASSEMBLY**

Changing the adjusting screw material from bronze to steel reduced the deflection of the screw. This change prevents the screw from bending at its neck, eliminating damage to the interfacing threads of the screw and slide bracket and the binding between the interfacing threaded slide bracket and its attaching guide. The material change was implemented since possible binding due to screw deflection was eliminated.

The bore diameter on the slide bracket cover was increased to eliminate binding between this cover and the top of the adjusting screw. This condition allows movement of the interfacing screw at this location. By increasing the bore diameter of the covers, all radial loads will be taken up by the slide bracket and not the cover. Therefore, any binding between the cover and screw is eliminated due to cocking of the adjusting screw.

The recommended (fig. 8) and original design were tested, and operational torques were taken at various gun tube elevations (tables 1 and 2). It was demonstrated that the operating torques at upper elevations (+250 mil and above) were reduced by more than 50%. In conclusion, the desired 60 ft-lb operating torque at travel lock position (+250 mil) was met by the new adjusting screw assembly.
