TECHNICAL REPORT EL-92-20

DISTRIBUTION AND ABUNDANCE OF FISH ABOVE HARTWELL DAM DURING A PERIOD OF ENTRAINMENT

Richard L. Kasul, Kenneth E. Conley

Environmental Laboratory

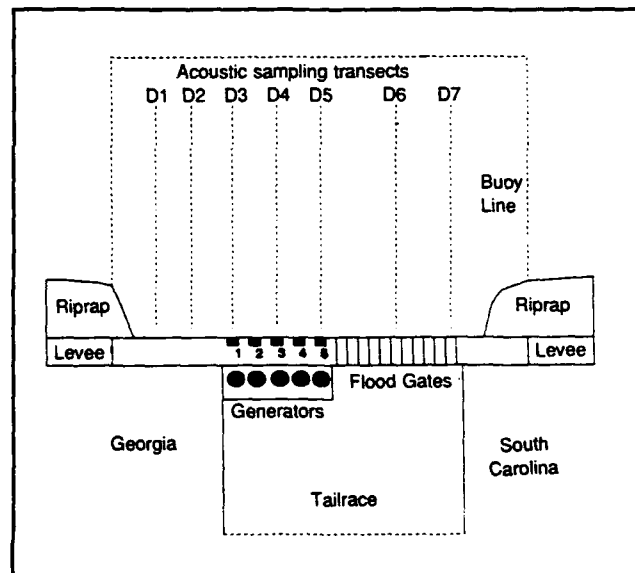
Figure 1. Schematic diagram of Hartwell Dam with acoustic transects D1-D7 in the forebay. Diagram is not shown to scale

The forebay surveys were performed along fixed survey transects located inside the buoy line. A preliminary layout used on the first four surveys of 3 September 1990 consisted of a set of three to four transects extending the length of the concrete portion of the dam at successive distances from about 3 to 100 m from the dam face. The remaining 11 surveys consisted of a set of seven transects running perpendicular to the dam from the buoy line to within 2 to 3 m of the face of the dam (Figure 1). Three of these transects (D3, D4, and D5) were located directly in line with the water intakes for generating unit Nos. 1, 3, and 5. Two additional transects (D1 and D2) were located to the west of the intake area, and two others (D6 and D7) were located to the east of the intake area at floodgate Nos. 6 and 12.

The transect layout was changed from the preliminary to the final arrangement to reduce the incidence of sound reverberation from the face of the dam. With the preliminary arrangement, any fish within about 5 m of the dam were obscured by sound reflected from the dam. The reverberation intensity gradually decreased over a distance from approximately 5 to 20 m from the dam, but levels within this range were still high enough to affect quantitative fish measurements. With the final transect arrangement, acoustic interference was minimal even within 3 m of the dam (cf. Appendix A, p A2), and it did not affect quantitative analysis of fish detections.

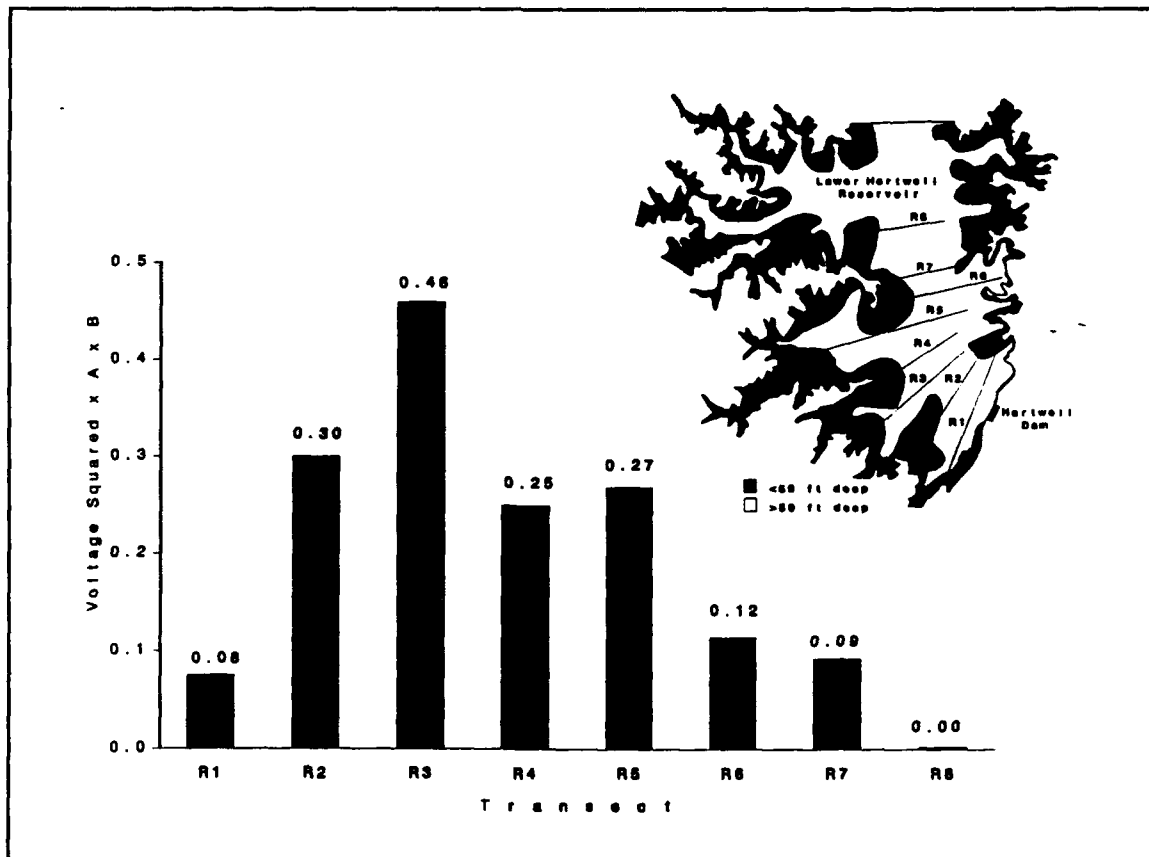
Figure 5. Acoustic integration estimates of fish biomass for individual transects of an acoustic survey performed in Hartwell Dam forebay on 5 September 1990. Integrator biomass units correspond to fish per square meter over the 28- to 40-m depth stratum
