# Evaluation of a Pneumatic Guy-Line Deicing Boot

John W. Govoni and Charles H. Franklin

February 1992

**U.S. Army Corps  
of Engineers**  
Cold Regions Research &  
Engineering Laboratory

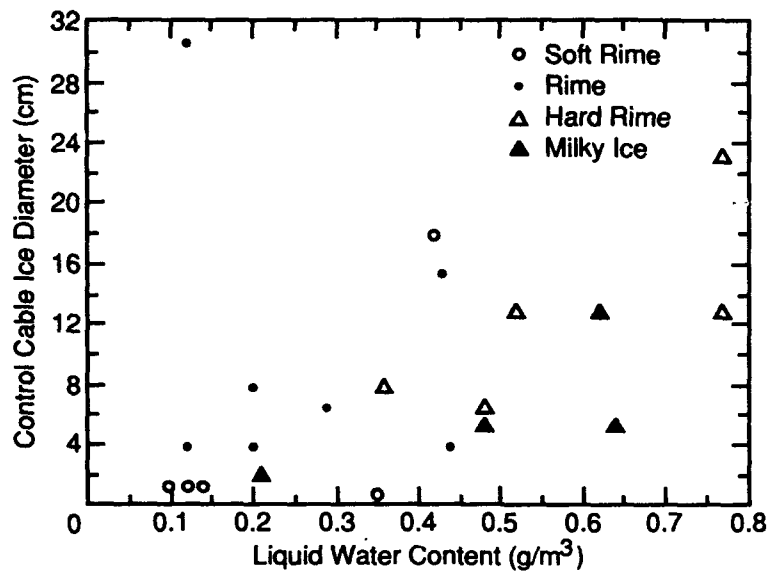
Figure 5. Ice accumulation on control cable versus the measured liquid water content from Table 1.

As an aside, we have plotted the ice accumulated on the control cable versus the measured LWC from the data in Table 1 in Figure 5. The points have also been labeled according to the type of ice formation. Unfortunately, the LWC can not be measured during the glaze events because of excessive moisture during these warm conditions. This figure shows a general relationship between the ice accretion and the LWC. With the one exception of the 30.5-cm rime case, the accretion amount generally increases with the liquid water content. There is considerable scatter shown owing to other factors involved, such as the temperature, wind speed, droplet

size and length of accretion period. It is also apparent that most soft rime and rime accumulations are generally small, occurring at low values of LWC, while the milky and hard rime form large accumulations in clouds having a high LWC. This figure makes clear that the boots were evaluated under a large range of icing conditions.
