MTL TR 92-31

## TESTING AND ANALYSIS OF MODIFIED HMMWV FRONT LIFT PROVISIONS

May 1992

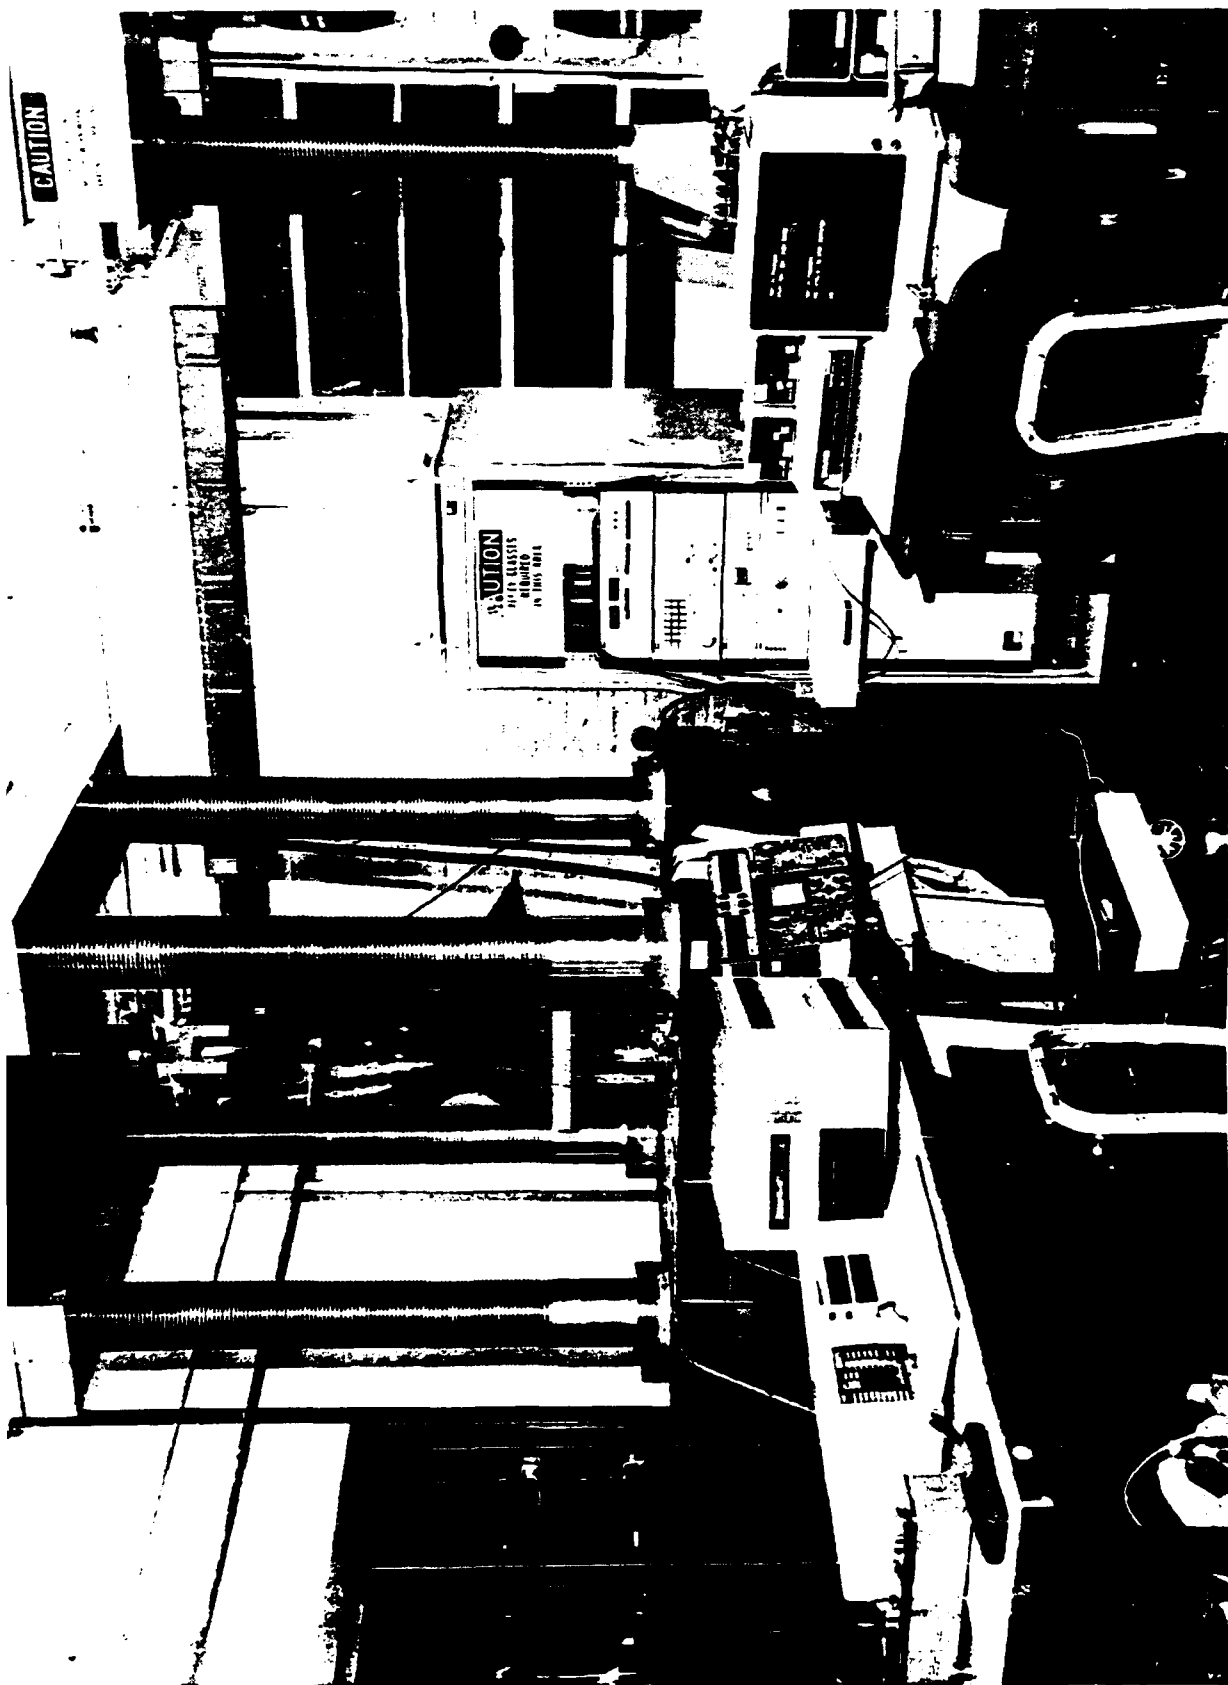
Figure 7. Ultimate pull test - machine and setup.

To assess the overall strength of the provision, an ultimate pull laboratory test was performed for each load configuration utilizing a new provision for each test (designated provisions A and B). These tests were performed in a 150,000 lb hydraulic tension/compression test machine (see Figure 7).
