Report No. NAWCADWAR-92018-60

STRESS CORROSION SUSCEPTIBILITY OF ULTRA-HIGH STRENGTH STEELS FOR NAVAL AIRCRAFT APPLICATIONS

Joseph Kozol and Charles E. Neu
Air Vehicle and Crew Systems Technology Department (Code 6063)
NAVAL AIR WARFARE CENTER, AIRCRAFT DIVISION
Warminster, PA 18974-5000

10 JANUARY 1992

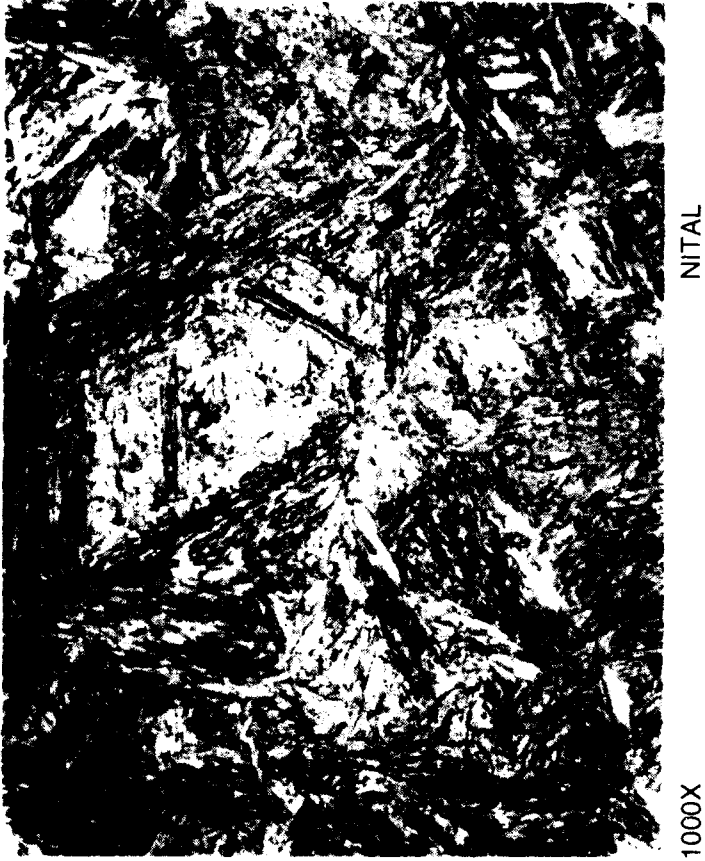
Figure 13. HYTUF Steel.

Specimens for metallographic examination were prepared by standard techniques from the cantilever bend test bars. The ultra-high strength steels were heat treated to the desired strength level after specimen fabrication, resulting in a tempered martensitic matrix. Tempered martensite provides the optimum combination of strength and toughness for these steels. The microstructures of AF1410, 0.20C AF1410 and AerMet 100 are shown in Figures 10 through 12. These low carbon steels are characterized by a lath type, low carbon martensite with a high dislocation density substructure (ref. 6). It may be seen that the microstructures are extremely fine with no coarse carbides visible. This microstructure is not inherent to the materials, but is produced by unique thermomechanical processing. The presence of fine M_2C type carbides is not revealed in the optical microscope at 1000X magnification. With this microstructure, the steels exhibit high strength and high fracture toughness. The microstructure of HYTUF, shown in Figure 13, also shows relatively few carbides under the optical microscope. Its low environmental resistance is attributed to the high iron, low alloy content.

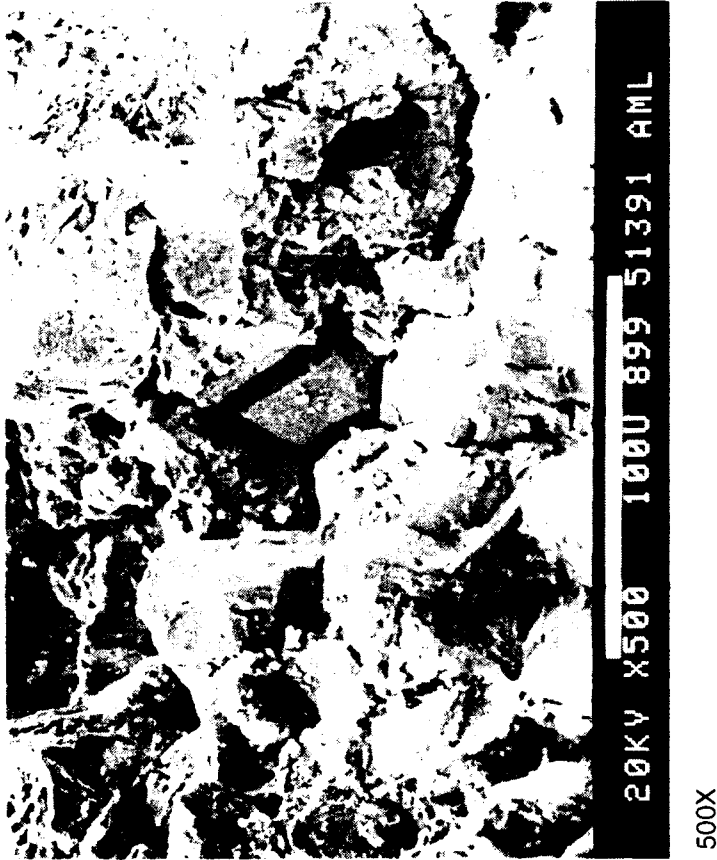
Figure 18. HYTUF Steel-Stress Corrosion Fracture.

In order to provide a frame of reference for observation of stress corrosion fracture surfaces with coverings of corrosion products, a fractograph of the final overload region on an AerMet 100 specimen is shown in Figure 15. The fractograph illustrates typical microvoid coalescence (dimpled rupture), characteristic of overload fractures. In contrast, Figures 16 through 18 are stress corrosion crack regions of AerMet 100, AF1410 and HYTUF specimens. These and all other materials tested in this study show predominantly intergranular fracture mode in the stress corrosion crack region.
