MISCELLANEOUS PAPER CERC-92-8

## BEACH RESPONSE TO THE REDINGTON SHORES FLORIDA BREAKWATER

September 1992

Final Report

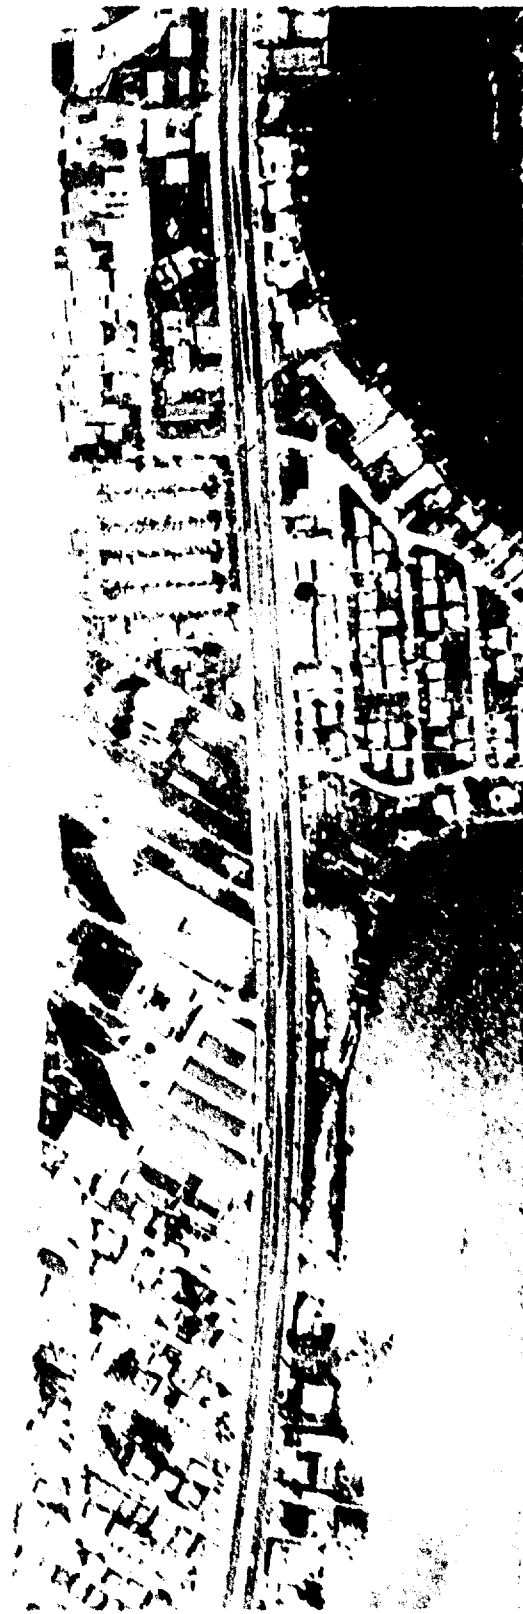
Figure A7. Redington Shores. Florida breakwater after modification and beach nourishment. September 1988
