USACERL Technical Report FF-92/08  
July 1992

# Seven-Year Summary of Fort Irwin, CA, Family Housing Comparison Test: Operation and Maintenance Costs of Manufactured vs. Conventionally Built Units

by  
Robert D. Neathammer

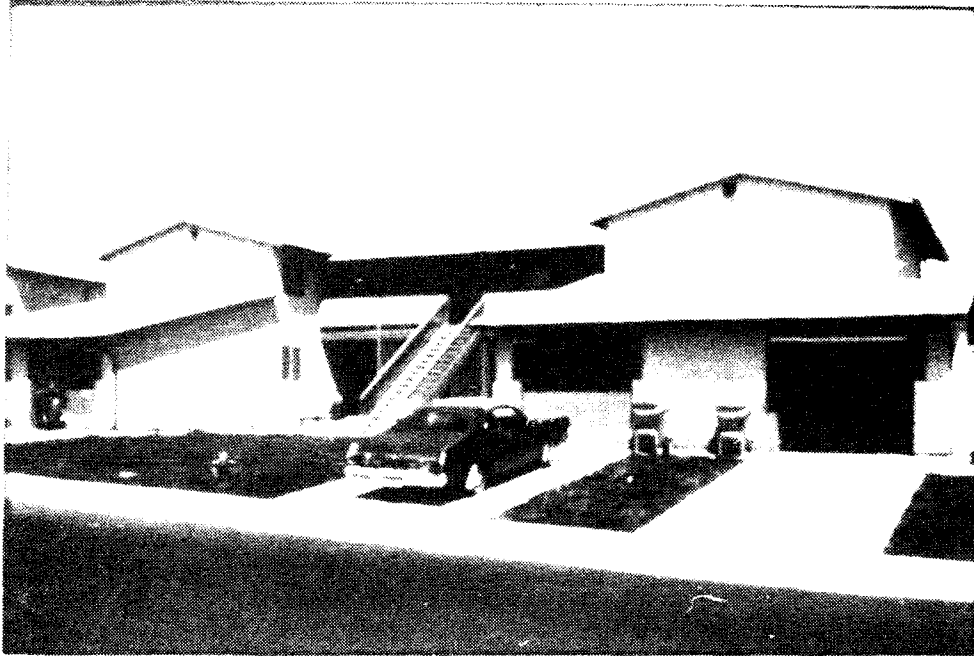
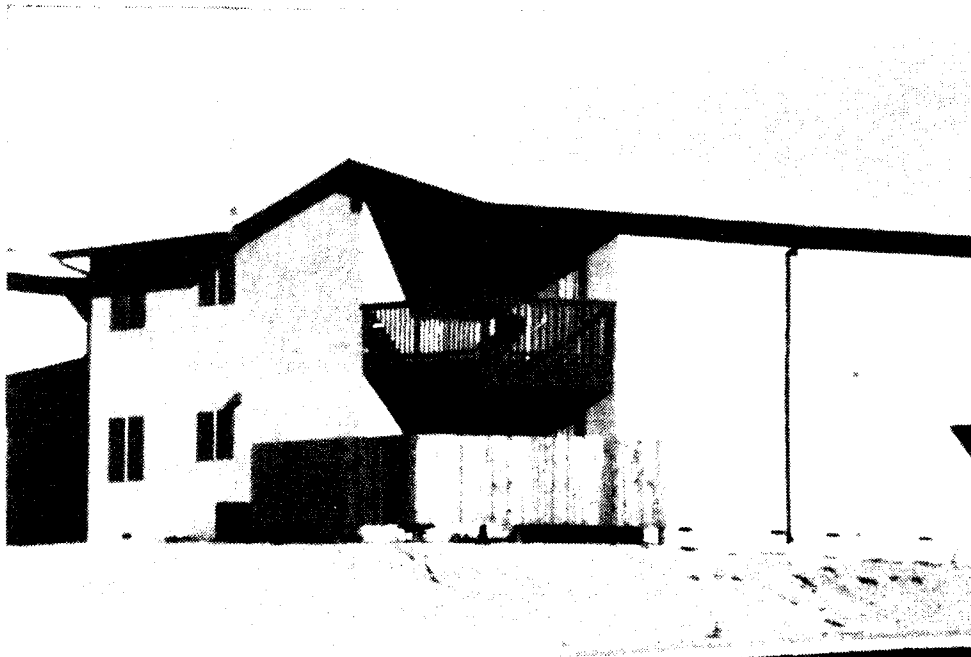
Figure 1. Front and rear views of typical MHUs.

These 200 units consist of 50 two-story fourplexes (two units on each of the first and second floors). Net floor area is 950 sq ft/unit.\* These were constructed on perimeter footing with wood floors and crawl spaces. Each upper unit has a balcony-porch and each lower one has a patio with privacy fencing. Figure 1 shows front and rear views of typical buildings. Each unit has a refrigerator, gas range, gas water heater, garbage disposal, dishwasher, central air conditioning, and gas-fired forced-air furnace (all provided by the contractor). Each unit has two bedrooms, a kitchen, living-dining area, one bathroom, utility room, and a one-car garage. The garage was constructed on site.

Front View - MHU

Rear View - MHU

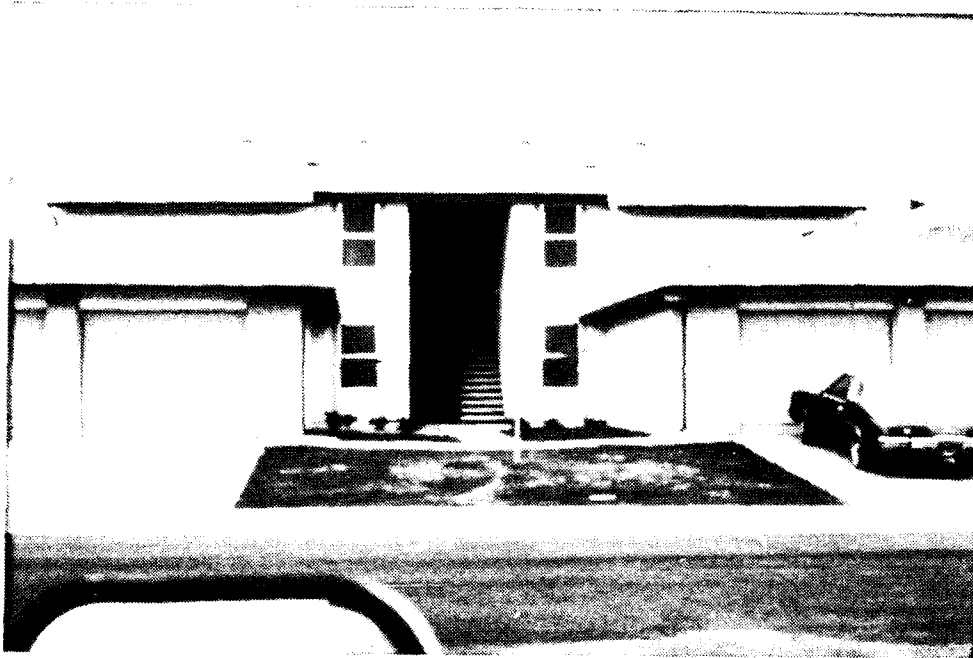
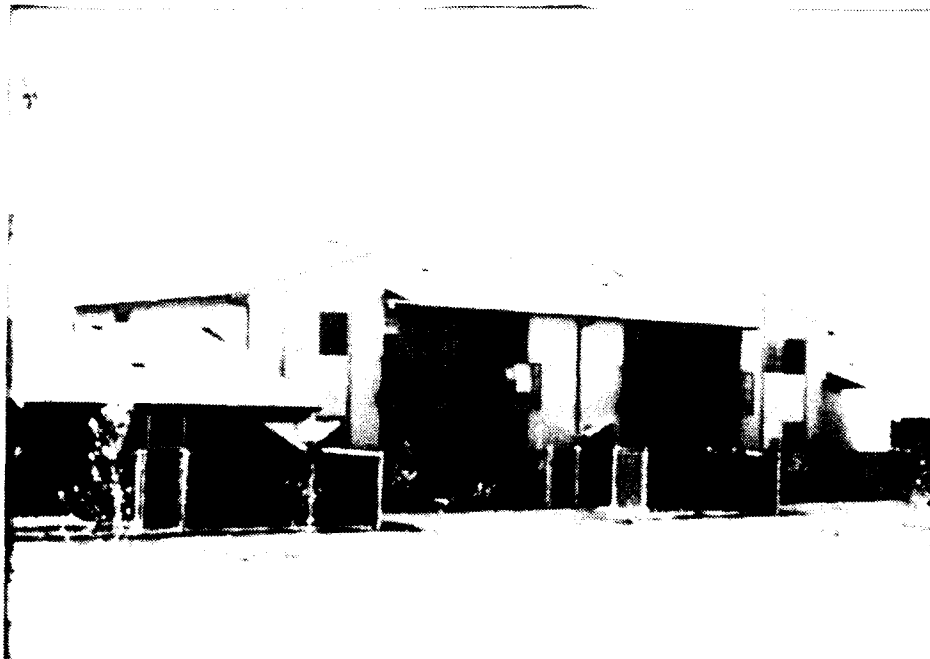
Figure 2. Front and rear views of typical CBUs.

Front View - CBU

Rear View - CBU

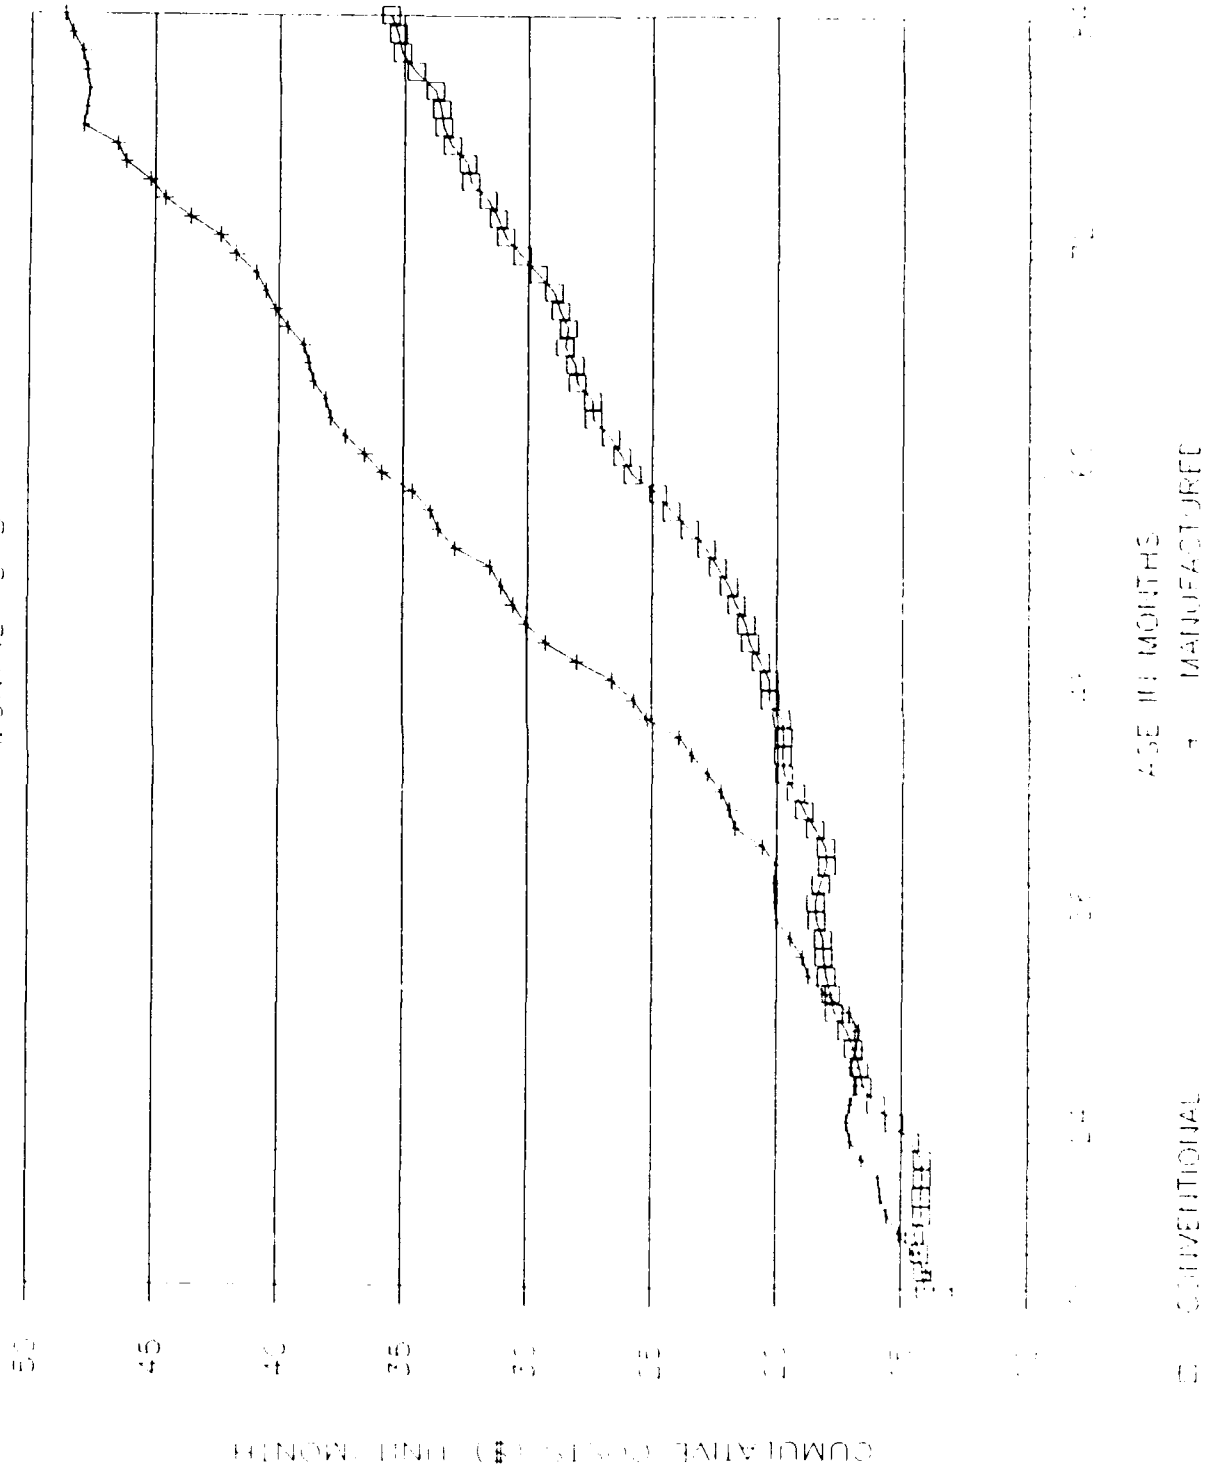
Figure 3. Cumulative cost per unit per month for ages 15 through 84 months.

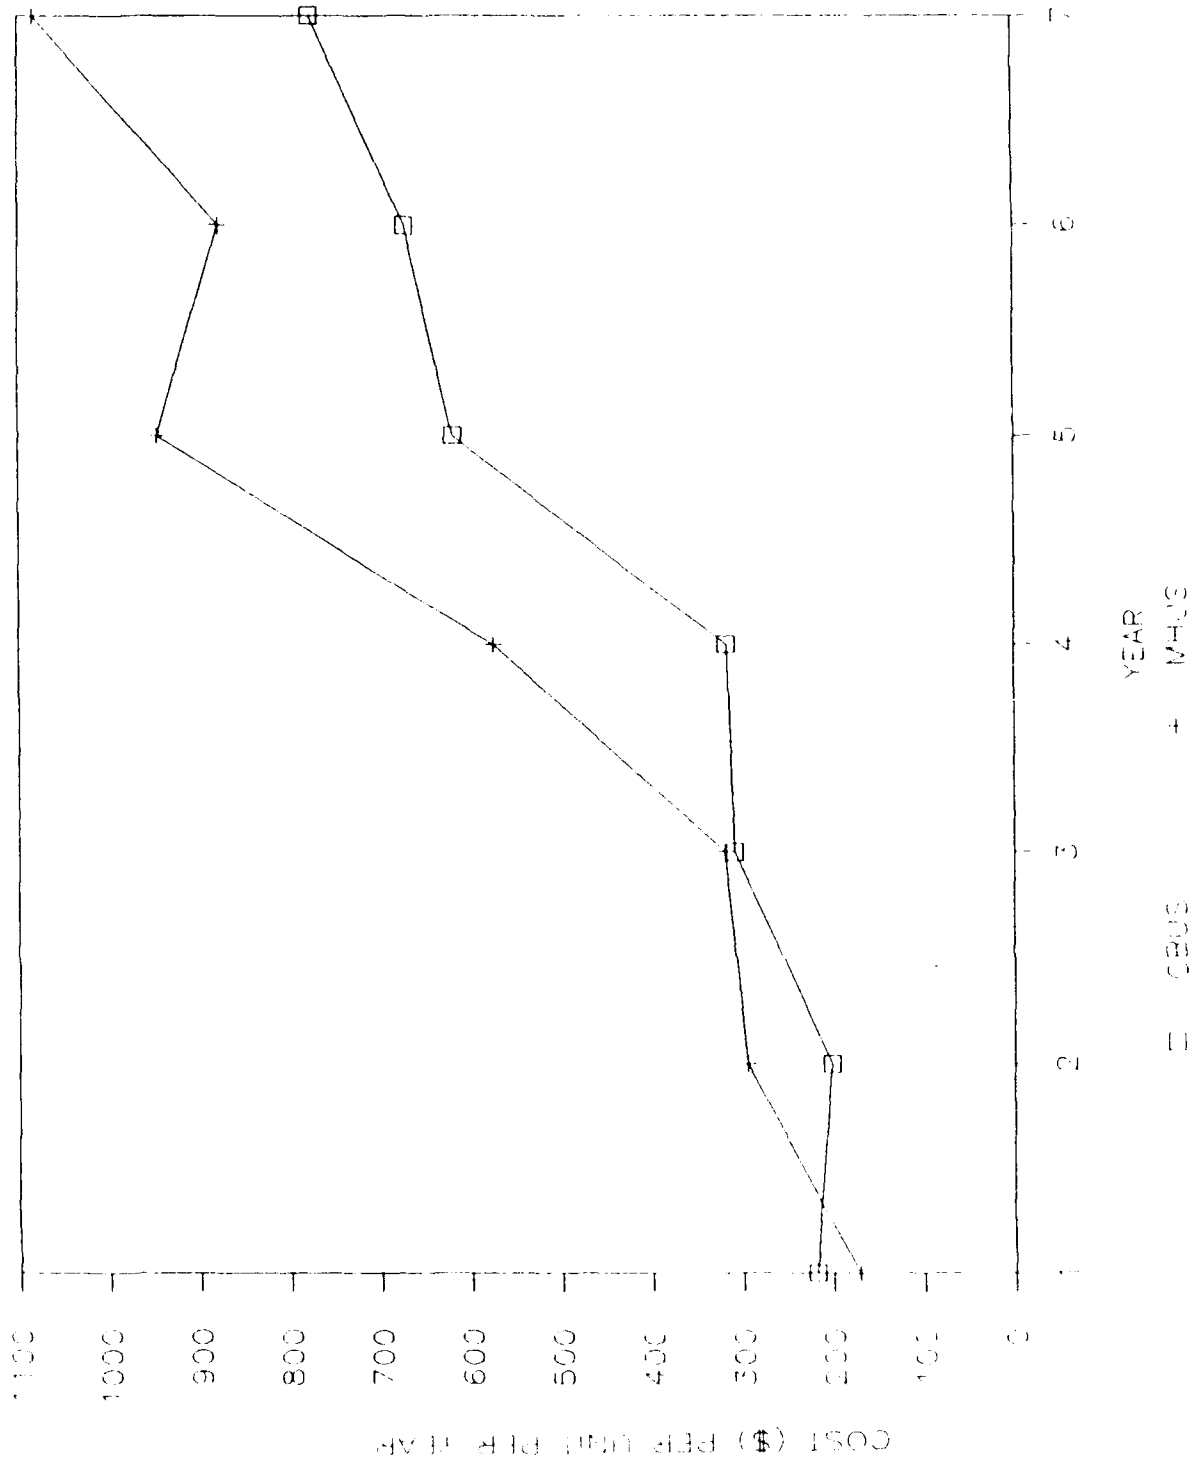
Figure 4. Total costs per unit per year.

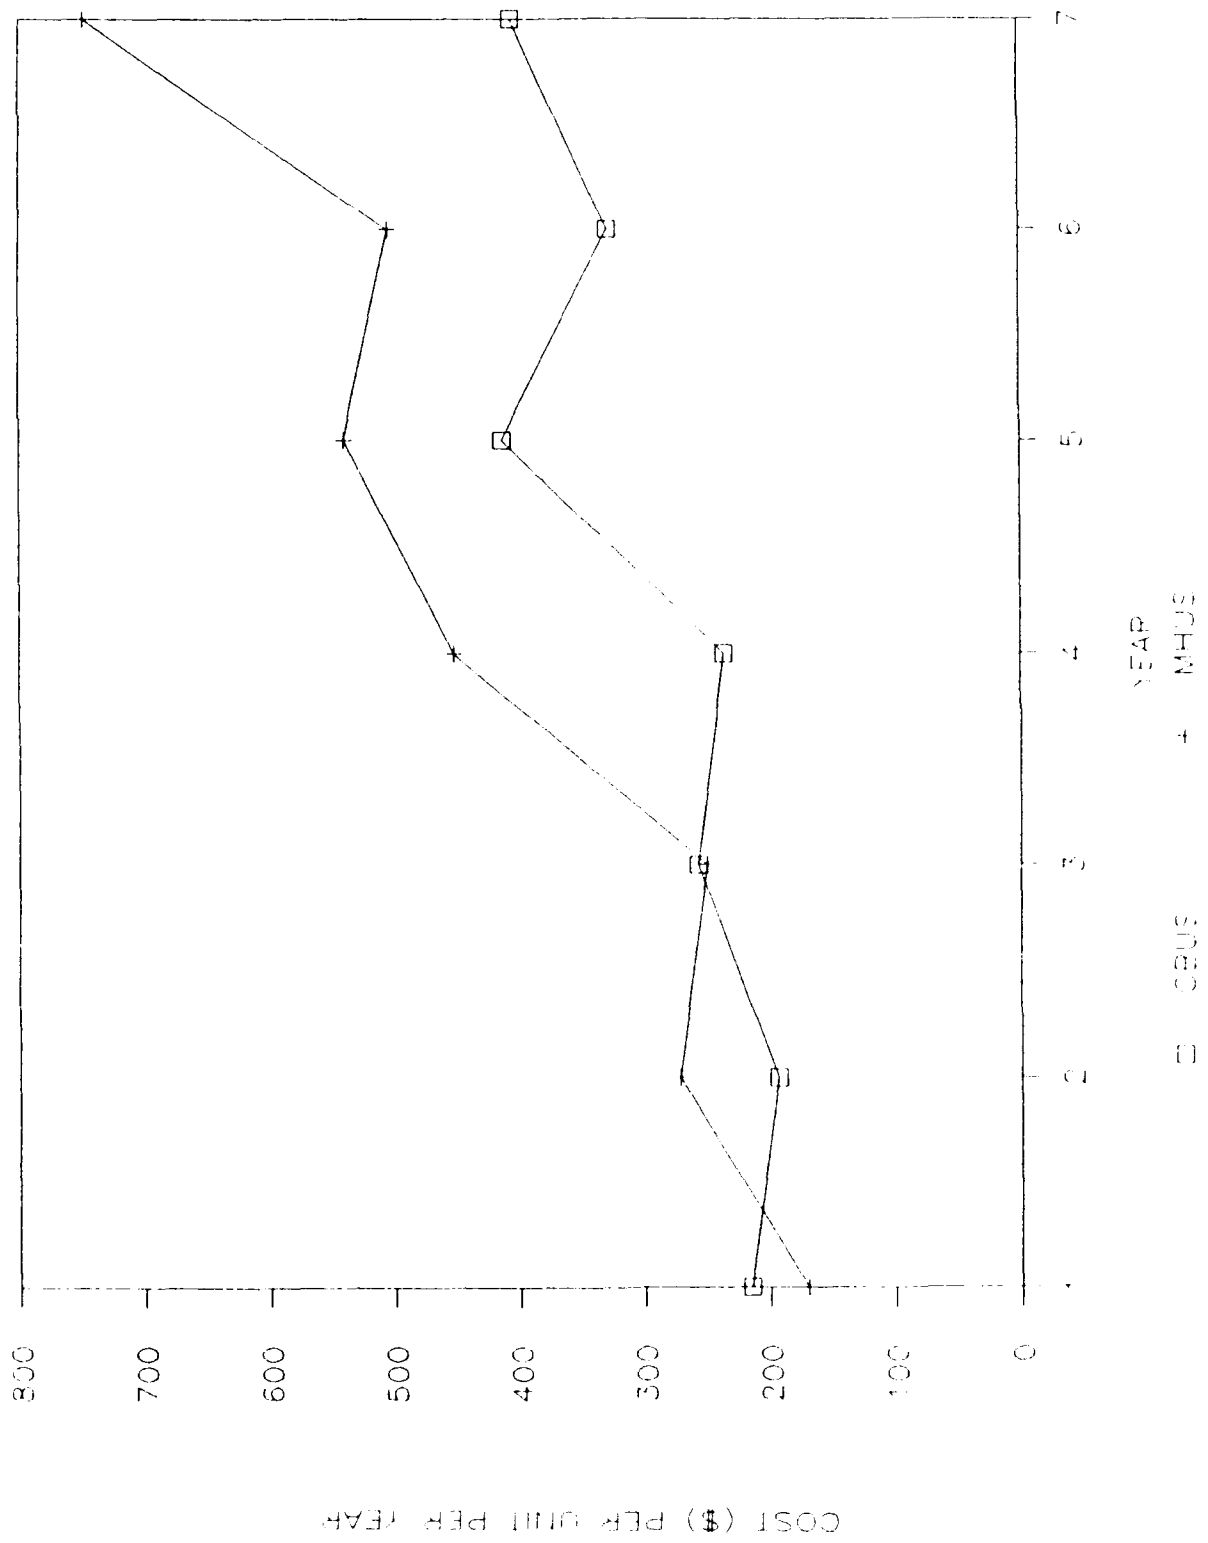
Figure 5. Costs per unit per year excluding interior painting costs.

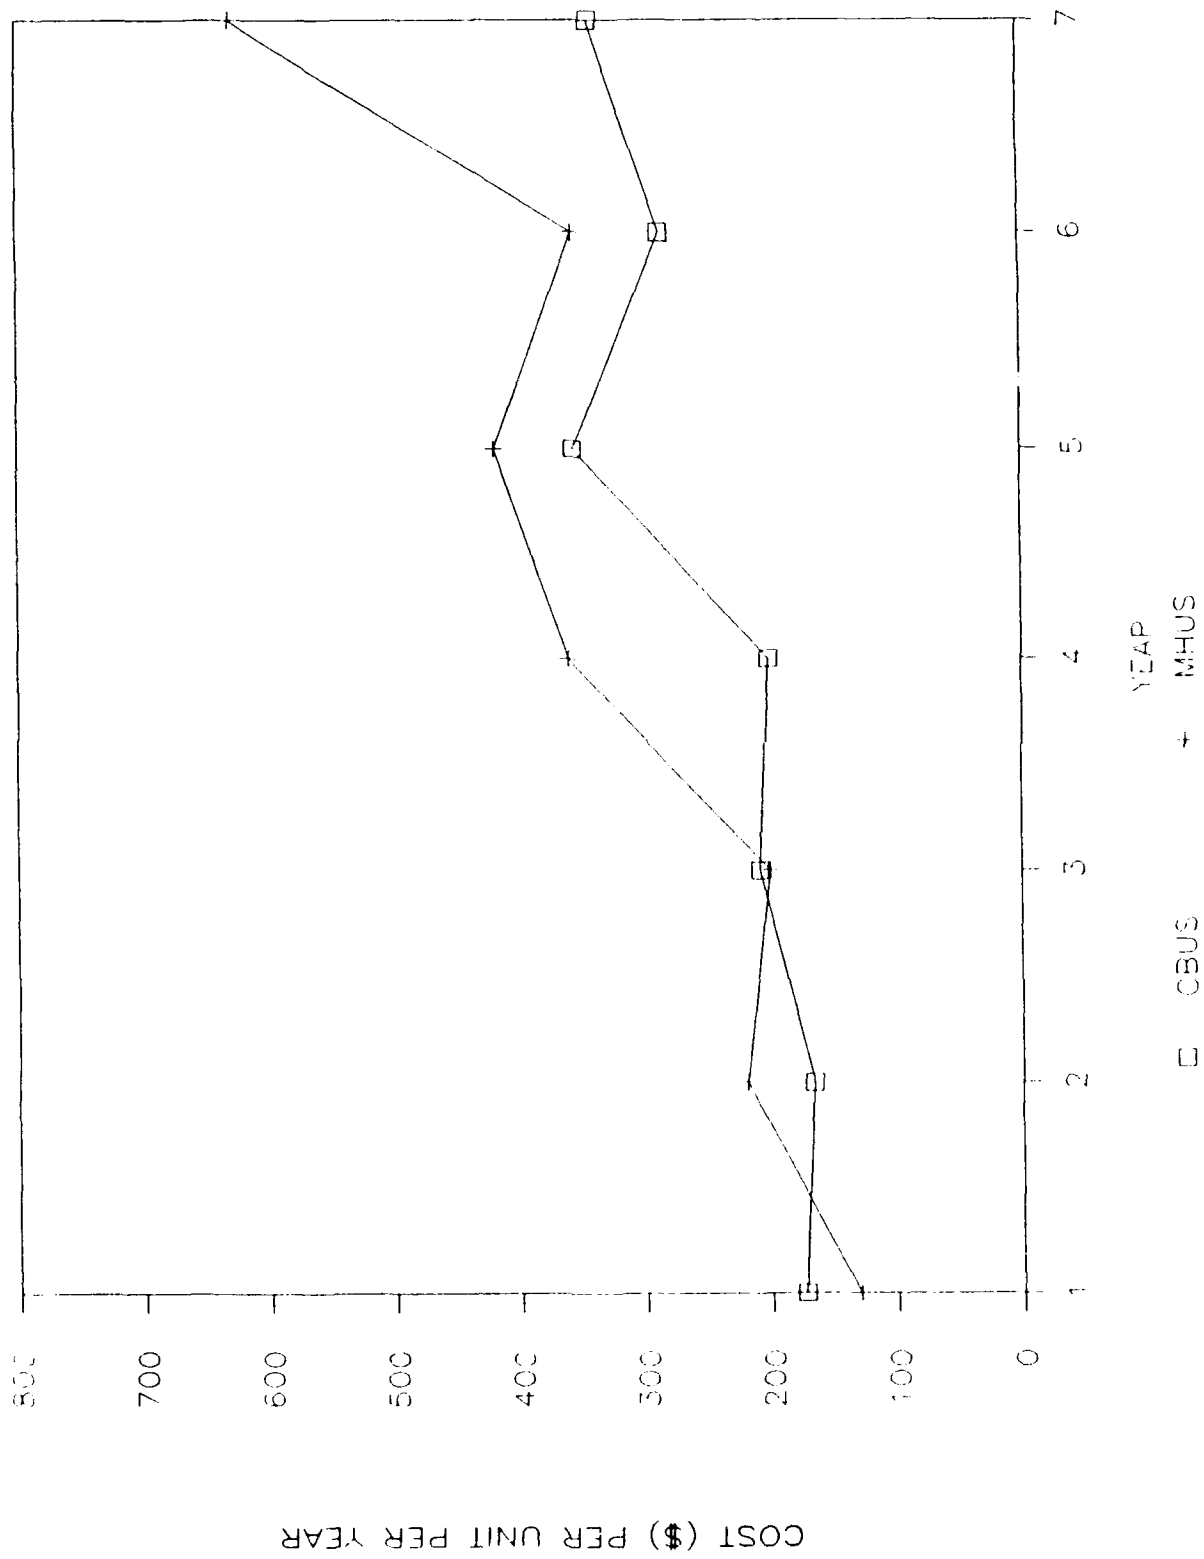
Figure 6. Costs per unit per year excluding certain equipment and painting costs.

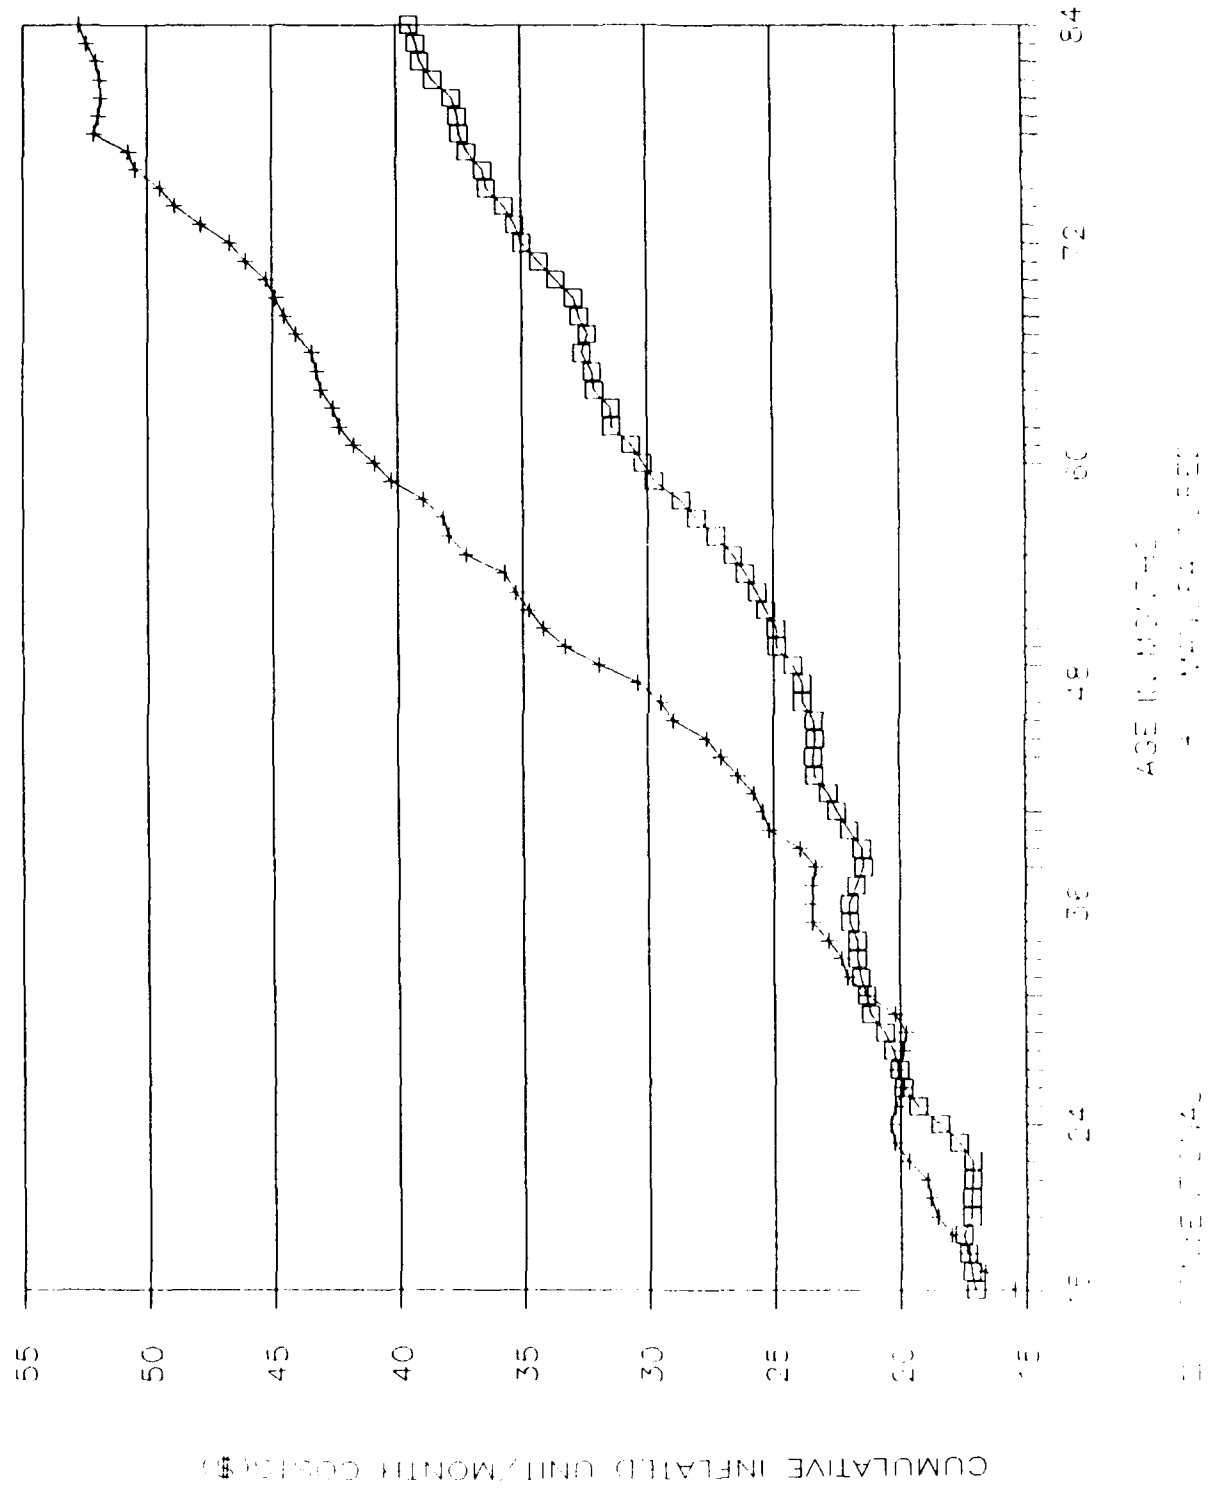
Figure 7. Cost per unit per month over time, adjusted for inflation.

The difference for cost/unit/year is \$160 for actual costs and \$162 for inflated costs. Thus, there is no difference in the two comparisons.

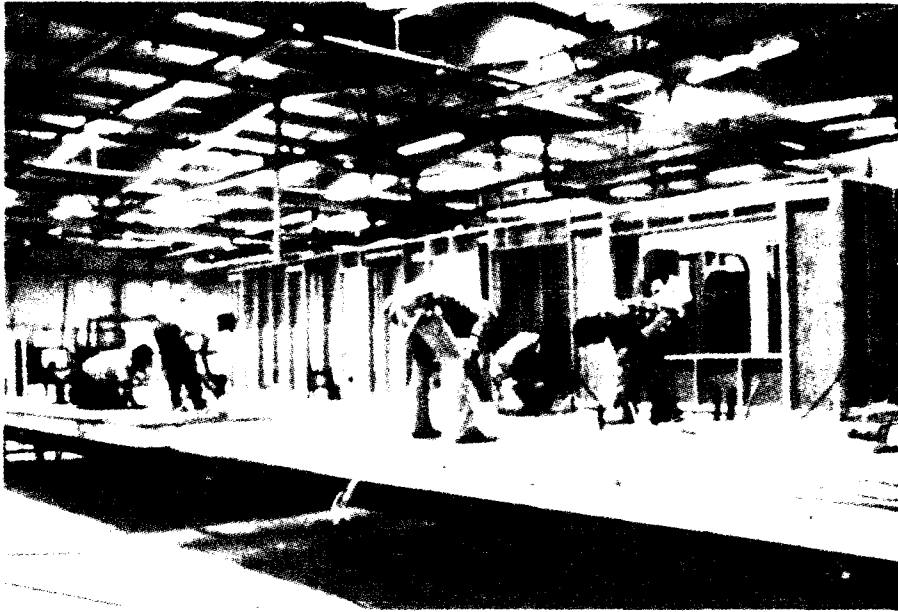
Figure A1. Construction in the factory.

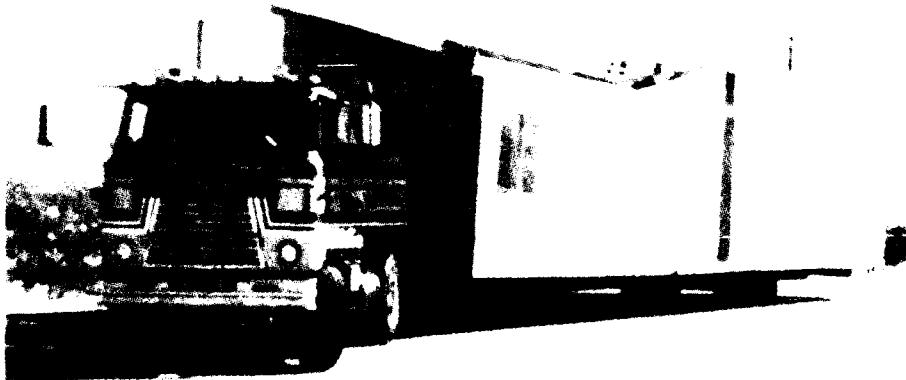
Figure A2. Two modules loaded on truck.

As is discussed in Chapter 10, the eaves were attached using flat metal straps and folded onto the roof for transportation (this decreased the width for highway transportation). Upon assembly at the site, the eaves were folded down and secured with only a few nails. This was a defect in the design/construction, as the eaves began to loosen and one actually fell to the ground. All eaves were then permanently secured at a cost of over \$6000 per building.

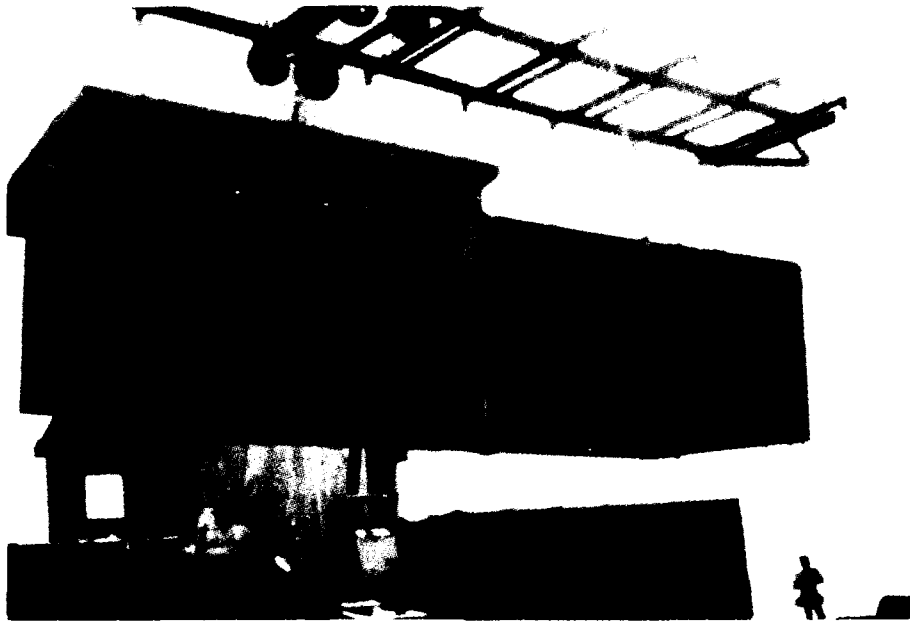
Figure A3. Module being set in place by crane.

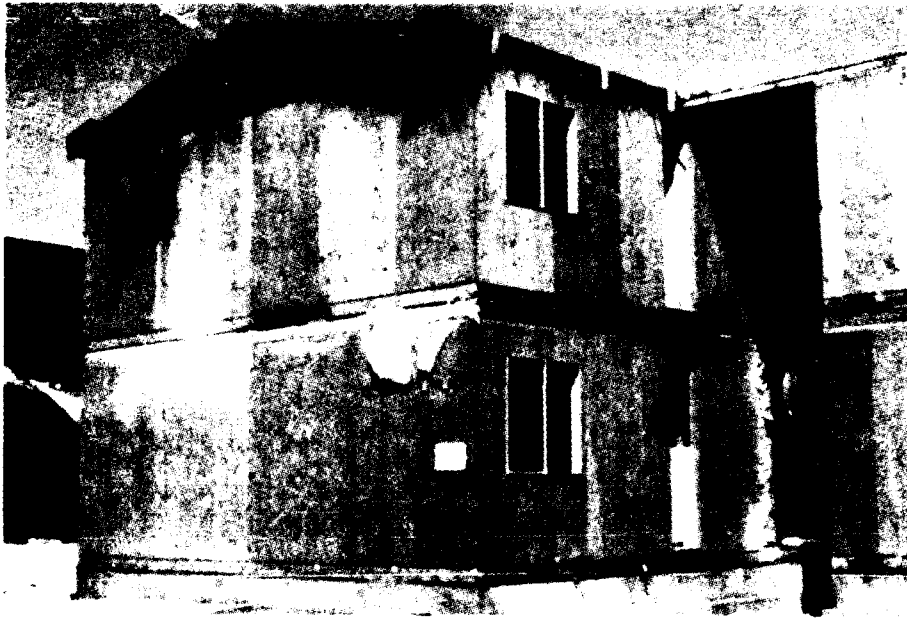
Figure A5. Completed assembly of modules.

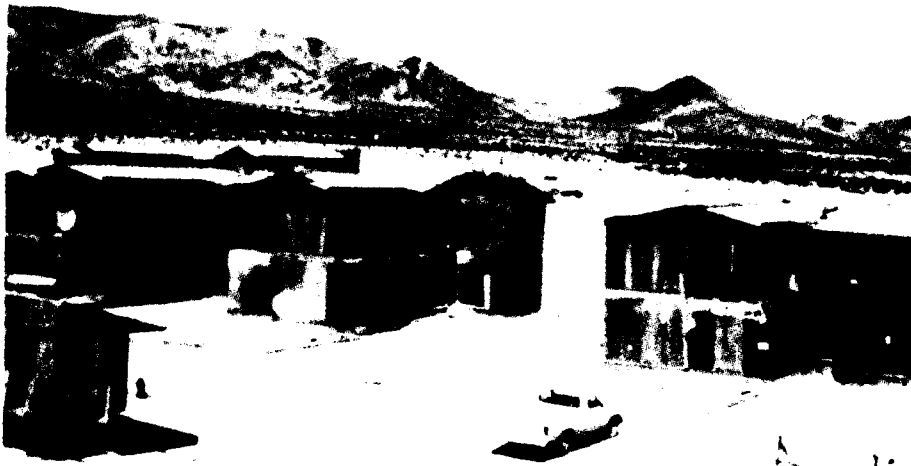
Figure A6. Overview of buildings without garages.
