**Behavior of a Centrally Notched  
Cross-ply and Unidirectional  
Ceramic Matrix Composite in  
Tension-Compression Fatigue**

Presented to the Faculty of the School of Engineering  
of the Air Force Institute of Technology  
Air University  
In Partial Fulfillment of the  
Requirements for the Degree of  
Master of Science in Aeronautical Engineering

December 1992

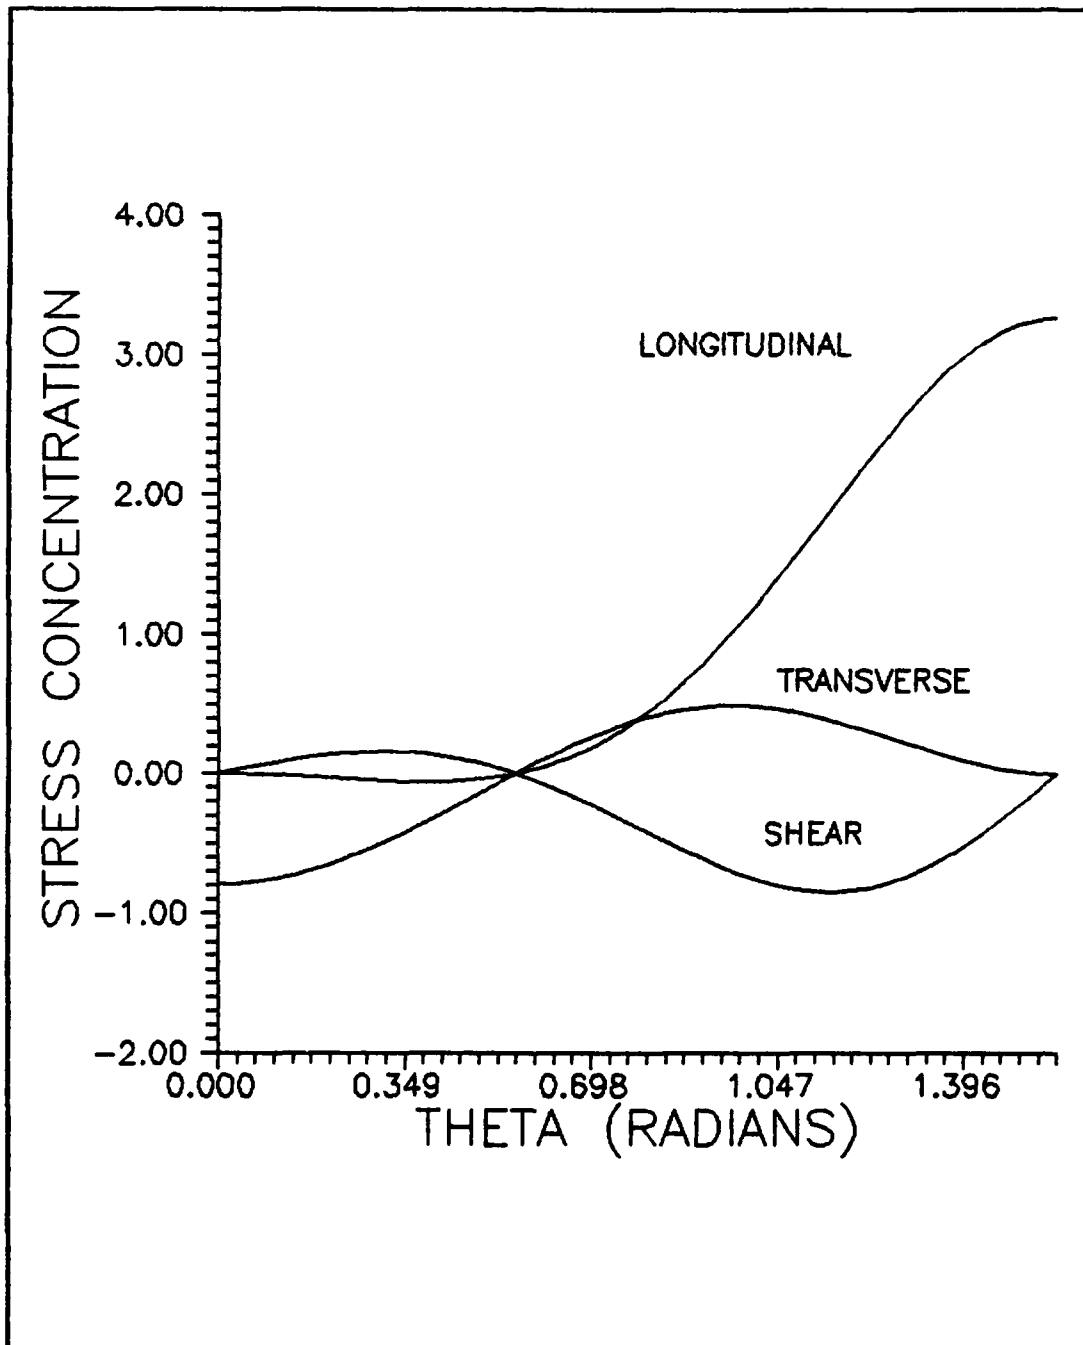
**Figure 2 Stress Concentrations at the Hole Periphery in an Infinite Orthotropic Plate**

This gives the stress concentrations from 0 to 1.57 radians ( $90^\circ$ ) as shown in Figure 2.

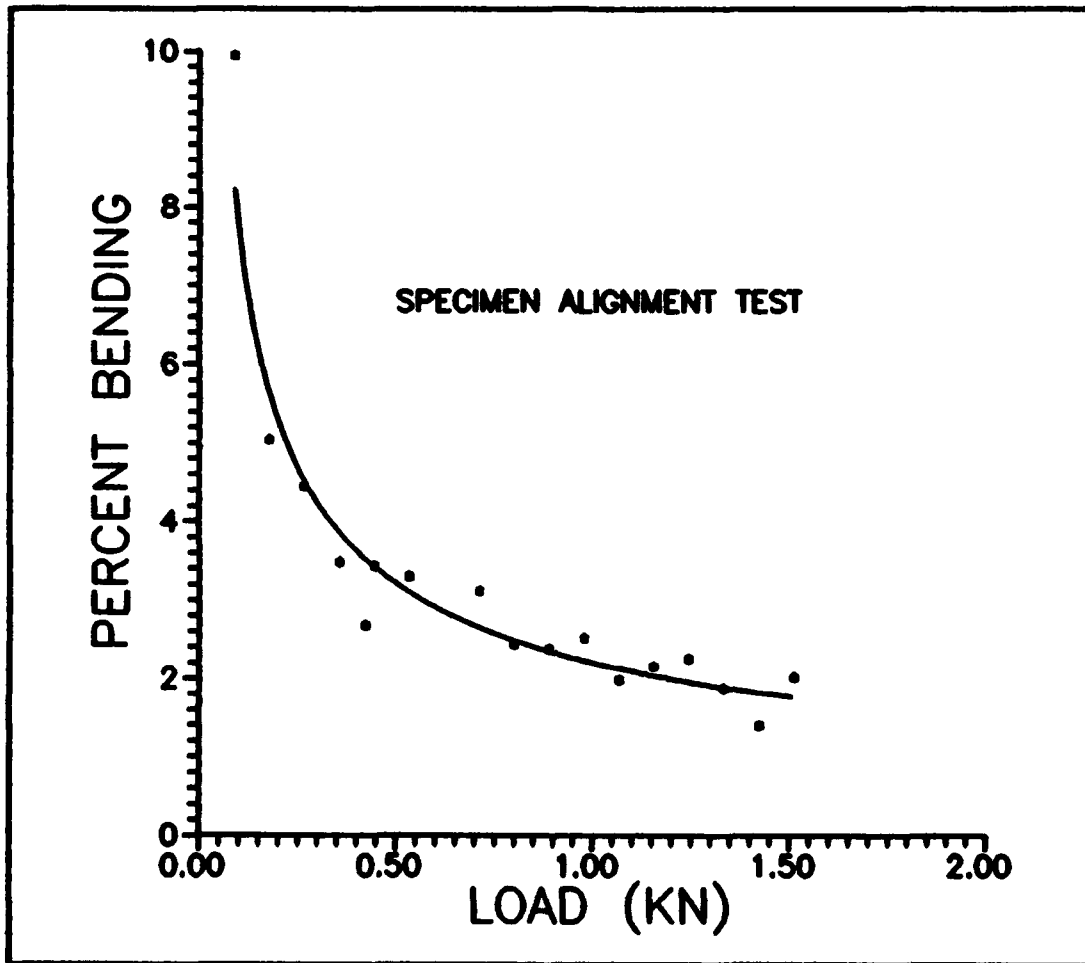
Figure 7 Specimen Alignment

steel specimen. This graph demonstrates the excellent alignment of the test station.

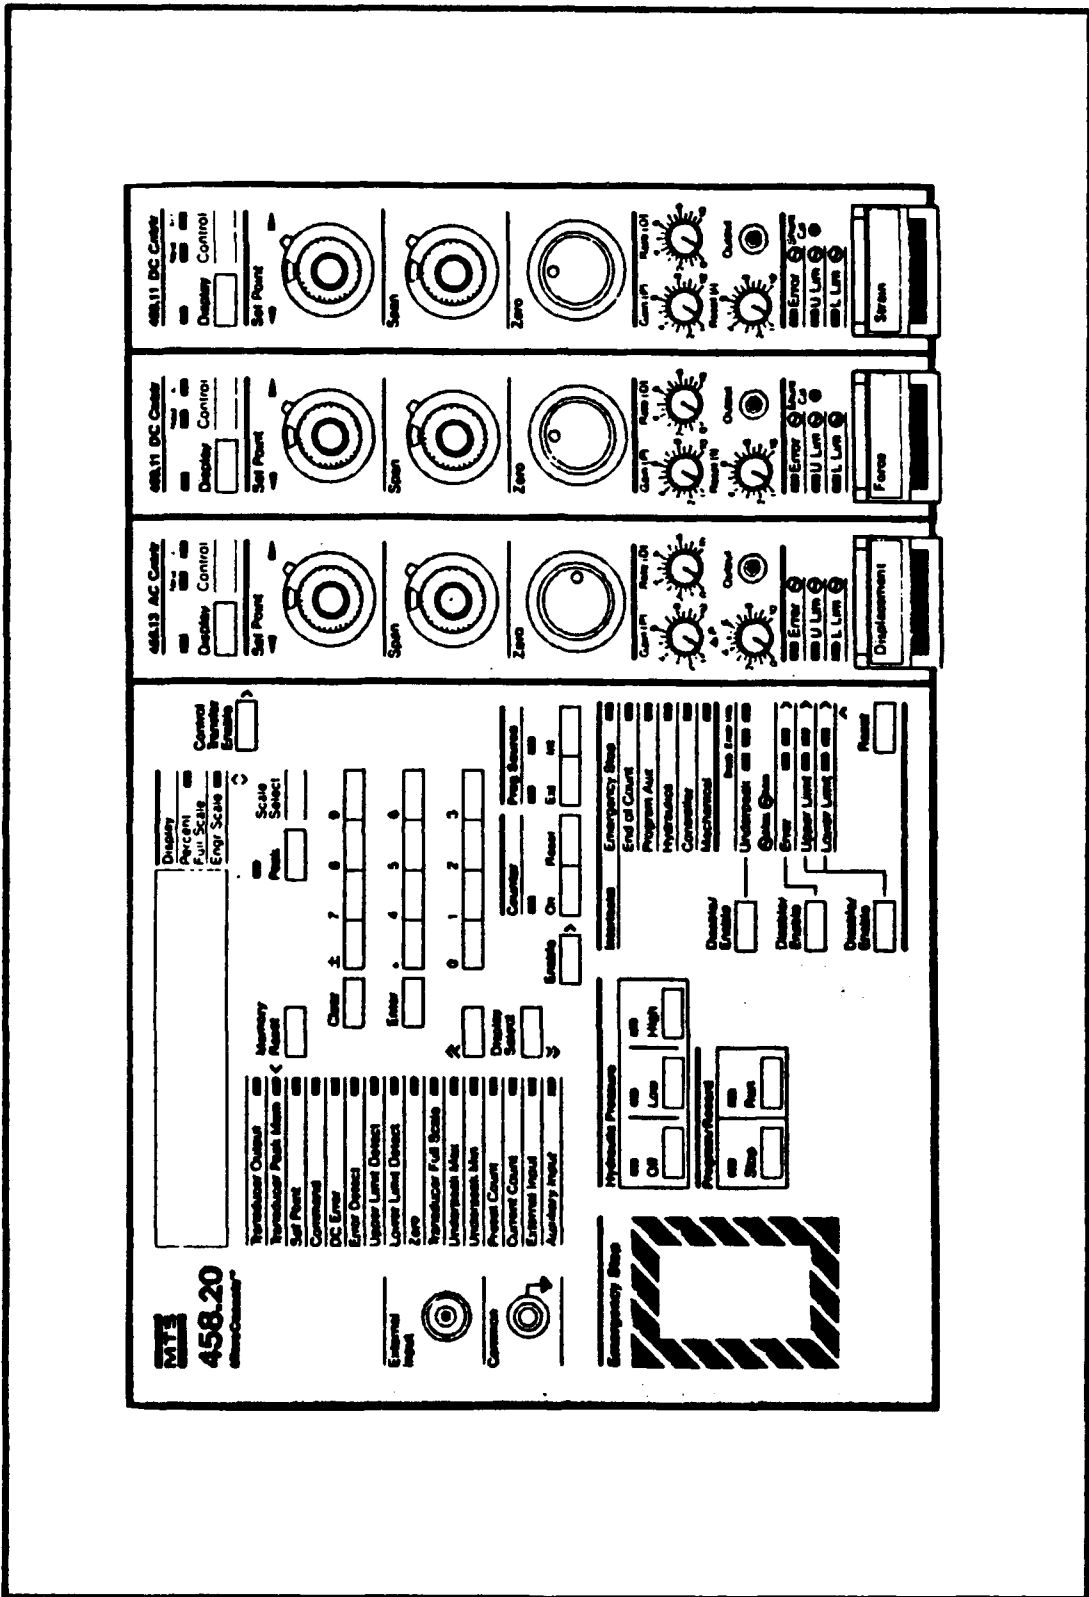
Figure 8 MTS 458.20 Microconsole Panel

Static tension and compression tests were run as well as fatigue tests. Test procedures for all of these tests were the same until the test control or data acquisition software was chosen. Control of the 22.24 kN tensile test machine was through the MTS 458.2 Microconsole (Figure 8) for this portion of the tests.

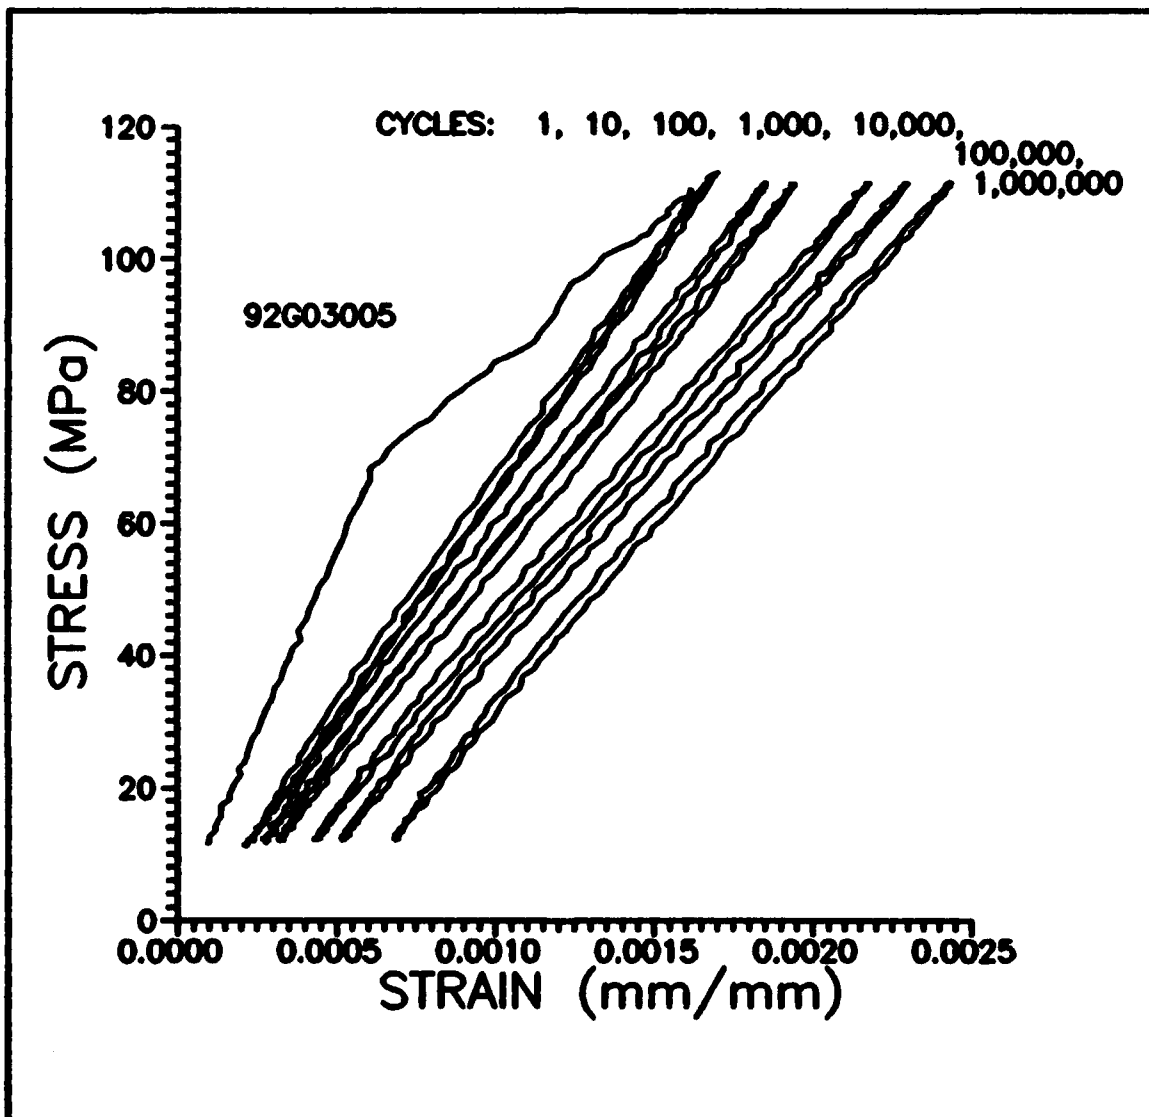
Figure 11 Tension-Tension Fatigue Stress-Strain Curves

These curves indicate that the greatest damage occurs in the first cycle. The curve for cycle one goes nonlinear at the point corresponding to the first proportional limit found in the static tensile test. The curves for the remaining cycles are nearly parallel below 30 MPa indicating the transverse cracks are closed at these stress levels.

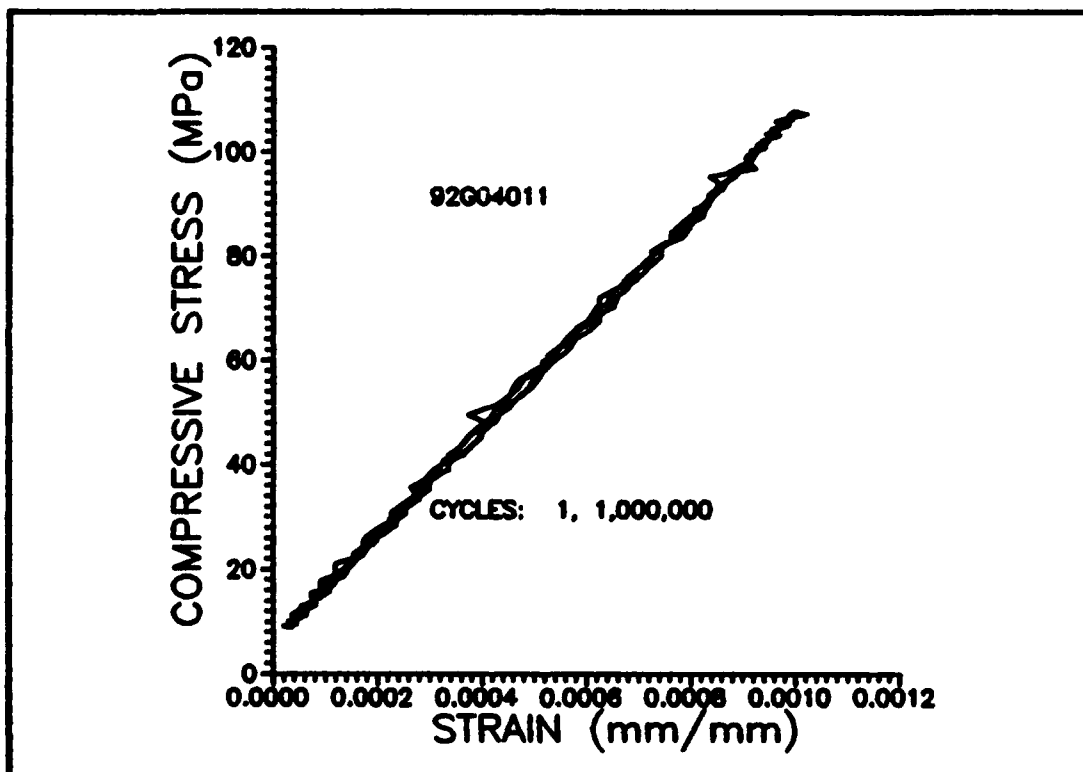
Figure 15 Compression-Compression Fatigue Stress-Strain Curves

Once the behavior of the material in tension-tension fatigue had been established it was time to look at its behavior when cycled in compression. The static compression tests showed no damage until final fracture, therefore one would expect no damage at the relatively small compressive loads required to be comparable with the tension-tension tests. Indeed, this was the case as can be seen in Figures 15-17. Specimen 92G04011 was cyclically tested from -150

MPa to -15 MPa at 10 Hz. No decrease in stiffness was observed. Extremely small, constant values of hysteretic energy density were recorded; and no damage was observed with edge replicas throughout the test. The test was stopped at 1,000,000 cycles. Stress-strain curves are shown in Figure 15. Only the curves from one and 1,000,000 cycles are plotted for clarity. The other curves are superimposed on top of these.

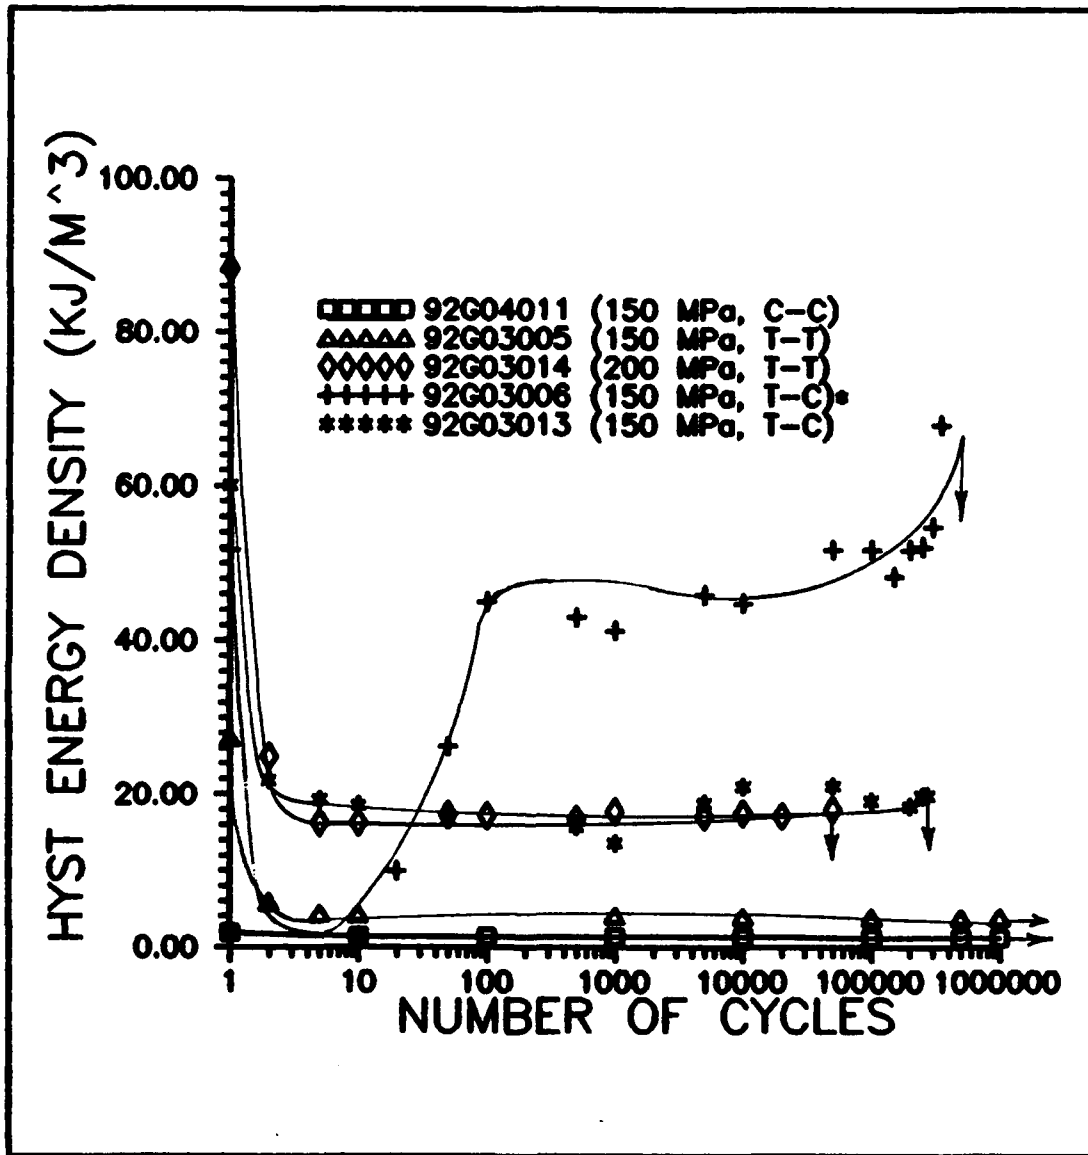
Figure 19 Hysteretic Energy Density vs. Number of Cycles \* Extensometer Near the Hole

extensometer near the hole. More investigation is required before a plausible explanation is developed.

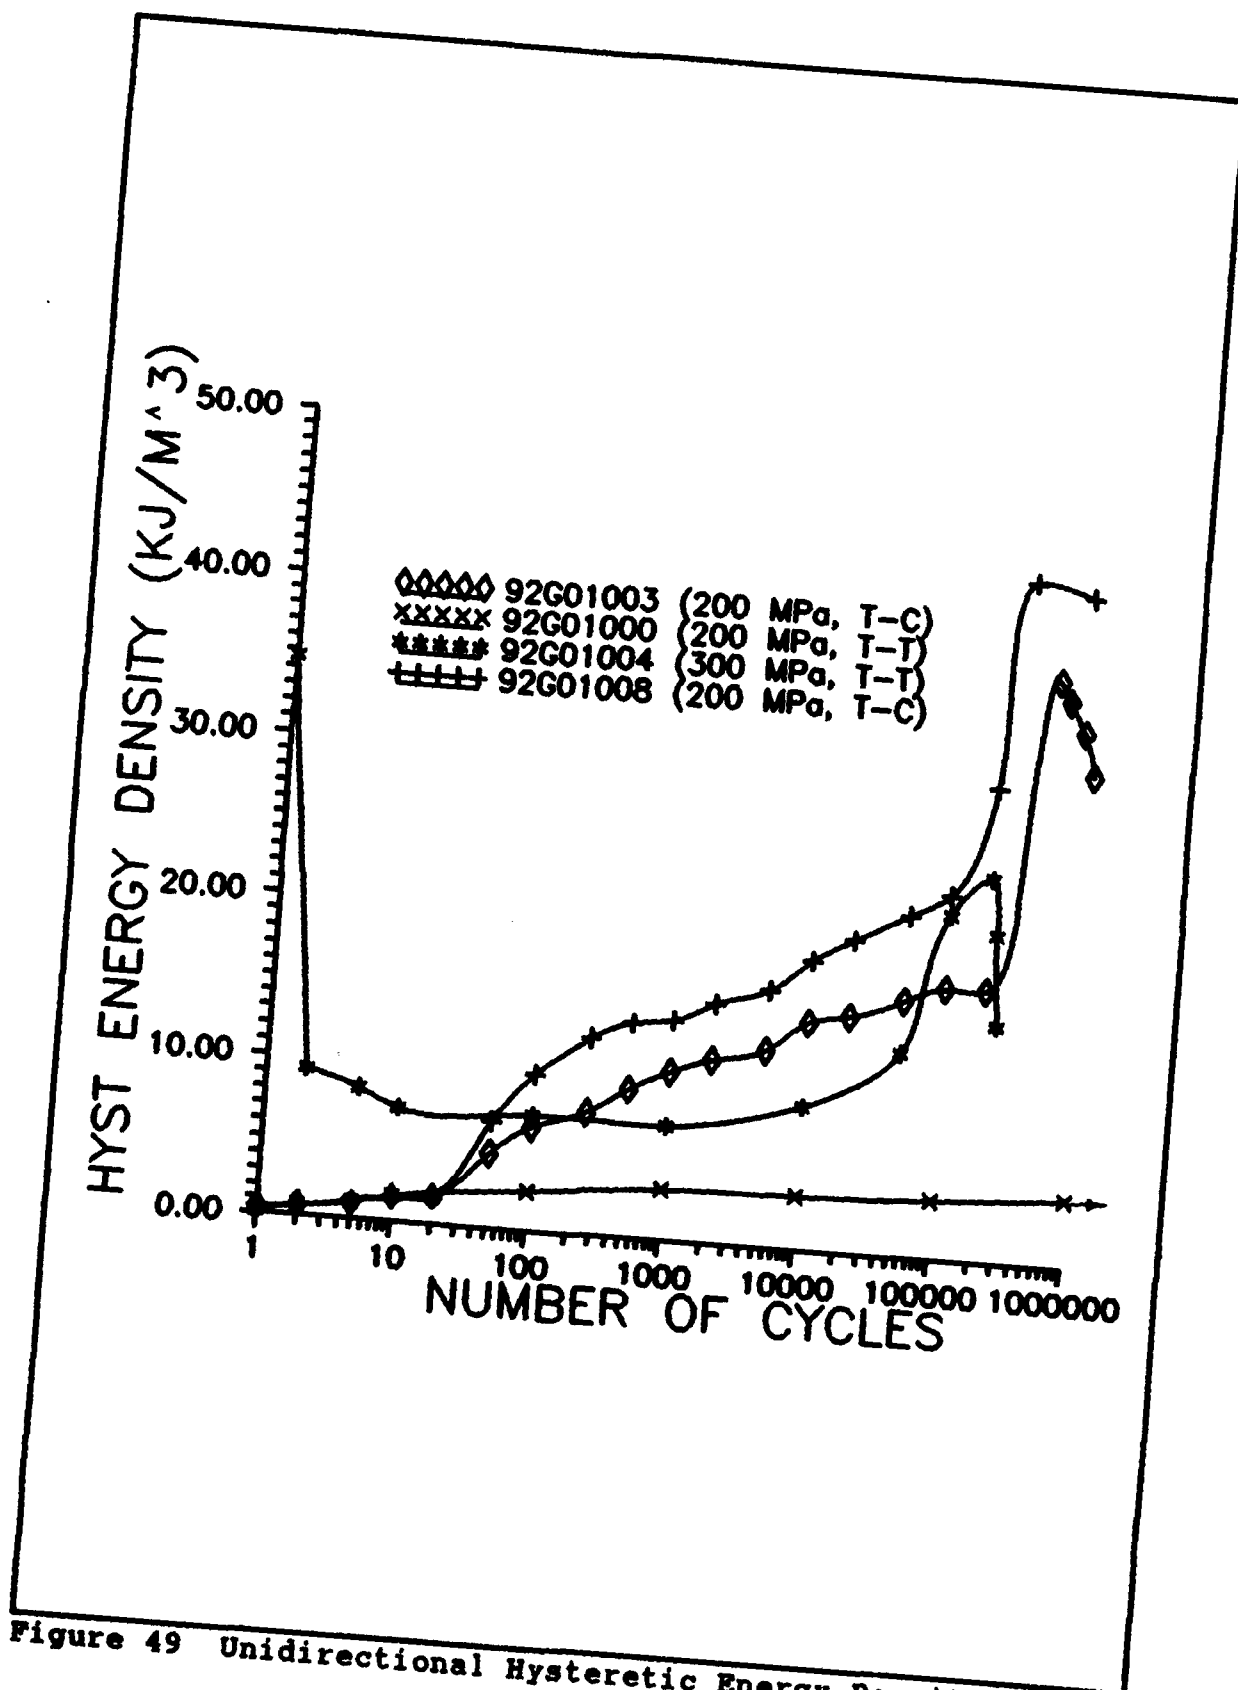
Figure 49 Unidirectional Hysteretic Energy Density Graphs

The energy density of the tension-compression fatigue specimens started low just like the tension-tension specimen, indicating the same damage level. However, once the longitudinal cracks formed, the compression loads helped them grow by opening them (Mode I) and the tensile loads caused them to slide increasing the energy density. The compression loads do not initiate the cracks but only lengthen them. The combination of Mode I (compression) and
