INVESTIGATION OF FATIGUE BEHAVIOR IN
NOTCHED CROSS-PLY TITANIUM METAL MATRIX
COMPOSITE AT ELEVATED TEMPERATURE

THESIS

Robert P. Baker, Captain, USAF

Presented to the Faculty of the School of Engineering
of the Air Force Institute of Technology
Air University
In Partial Fulfillment for the
Requirements for the Degree of
Master of Science in Aeronautical Engineering

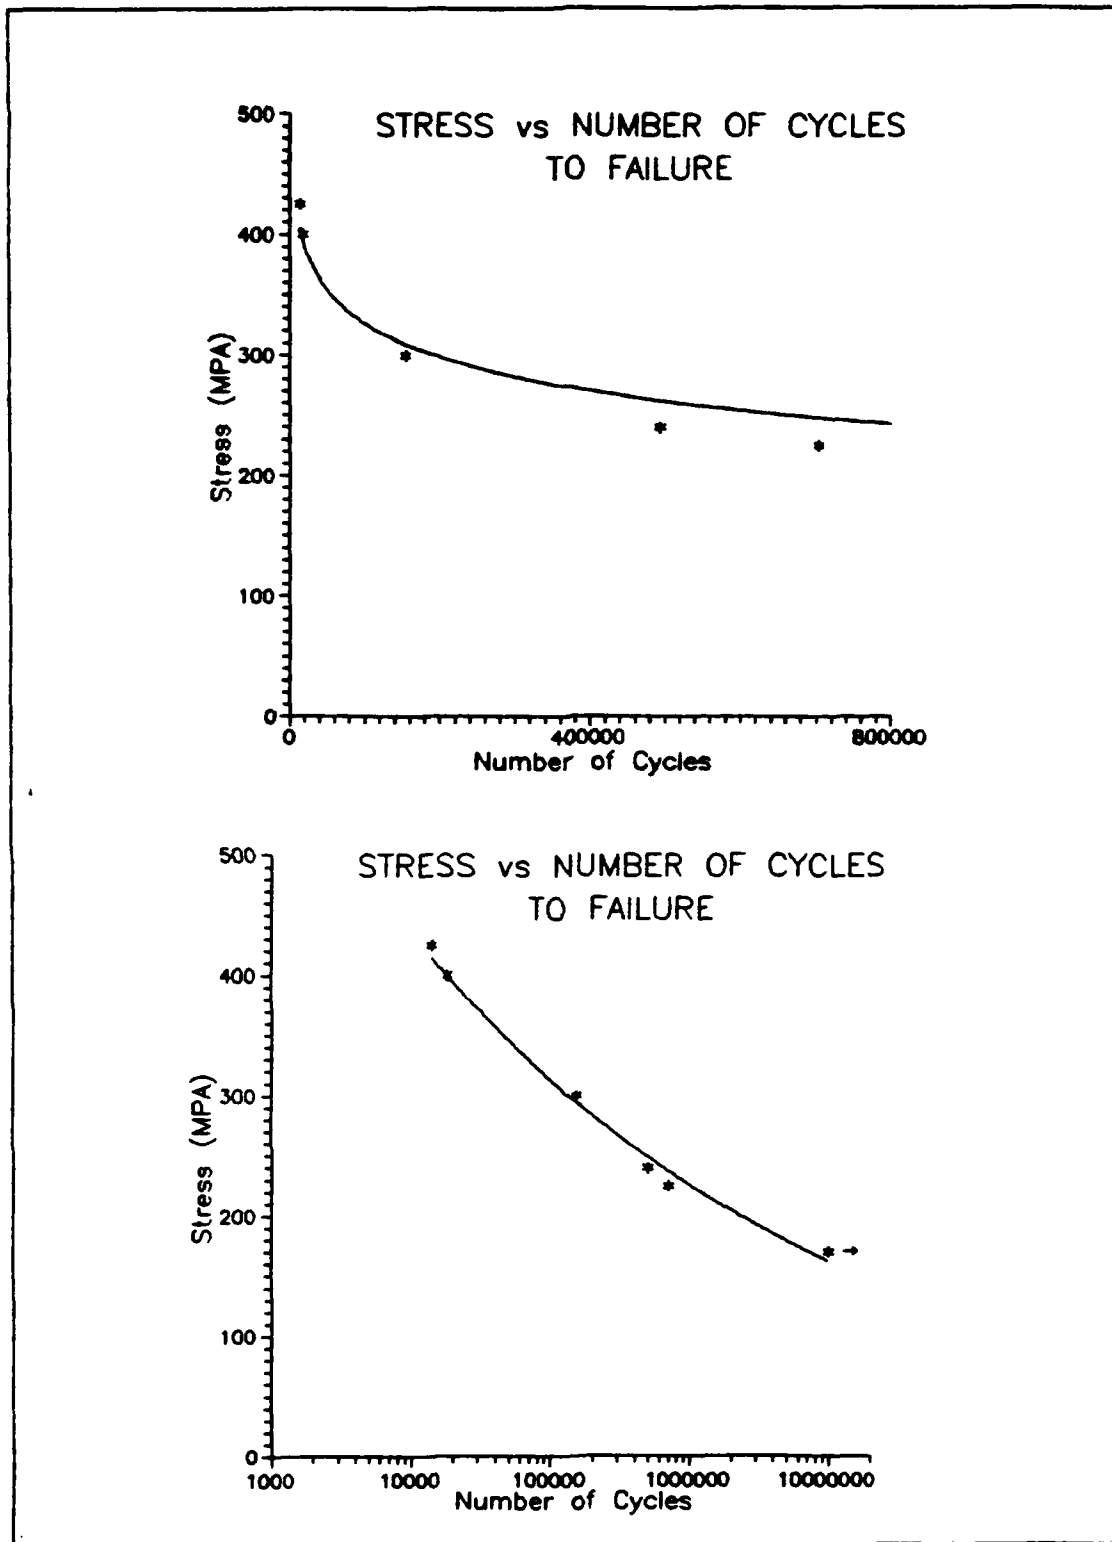
Figure 10: Failure S-N Curve

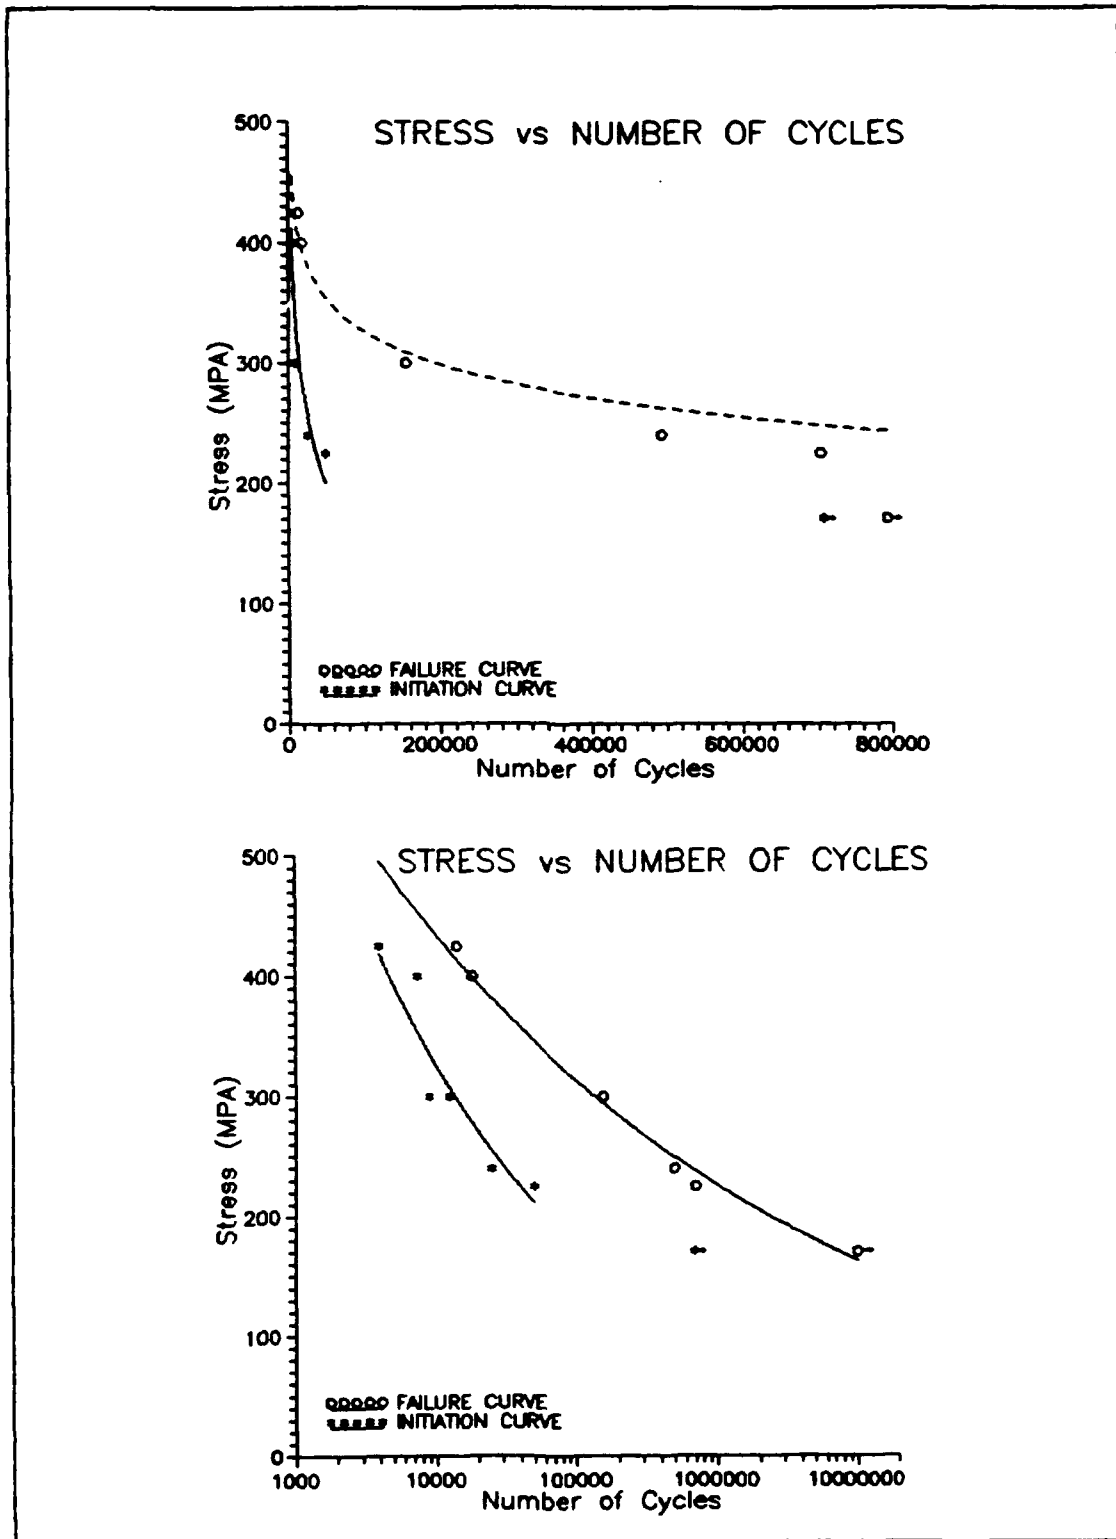
Figure 11: Initiation and Failure S-N Curves

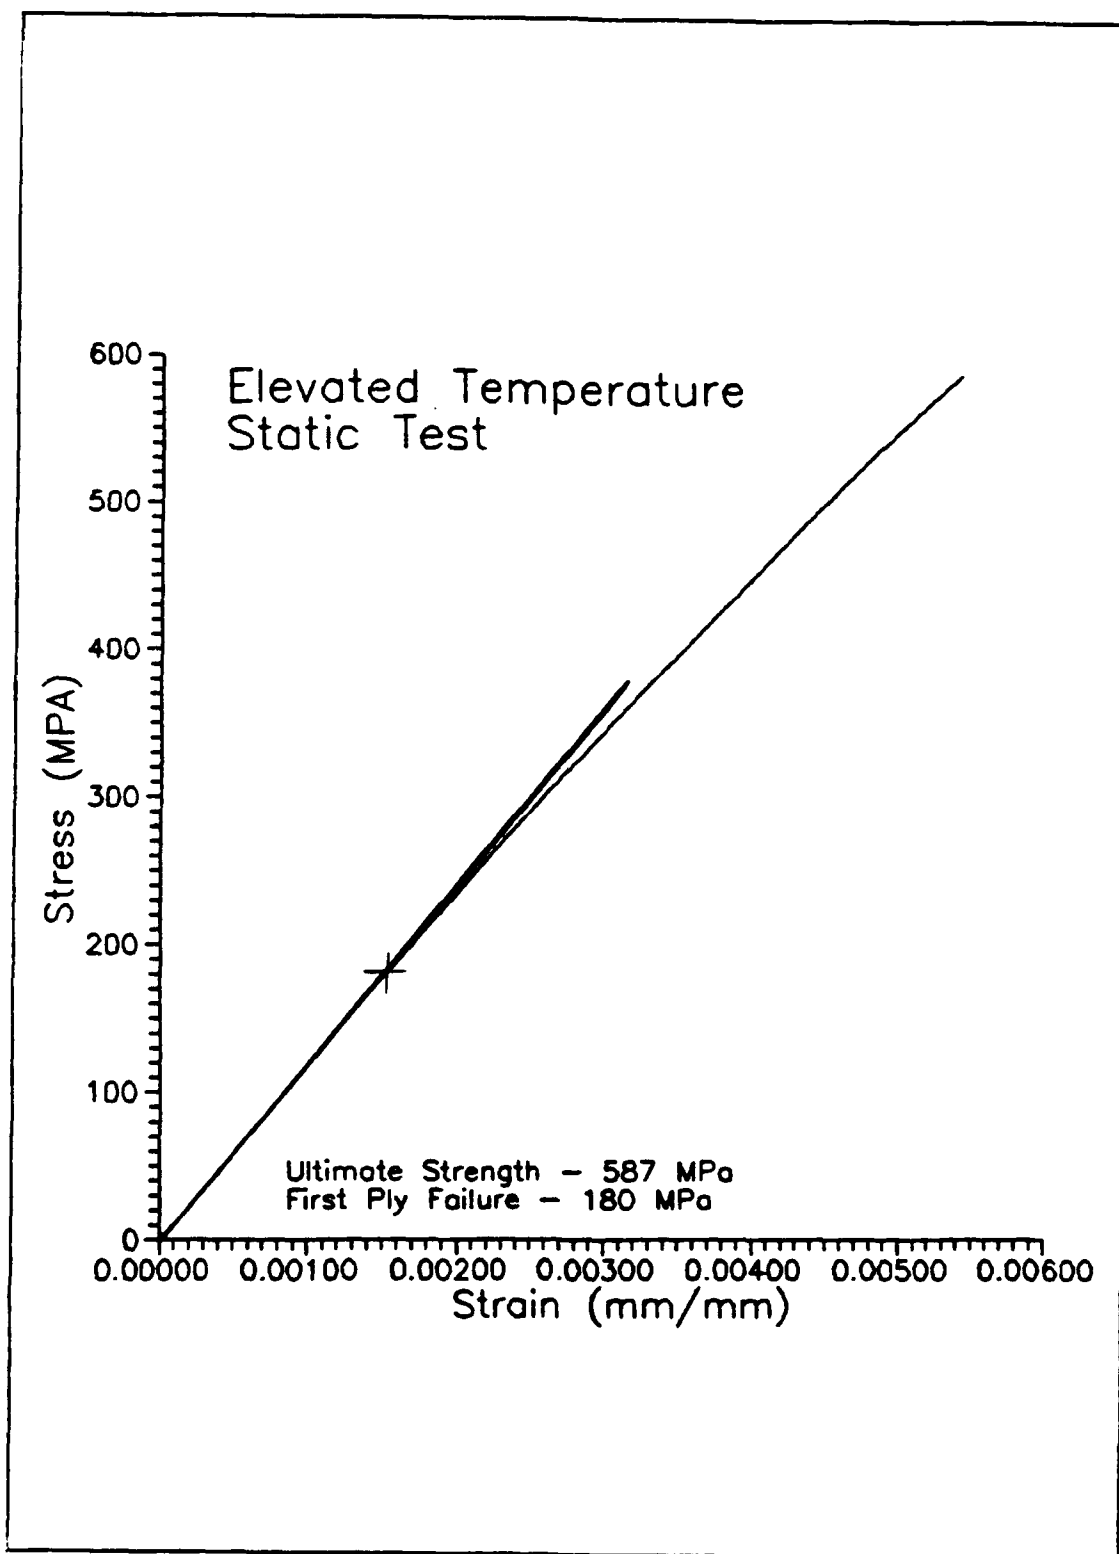
Figure 13: Monotonic Tension Test

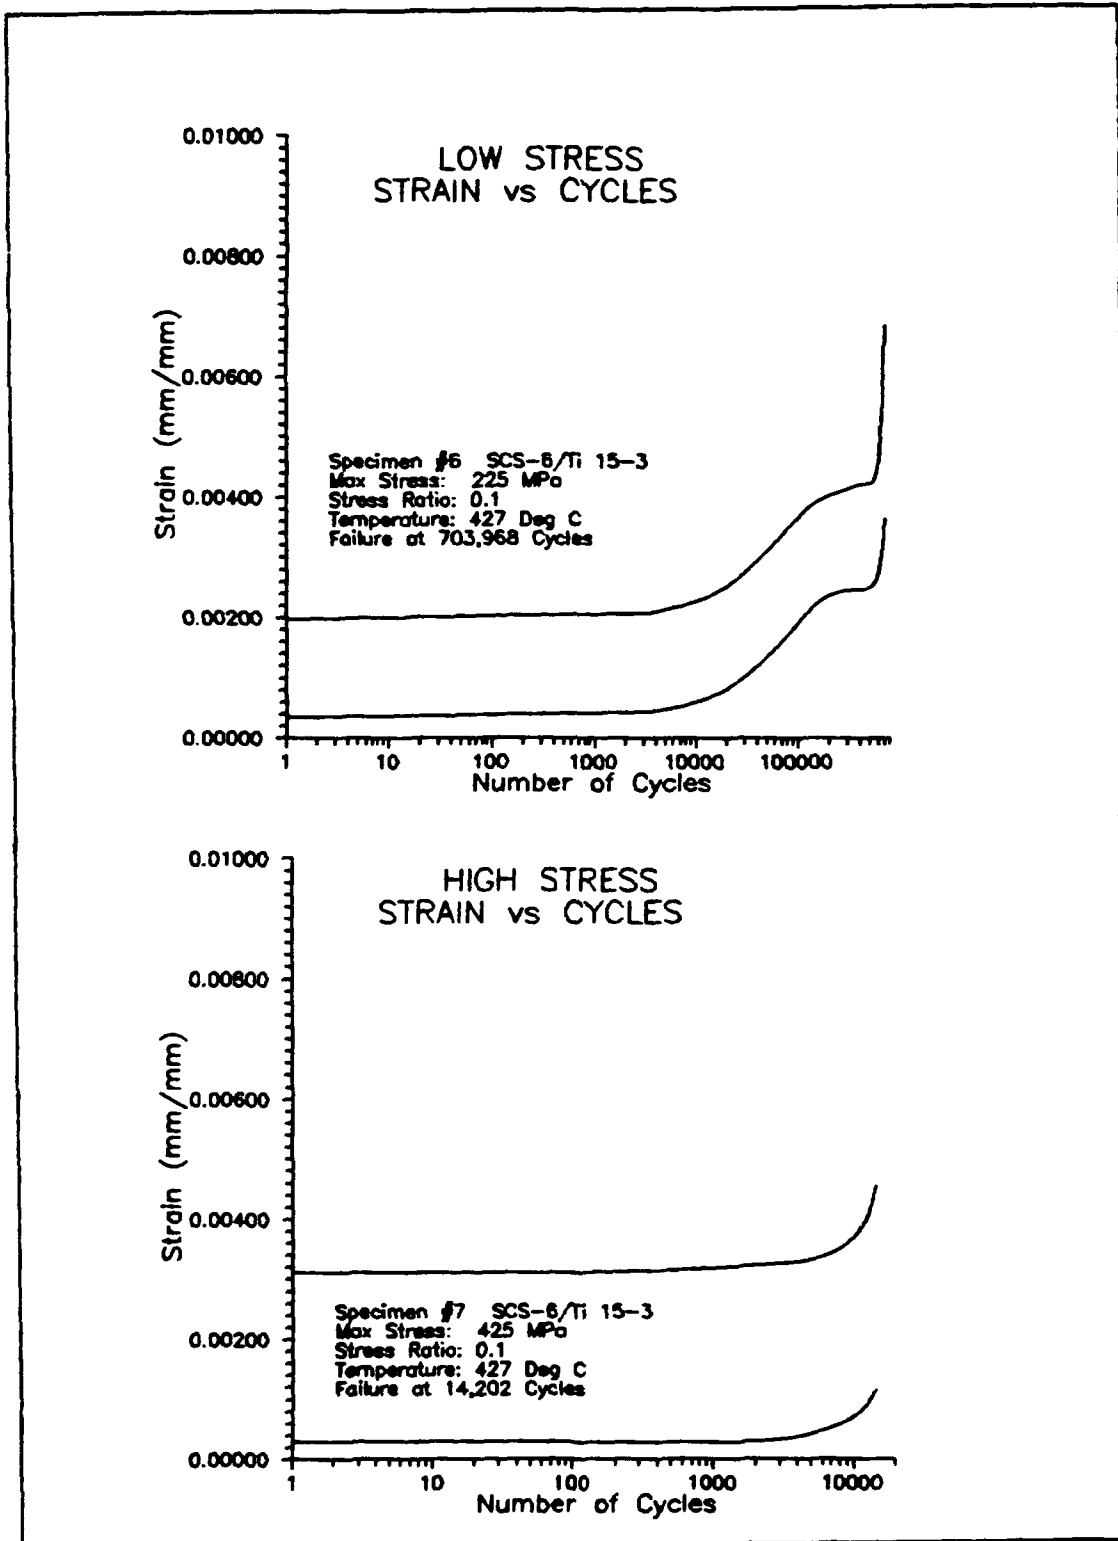
Figure 18: Strain Range

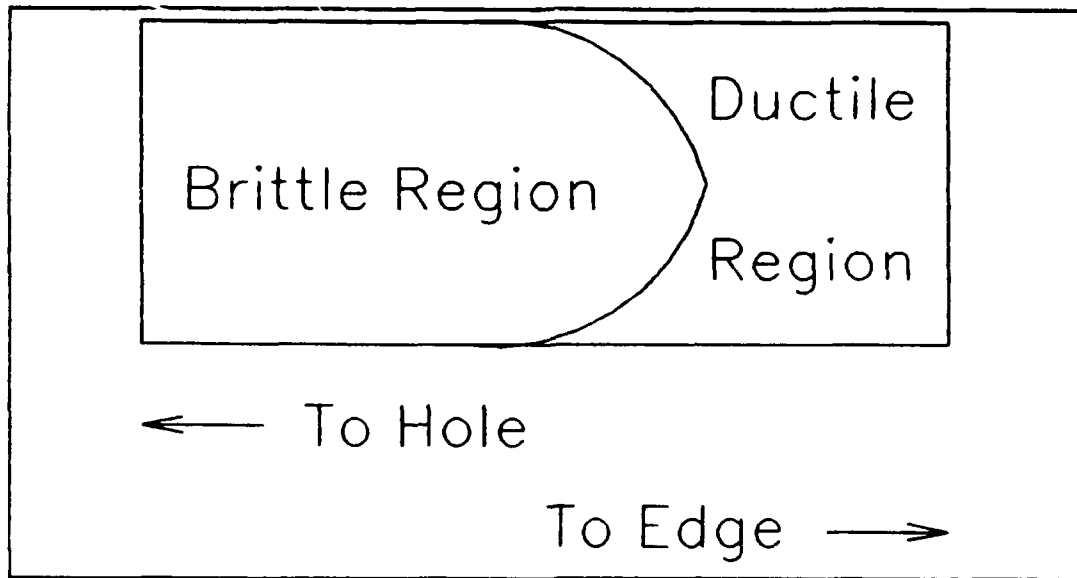
Figure 30: Fatigue Crack Shape Prior to Failure
