**COMPRESSION AFTER IMPACT  
BEHAVIOR OF ARALL®-1  
LAMINATES**

**WILLIAM P. HOOGSTEDEN  
MATERIALS BEHAVIOR & EVALUATION GROUP  
MATERIALS ENGINEERING BRANCH  
SYSTEMS SUPPORT DIVISION**

**JULY 1992**

**FINAL TECHNICAL REPORT FOR PERIOD  
JUNE 1987- NOVEMBER 1987**

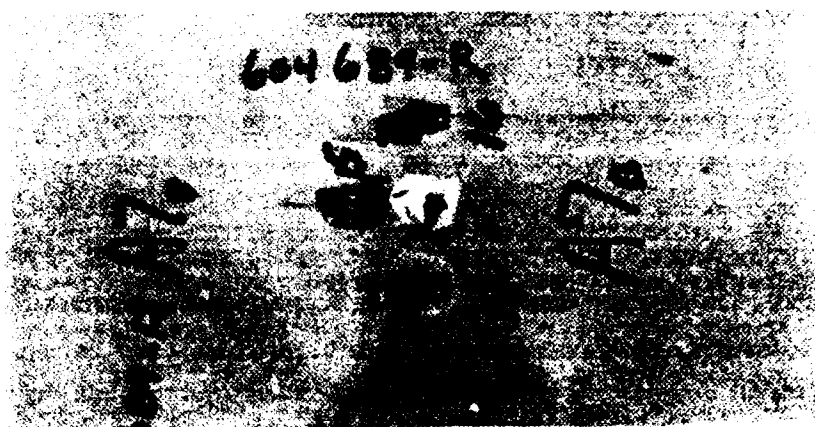
**Fig. A-9: Impact Side of Specimen A7, 10.45 ft-lbs (14.2J).**

**Fig. A-10: Back Side of Specimen A7, 10.45 ft-lbs (14.2 J).**

**Fig. A-11: Impact side of Specimen A8, 10.31 ft-lbs (14 J).**

**Fig. A-12: Back Side of Specimen A8, 10.31 ft-lbs (14 J).**

**Fig. A-13: Impact side of Specimen A9, 11.69 ft-lbs (15.8 J).**

**Fig. A-14: Back Side of Specimen A9, 11.69 ft-lbs (15.8 J).**

**Fig. A-15: Impact Side of Specimen A10, 11.7 ft-lbs (15.9 J).**

**Fig. A-16: Back Side of Specimen A10, 11.7 ft-lbs (15.9 J).**

The ARALL®-1 laminates impacted at above 10 ft-lbs (13 J) were penetrated. Penetration is defined as the imbedding of the impactor nose or "tip" in the impact specimen so that the impactor cannot rebound back through the timing gate. At 10.31 ft-lbs (14.00 J), the ARALL®-1 laminate was totally penetrated. Specimens A-7 through A-10 received impacts at 10.31 ft-lbs (14.00 J), 10.45 ft-lbs (14.20 J), 11.69 ft-lbs (15.8 J), and 11.7 ft-lbs (15.9 J). All four specimens were penetrated at these impact energy levels (Appendix figures A-9 and A-16).

However, the ARALL<sup>®</sup>-1 laminates are penetrated at 10 ft-lbs (13.56 J), shown in Appendix figures A-9 thru A-16, as compared with over 40 ft-lbs (54.2 J) for graphite/epoxy and 25 ft-lbs (33.9 J) for fiberglass SMC.
