NAVSWC TR 91-645

# PERFORMANCE OF REINFORCED POLYMER ABLATORS EXPOSED TO A SOLID ROCKET MOTOR EXHAUST

OCTOBER 1992

**NAVAL SURFACE WARFARE CENTER**

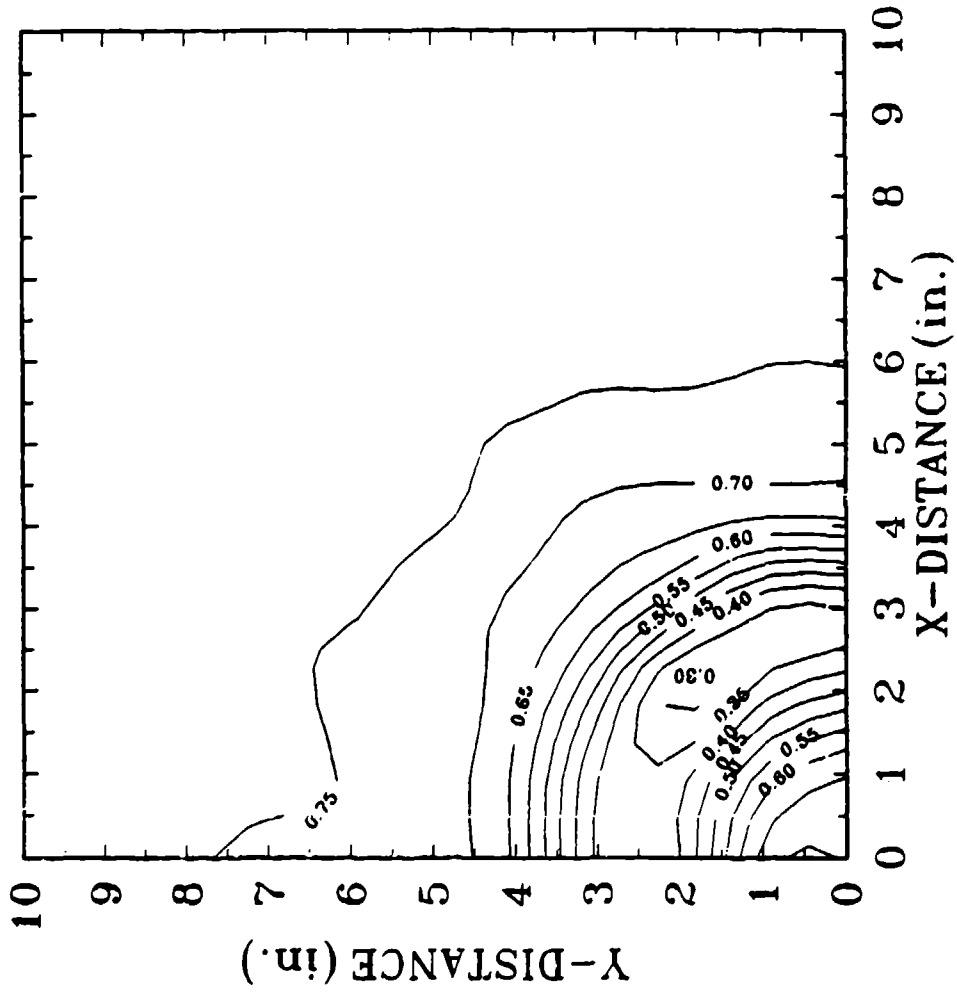
FIGURE 16. FM16771 CONTOURS (SW3)

After the testing, FM16771 was covered with a coating of aluminum oxide similar to that on MXBE350; i.e., thin inside the 4-inch radii and much thicker outside. Apparent in Figure 16 is a circumferential variation in the erosion in the annulus between the radii of two and three inches, similar to what is shown in Figure 15. This is a common but unexplained observation in restrained Sidewinder tests at this standoff distance.<sup>13</sup> It is speculated this is caused by the star perforation design of the propellant grain in the MK 36 MOD 5 motor. The average peripheral erosion of the Fiberite material from tests SW1 and SW3 was 20 and 30 mils, respectively; whereas, in the American Poly-Therm material from tests SW3 and SW4, it was 30 and 40 mils, respectively. The average central erosion of the Fiberite materials was 320 and 280 mils; for the American Poly-Therm ablators, it was 270 and 320 mils. Finally, the maximum erosion in the Fiberite version was 520 and 470 mils, in comparison to the American Poly-Therm materials' erosion of 460 and 440 mils. The erosion of both versions of FM16771 was similar. The erosion measured inside the four-inch radius, for both versions of FM16771, is comparable to that of MXBE350; there was much less erosion outside the four-inch radius.

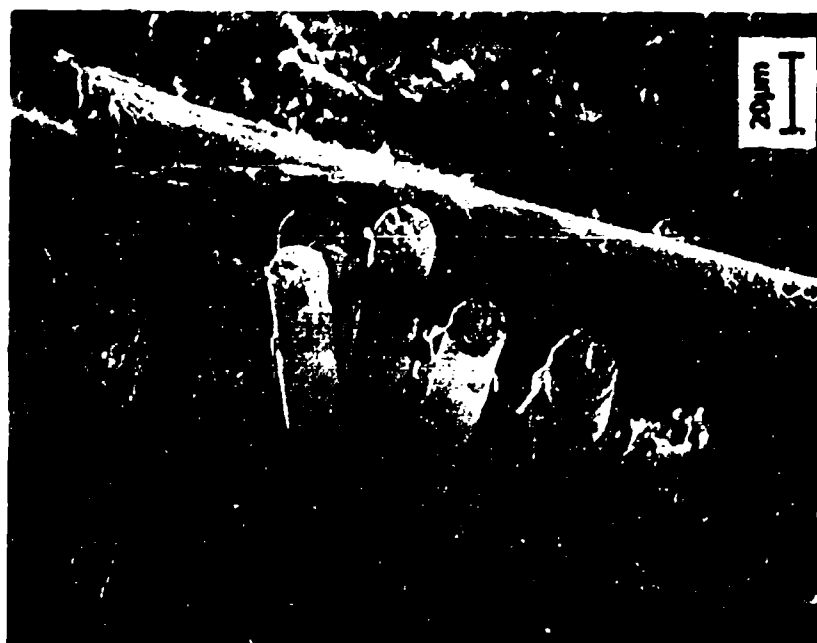
**FIGURE 34. SEM MICROGRAPHS OF MXBE350 SAMPLE BEFORE AND AFTER NSWCCD TEST**

Fracture surfaces of the virgin areas of the MXBE350 and FM16771 (both Fiberite and American Poly-Therm) samples exhibited pull-out of the reinforcing fibers (Figures 34A, 35A, and 36A). This type of fracture behavior is an indication of increased toughness of materials and correlates very well with the Izod test data where these materials demonstrated the highest impact strength. Contrary to that, the FR1 and CD208 samples (Figures 37 and 38) did not show any noticeable fiber pull-out and, correspondingly, had low Izod impact strength. The presence of

The charred areas of the MXBE350 and FM16771 samples (Figures 34B, and 35B, and 36B) appear to be very dense with slight traces of the residual silica-rich glass fibers, which were melted during the test, and infiltrated carbon char from matrix decomposition. The SEM micrographs of the charred area of the CD208 sample (Figure 39) do not show any indications of a matrix present. The melt from silica and aluminosilicate fibers bonded the carbon fibers, holding them together. The results of the NSWCCD and FMC tests are compared in Figures 40A and 40B for the FR1 ablator. The glass fiber reinforcement was still clearly distinguished in the charred region of the sample subjected to the NSWCCD test. Contrary to that, no fibers were found in the charred area of the material after the FMC test. The droplets of solidified glass melt from the fibers are clearly identified in the SEM micrograph (Figure 40B). These differences can be an indication of more severe conditions; e.g., higher heating, in the FMC tests or the result of removing the aluminum oxide from the charred surface of the NSWCCD samples.

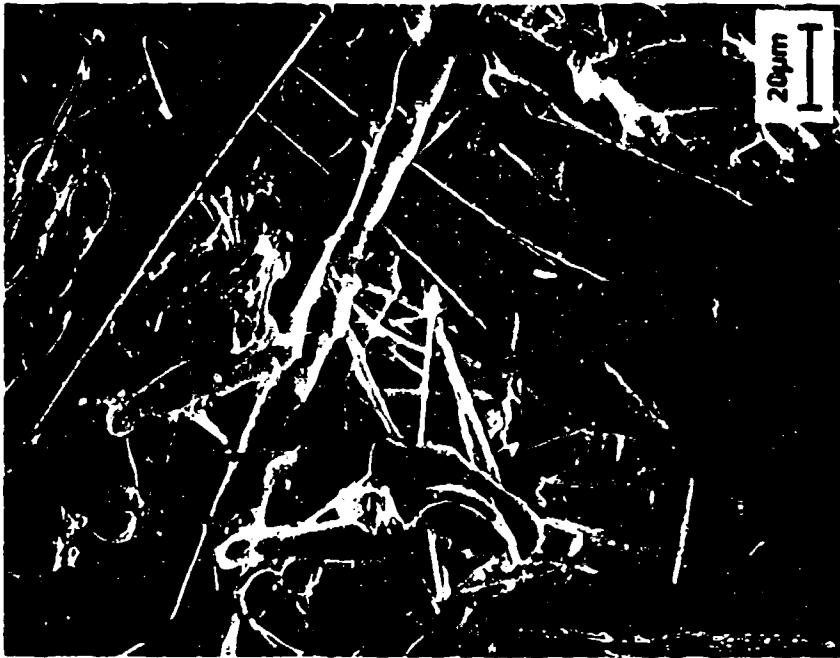
FIGURE 38. SEM MICROGRAPHS OF CD208 SAMPLE (VIRGIN AREA)

reinforcing fibers of irregular shape and high amount of glass droplets was determined in the structure of the FR1 ablator (Figure 37) The SEM micrographs of the virgin CD208 material (Figure 38) show smaller diameter silica and aluminosilicate fibers and much larger diameter carbon fibers. They also reveal the absence of the matrix around reinforcing fibers in some areas, which probably represents internal voids such as those already discussed relative to the CD208 sample in test SW3 (Figure 24). This condition could be caused by incomplete mixing of the resin and reinforcing fibers during manufacturing. The defects found in the FR1 and CD208 ablators could also contribute to the low values of impact strength.
