INVESTIGATION OF CAST AUSTEMPERED DUCTILE IRON (CADI)

TRACKSHOES IN T-158 CONFIGURATION

Timothy D. Balliett  
FMC Corporation  
Steel Products Division  
2101 W. 10th Street  
Anniston, Alabama 36201

U.S. ARMY TANK-AUTOMOTIVE COMMAND  
RESEARCH, DEVELOPMENT & ENGINEERING CENTER  
Warren, Michigan 48397-5000

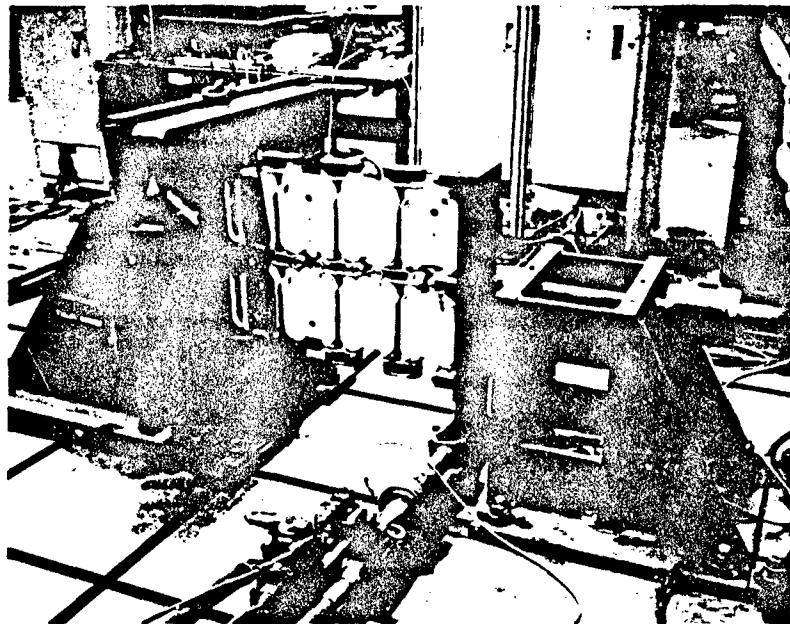
**FIGURE 4**

**TENSION/TORSION FATIGUE TEST SET-UP**

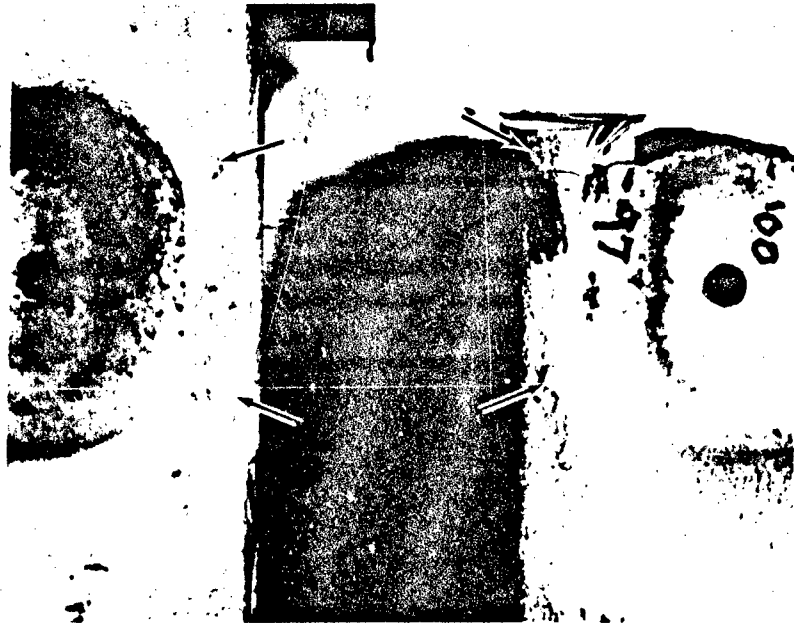
**FIGURE 11**

The fracture initiation sites in the two forged shoes that failed were at one of the small round bumps formed on the top of the vertical web (Figure 11) at the vent hole locations. There may have also been a material defect at that location in Sample #6.

**LOCATION OF VENT HOLES ON FORGED SHOE (SAMPLE #6)**

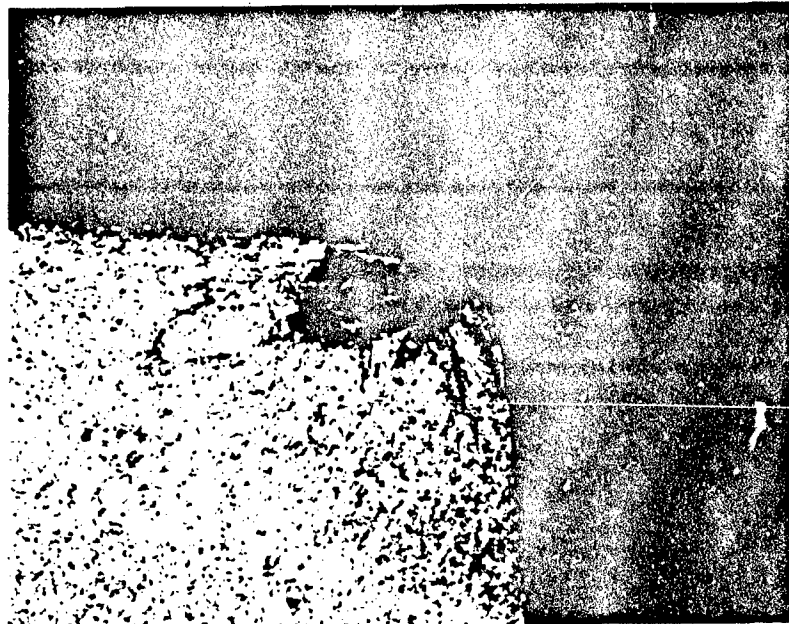
**FIGURE 14**

**FRACTURE INITIATION SITE OF CAST TRACK BLOCK**

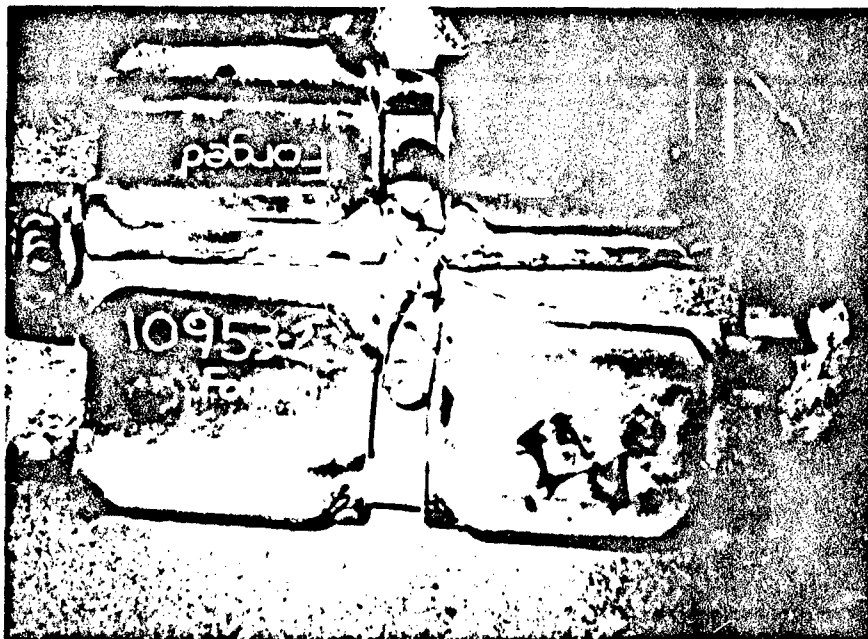
Figure 11. Forged - Forged Shoe Test, Broke Track Links

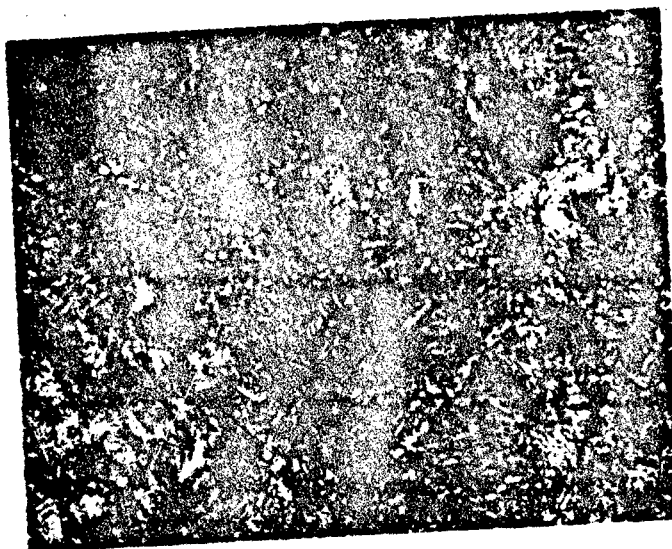
Figure 1  
Typical Microstructure

Magnification: 400x  
Etch: 3% Nital
