NASA  
Technical Memorandum 105830

AVSCOM  
Technical Report 92-C-007

# Evaluation of an Oil-Debris Monitoring Device for Use in Helicopter Transmissions

August 1992

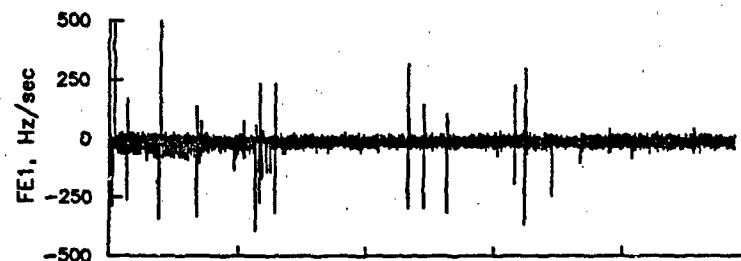
Figure 7. — Test 2 results; no component failure after 122 hours.

(a) FE1 parameter.

(b) FE2 parameter.

(c) Spectroscopy results.

Test 2 was a 122-hr endurance run with the goal of producing spiral bevel scoring and mast-shaft ball bearing micropitting failures. The operating conditions were the same as for test 1, but with reduced oil flow to the spiral bevel mesh. This test did not produce any component failures. The ODMD and spectroscopy results again indicated low ferrous content in the oil (fig. 7). The spectroscopy results indicated that the oil contained some debris at the start of the tests and then gradually cleaned itself during the run. This is not uncommon, because debris might have been left in the passageways from the previous run or might have been introduced in the transmission during build-up. The ODMD results generally agreed with the spectroscopy results showing some activity at the start of the run and then remaining constant for the rest of the test.

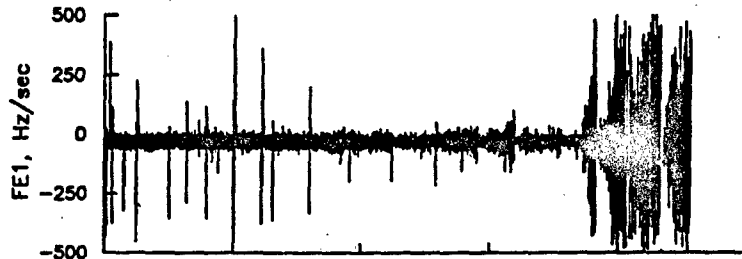
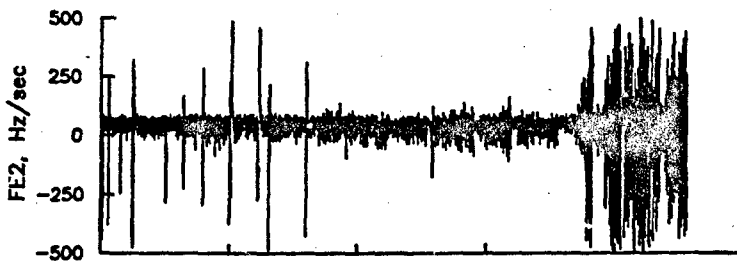
Figure 10. — Test 4 results; no component failure after 114 hours.

(a) FE1 parameter.

(b) FE2 parameter.

(c) Spectroscopy results.

Test 4 was a 114-hour endurance run with the goal of producing planetary fatigue, spiral bevel scoring, and mast-shaft ball bearing micropitting failures. A lubricant conforming to DOD-L-85734 specifications was used (this is basically a MIL-L-23699 specification oil with additives for improved load-carrying capacity). A new ODMD sensing unit was installed. As with test 2, no component failures were produced. The spectroscopy indicated an initial containment of debris, a quick cleaning of the oil, then a gradual increase of debris as the test progressed (fig. 10). The ODMD indicated activity at the end of the test, which supported the spectroscopy results. However, no significant component wear was apparent during inspection of the transmission after the test.
