WL-TR-92-4104

MICROSTRUCTURAL EFFECTS ON THE  
DEFORMATION AND FRACTURE OF THE ALLOY  
TI-25AL-10NB-3B-1MO

MATERIALS DEVELOPMENT BRANCH (WL/MLLM)  
METALS AND CERAMICS DIVISION  
MATERIALS DIRECTORATE  
WPAFB, OH 45433-6533

FINAL REPORT FOR 07/01/88-12/15/92

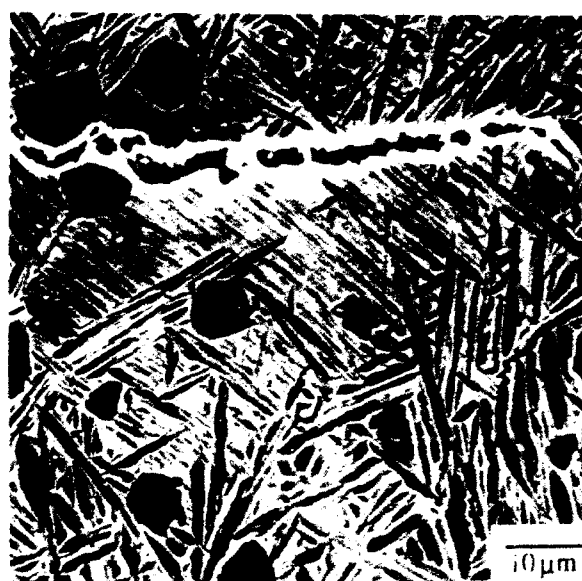
**Figure 4.50** Sectioned tensile specimen from microstructure 10/C. Crack nucleation at primary  $\alpha_2$ /matrix interfaces and extension into the matrix.

| Figure 4.50 | Sectioned tensile specimen from microstructure 10/C. Crack nucleation at primary $\alpha_2$ /matrix interfaces and extension into the matrix..... | 122 |

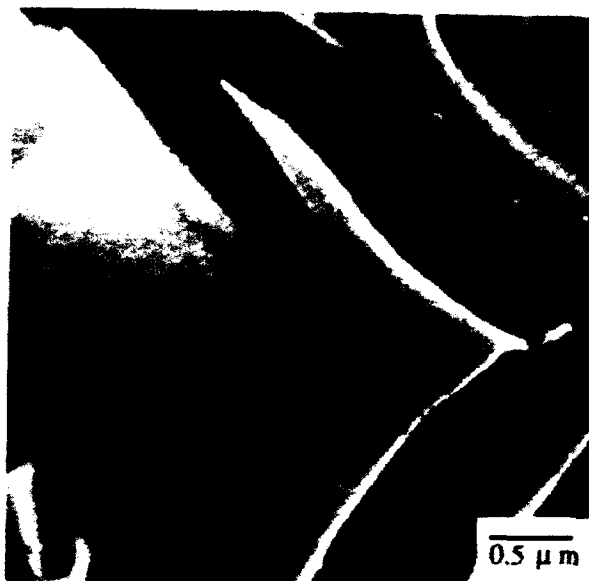
**Figure 4.51** Sectioned tensile specimen from microstructure 10/C. Enlargement of crack tip from Figure 4.50; note the apparent plastic region at the crack tip.

| Figure 4.51 | Sectioned tensile specimen from microstructure 10/C. Enlargement of crack tip from Figure 4.50..... | 123 |

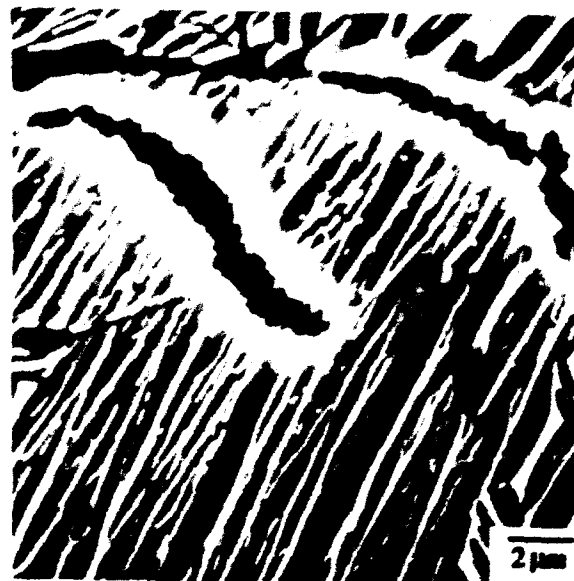
**Figure 4.52** Sectioned tensile specimen from microstructure 0/C. Crack nucleation associated with the prior  $\beta$  grain boundary.

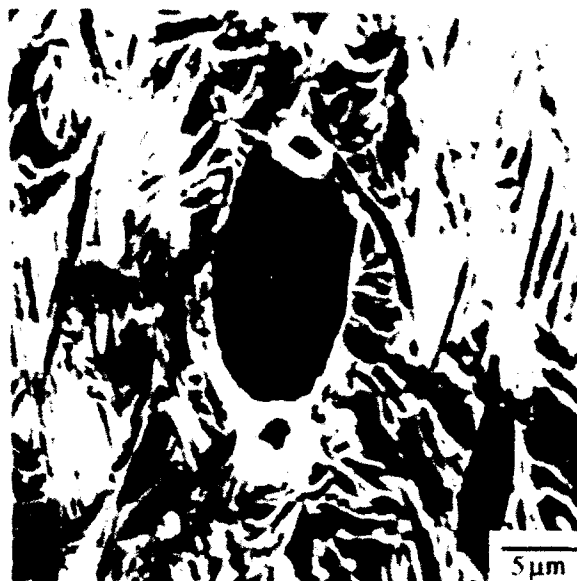
**Figure 4.67** Tensile bar from microstructure 10/F tested at 450°C. Primary  $\alpha_2$  was elongated in direction of the tensile axis, with voids nucleating at ends.

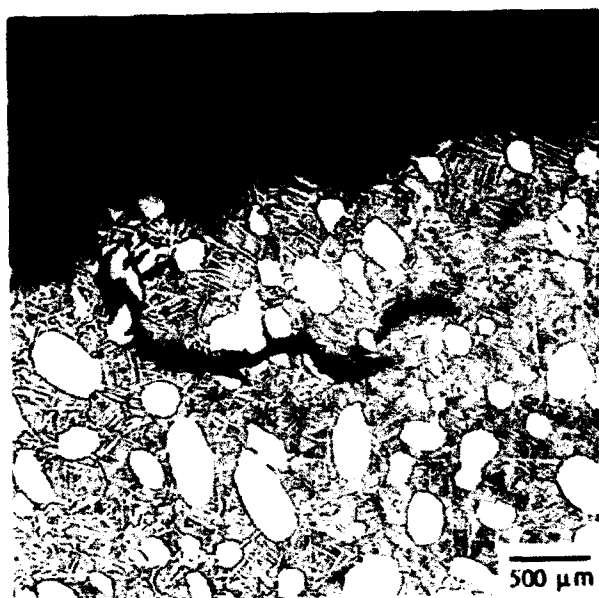
**Figure 4.88** Enlargement of sectioned crack path from microstructure 10/C showing limited secondary cracking.

Cross sectioning the fractured compact tension specimens revealed that the macroscopic appearance of the fracture path was relatively flat in all of the  $\alpha_2 + \beta$  processed microstructures, Figure 4.86. The fracture path was only slightly more tortuous in the  $\beta$  processed microstructure 0/C, Figure 4.87. Microscopically, crack extension occurs by an apparently low energy mechanism, following a direction which was perpendicular to the long axis of secondary  $\alpha_2$  laths, through primary  $\alpha_2$  particles, and along the interfaces of the  $\alpha_2/\text{B2}$  phases. While there were limited instances of secondary cracks, Figure 4.88, in general there were few cracks observed below the fracture surface.

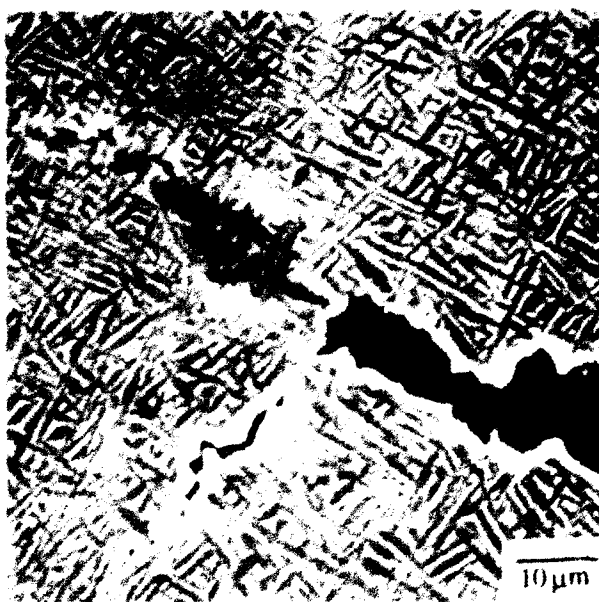
**Figure 4.104** Enlargement of bifurcating crack front in Figure 4.102.

Crack growth deviated from a straight path at 550°C and showed significant bifurcation of the crack tip in all three microstructures; sometimes resulting in multiple crack fronts, Figure 4.102. The crack tips appeared to have been blunted prior to extension and bifurcation, particularly in microstructure O/C, Figure 4.103. The direction of the branches followed the microstructural texture of the secondary  $\alpha_2$  laths, propagating by the failure of the laths in a direction generally perpendicular to their long axis, Figure 4.104. As at 450°C, cracks were observed to nucleate ahead of the crack tip by 10 - 50  $\mu\text{m}$ . These cracks were again associated with the  $\alpha_2$  phase, but appeared to have a larger crack tip opening displacement (CTOD) as compared to those at 450°C.

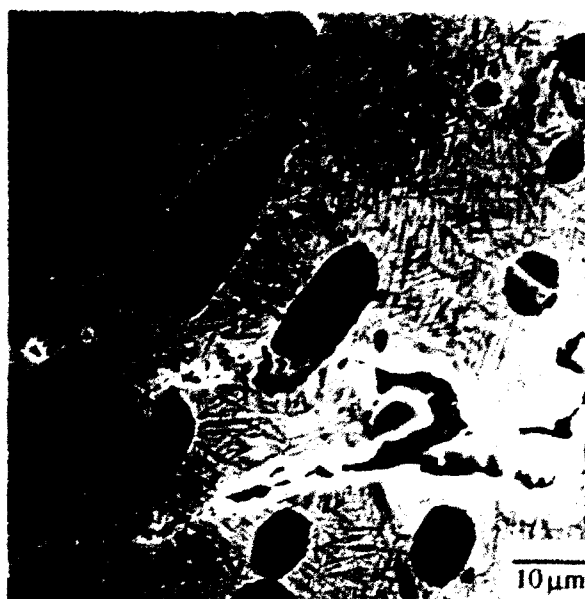
**Figure 4.106** Enlargement of crack tip region in Figure 4.105.

At 650°C the crack tips no longer exhibited large scale bifurcation. Also, the crack tips were sharper, with the CTOD visibly smaller than at 450 and 550°C, Figure 4.105. The main crack appeared to be growing by linking with large cracks nucleated ahead of the crack tip, Figure 4.106. These cracks appeared to be associated with the failure of  $\alpha_2$  and the separation of the  $\alpha_2/\text{B2}$  interfaces, Figure 4.107. In microstructure O/C these cracks were usually associated with prior  $\beta$  grain boundaries, Figure 4.108.

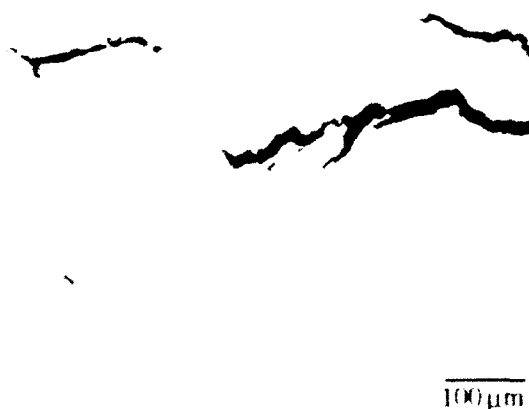
**Figure 4.108** Metallographic section of J bend bar from microstructure 0/C tested at 650°C
