NASA  
Technical Memorandum 105950

## An Analysis of Gear Fault Detection Methods as Applied to Pitting Fatigue Failure Data

Prepared for the  
47th Mechanical Failure Prevention Group  
Virginia Beach, Virginia, April 13-15, 1993

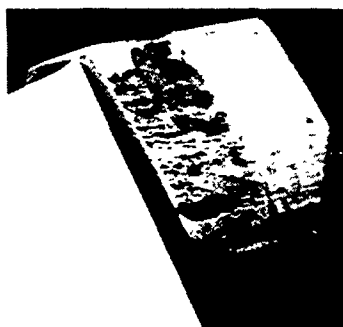
(b) Example of spalling on tooth in Run 1 at end of test ( $t = 198$  hr).

Some examples of the different magnitudes of tooth damage found in the five tests (runs 1 to 5) of this study are illustrated in Figure 1. Figure 1(a) shows the isolated heavy pitting damage that was found on the test gears in run 1 at 131 hours into the test. Figure 1(b) shows an example of the spalling damage found at the end of the test of run 1. Figure 1(c) illustrates an example of the moderate pitting found in the tests. Similarly, Figure 1(d) gives an example of the heavy pitting damage found in the tests. Details of the damage found in each test are given below, with Figure 1 serving as a pictorial reference of damage magnitude.

advance of the RMS level increase. NA4 gave the best performance for run 1. Figure 2(f) shows the first 135 hours of Figure 2(d), with an expanded vertical scale, for clarity. As seen in these two figures, NA4 reacts very robustly to the start of damage, sharply increasing to a value of 25, and remains somewhat steady at a value of 15 even as the other parameters (FM4, M6A, etc.) drop back down to nominal values. NA4 then increases sharply to a peak value of 230, following a trend similar to the RMS level increase. This could be the point at which the extremely heavy damage started (as seen in Figure 1(b)), continuing to the end of the run.

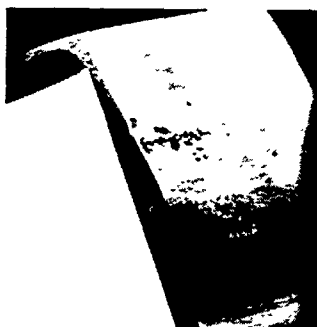
(c) Example of moderate pitting (Run 5, end of test).

At 294 hours into run 5, micropitting and wear was found on nearly all the teeth of the driver gear. At the end of run 5, moderate pitting was found on eight teeth distributed on the driver gear. Three consecutive teeth on the driven gear were found to have moderate pitting damage.

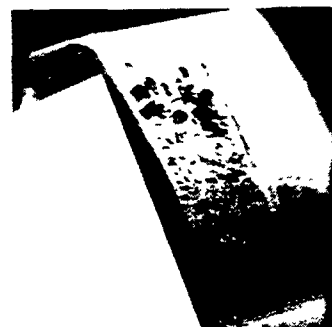
(d) Example of heavy pitting (Run 3, end of test).

At the end of run 3, damage was found on four consecutive teeth on the driver gear (one spalling, two heavy, and one moderate pitting). One of the four mating teeth on the driven gear was also found to be damaged (moderate pitting).
