**DEPARTMENT OF DEFENCE**  
**DEFENCE SCIENCE AND TECHNOLOGY ORGANISATION**  
**AERONAUTICAL RESEARCH LABORATORY**

Technical Report 13

**ENVIRONMENTAL CORROSIVITY AT OAKLEY ARMY AIR BASE, QLD.**  
**AUGUST 1991 TO AUGUST 1992**

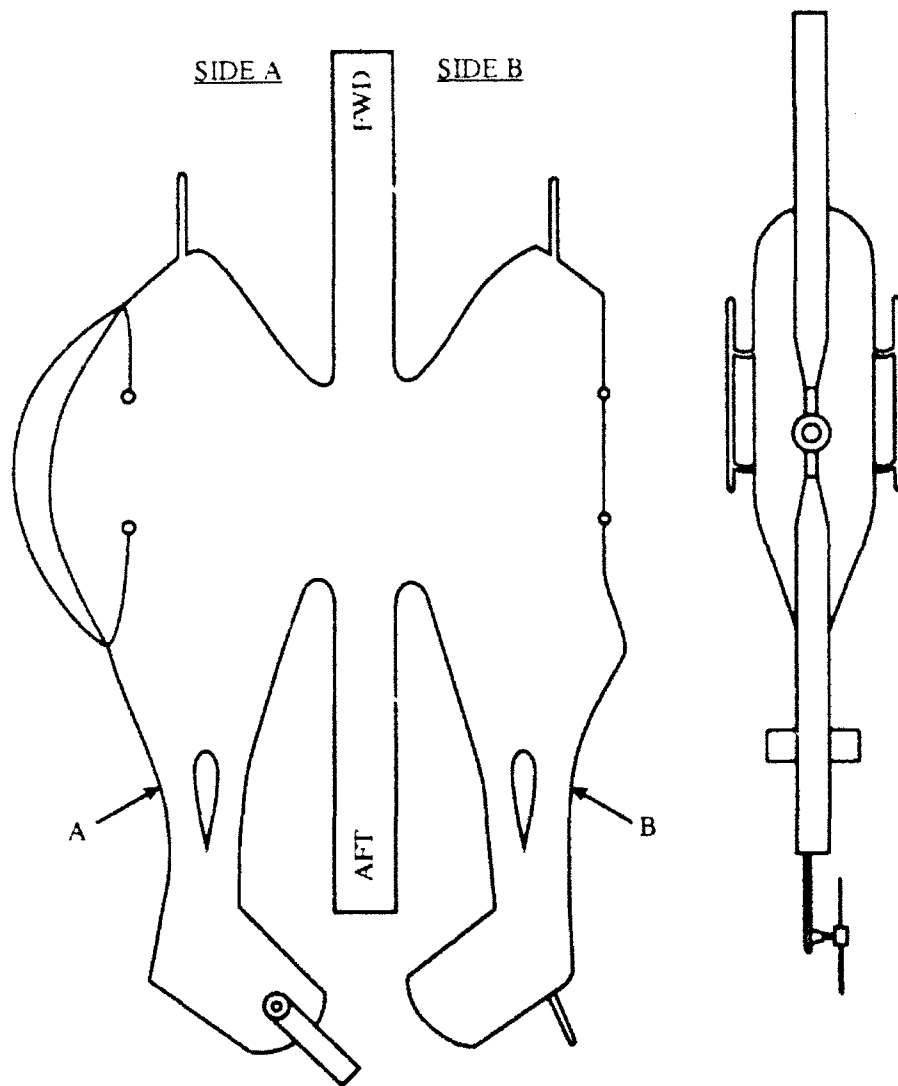
Figure 1: The Global Redicover Bag for Long term Storage of the Bell 206-B1 Helicopter

To prevent corrosion during the storage of Bell 206-B1 helicopters for periods greater than 90 days, the aircraft are enclosed in a Global Redicover Bag (Figure 1), which is connected to a dehumidifier (1). Although these one-piece bags with a special airtight maxigrip zipper are fabricated from a tough, abrasion resistant polyurethane film, they are susceptible to punctures, tears and failure (2)(3). They are not readily available at the Oakey Army Air Base, and their replacement cost is approximately \$20,000.

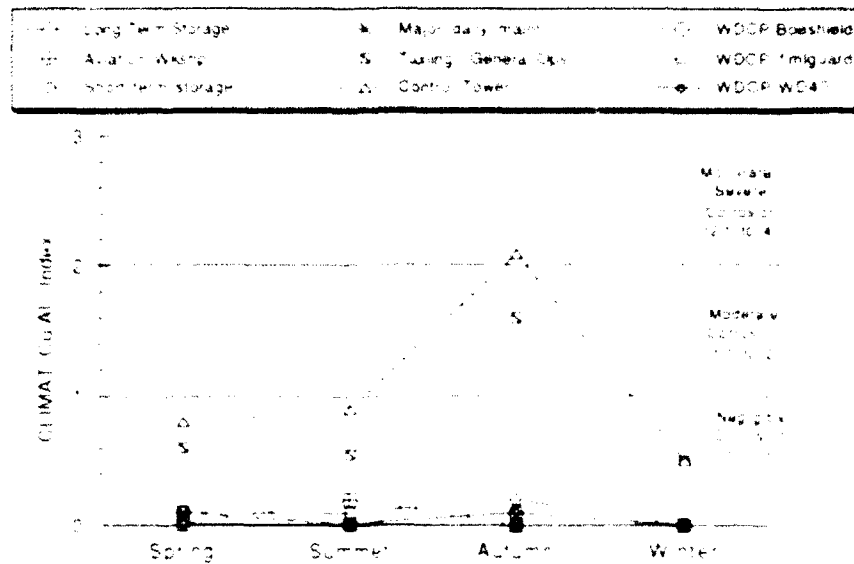
Figure 2: CLIMAT Corrosion indices obtained with the Al/Cu couple at various Base locations from Aug 91 to Aug 92.

Figures 2 and 3 compare the 'Corrosion Indices' obtained with Al/Cu or Al/Fe couples after exposure over the 12 month period. It should be noted that scatter in the CLIMAT results for the Al/Cu and Al/Fe couples (12-15) is  $\pm 0.1$  index points. This data indicates that over four successive seasons, the outside environment (ie Control tower) is more corrosive than the indoor environment (ie Long term storage hangar). The range of results for the outside specimens were index values of 0.5 to 2.10 (Al/Cu couple) and 0.3 to 2.60 (Al/Fe couple). Figures 4 and 5 show specimens after exposure on the control tower and in the long term storage hangar.

Based on these values, general environmental corrosivity of the Oakey Aviation Area, was found to be in a range of index values of 0.5 to 2.6 (Al/Fe couple) and 0.3 to 2.1 (Al/Cu couple). The CLIMAT assessment may thus be classified as negligible to moderate with a brief moderate to severe condition experienced in Autumn.

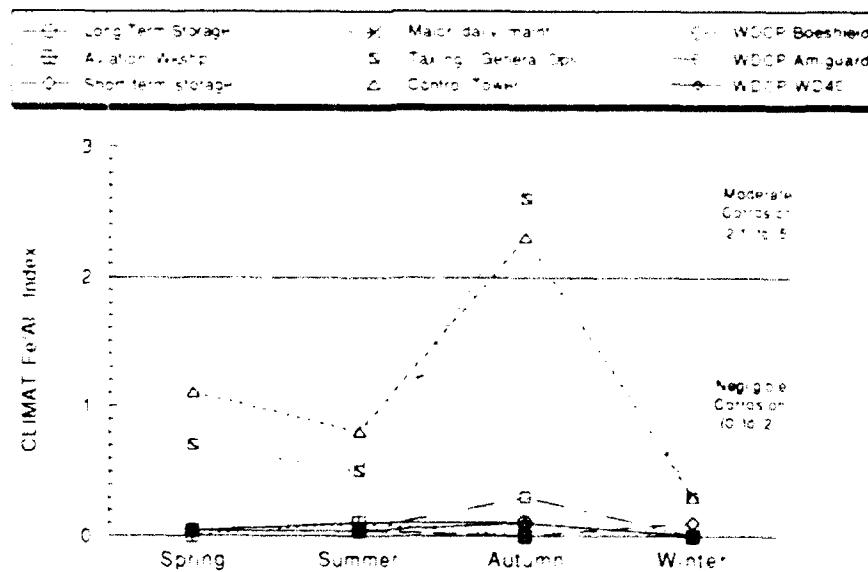
Figure 3: CLIMAT Corrosion indices obtained with the Al/Fe couple at various Base locations from Aug 91 to Aug 92.

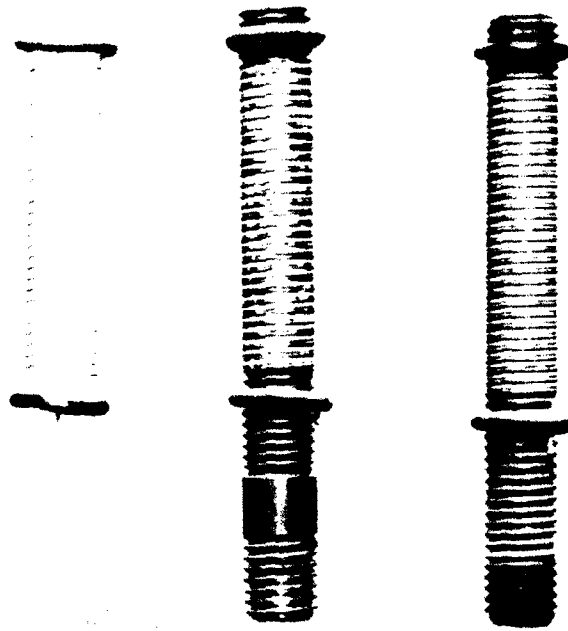
June 92    Aug 92:    Control Tower

Figure 4: CLIMAT Specimens after 90 days exposure on the control tower northern balcony at Oakey.

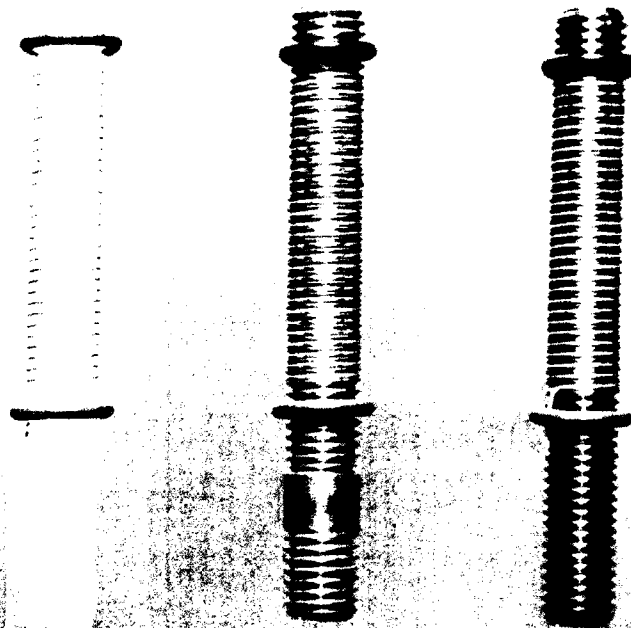
Long Term  
Storage Hangar

Figure 5: CLIMAT Specimens after 90 days exposure in the long term storage hangar at Oakey.

The range of index values for the indoor specimens were from 0.00 to 0.10 (Al/Fe couple) and 0.00 to 0.20 (Al/Cu couple). No significant corrosion had occurred in the enclosed areas over the past 12 months of evaluation. The long term and short term storage areas had the lowest recorded corrosivity of all of the indoor specimens and the range of results were index values of 0.00 to 0.01 (Al/Fe couple) and 0.00 to 0.01 (Al/Cu couple).

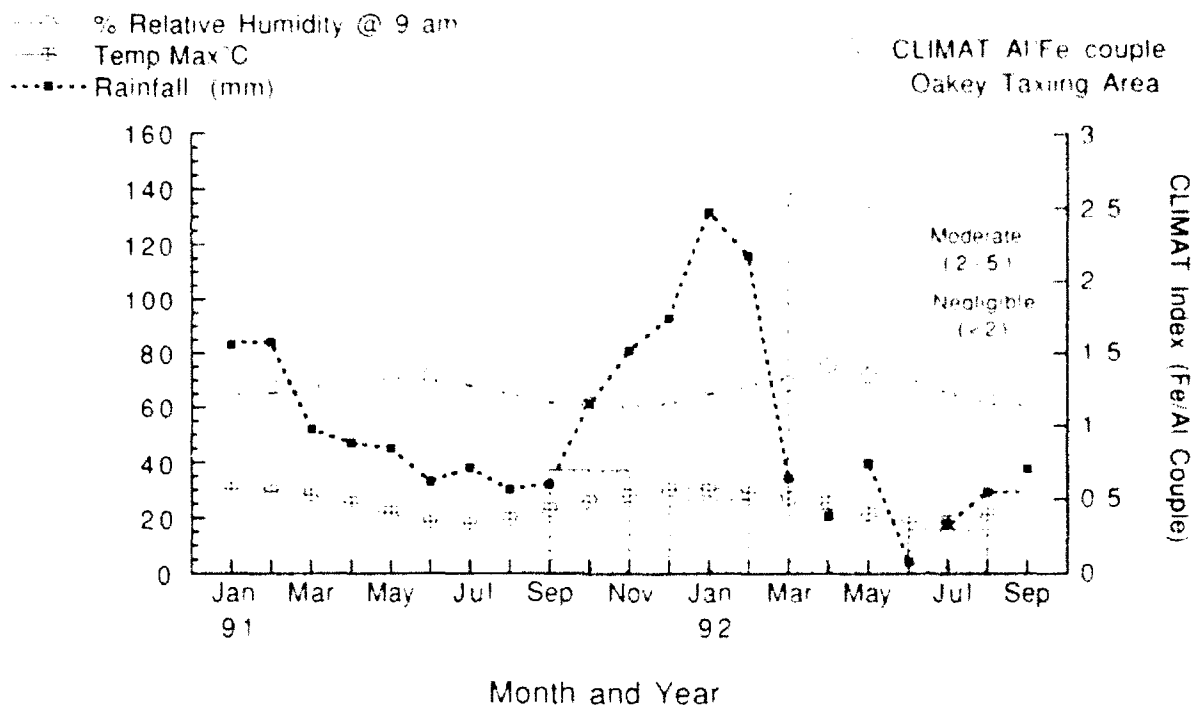
Figure 6: CLIMAT Corrosion indices obtained with the Al/Fe couple compared to measured climatic conditions for 12 months.

In figure 6 environmental corrosivity ('CLIMAT index' from the Al/Fe couple) and the climatic variables are plotted for each month over the past year.

There is no obvious correlation between the averaged monthly climatic variables (figure 6) and the seasonal variations in environmental corrosivity. The higher rainfall during summer did not apparently increase the corrosivity of the environment.

The higher environmental corrosivity measured during Autumn could be related to other non-climatic factors such as: airborne contaminants, arising from the local use of fertilisers, used during the preparation for planting of the local grain crops or, the aerial spraying of herbicides and pesticides.
