| 4. TITLE AND SUBTITLE<br>Cyclic Load Testing of Unreinforced Masonry Walls | | 5. FUNDING NUMBERS<br>DAAL03-87-K-0006 | |
| 6. AUTHOR(S)<br>Daniel P. Abrams & Nirav Shah | | | |
| 7. PERFORMING ORGANIZATION NAME(S) AND ADDRESS(ES)<br>Advanced Construction Technology Center<br>University of Illinois at Urbana-Champaign<br>Department of Civil Engineering<br>205 N. Mathews Ave., MC - 250<br>Urbana, IL 61801 | | 8. PERFORMING ORGANIZATION<br>REPORT NUMBER<br>ACTC Document #92-26-10 | |

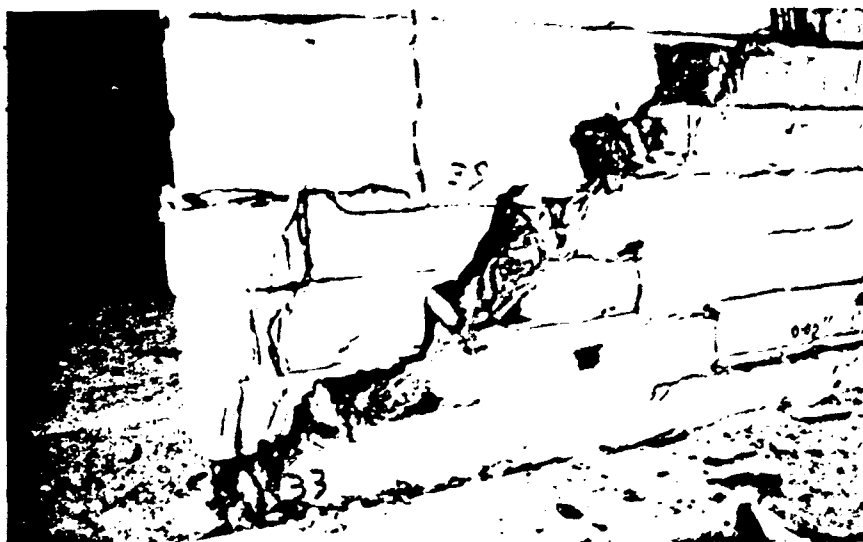
Vertical splitting cracks, and spalling of bricks was observed at the toe of specimen W2 (Fig. 3.2) much like that for a masonry prism subjected to concentric vertical compression. This condition represented the ultimate limit state of the wall. A toe compression failure such as this may be construed to be a flexural failure, however, it was precipitated by diagonal shear cracking. Thus, the limit state for specimen W2 may be classified as a flexure-shear failure.

Figure 3.2 Toe Crushing for Specimen W2
