# PROCESSING AND PROPERTIES OF COATED HPZ FIBER REINFORCED GLASS-CERAMIC MATRIX COMPOSITES

FINAL REPORT

MARCH 31, 1993

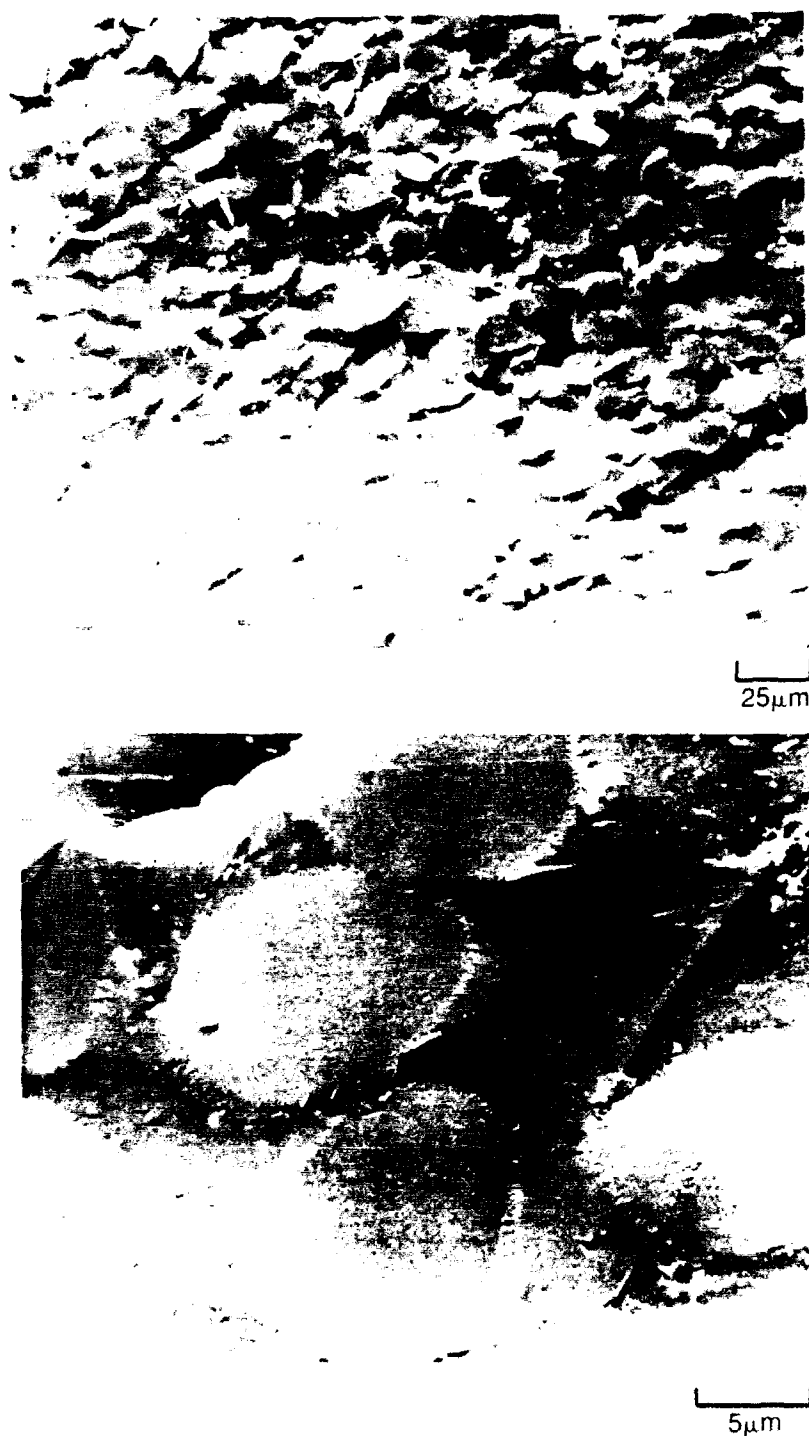
**Fig. 1** Fracture Surface of LAS Matrix/HPZ Fiber Composite

As was shown in Fig. 1, it was found that the fracture surface of an early HPZ fiber composite utilizing an LAS (lithium aluminosilicate) glass-ceramic matrix was extremely brittle, with little evidence of the fibers contributing to either the composite strength or toughness. A more recent BMAS matrix/uncoated HPZ fiber composite (#349-91) fracture surface is shown in Fig. 23. This composite exhibited a RT flexural strength of 23 ksi (159 MPa), which is comparable to that for an unreinforced BMAS glass-ceramic. As in the composite of Fig. 1, the fracture characteristics are that of a monolithic glass-ceramic, with obviously strong bonding between the fibers and matrix. The oval shape of the more recent HPZ fibers (lot # 9545-20-12), along with the few round but hollow fibers, can be seen in Fig. 23.

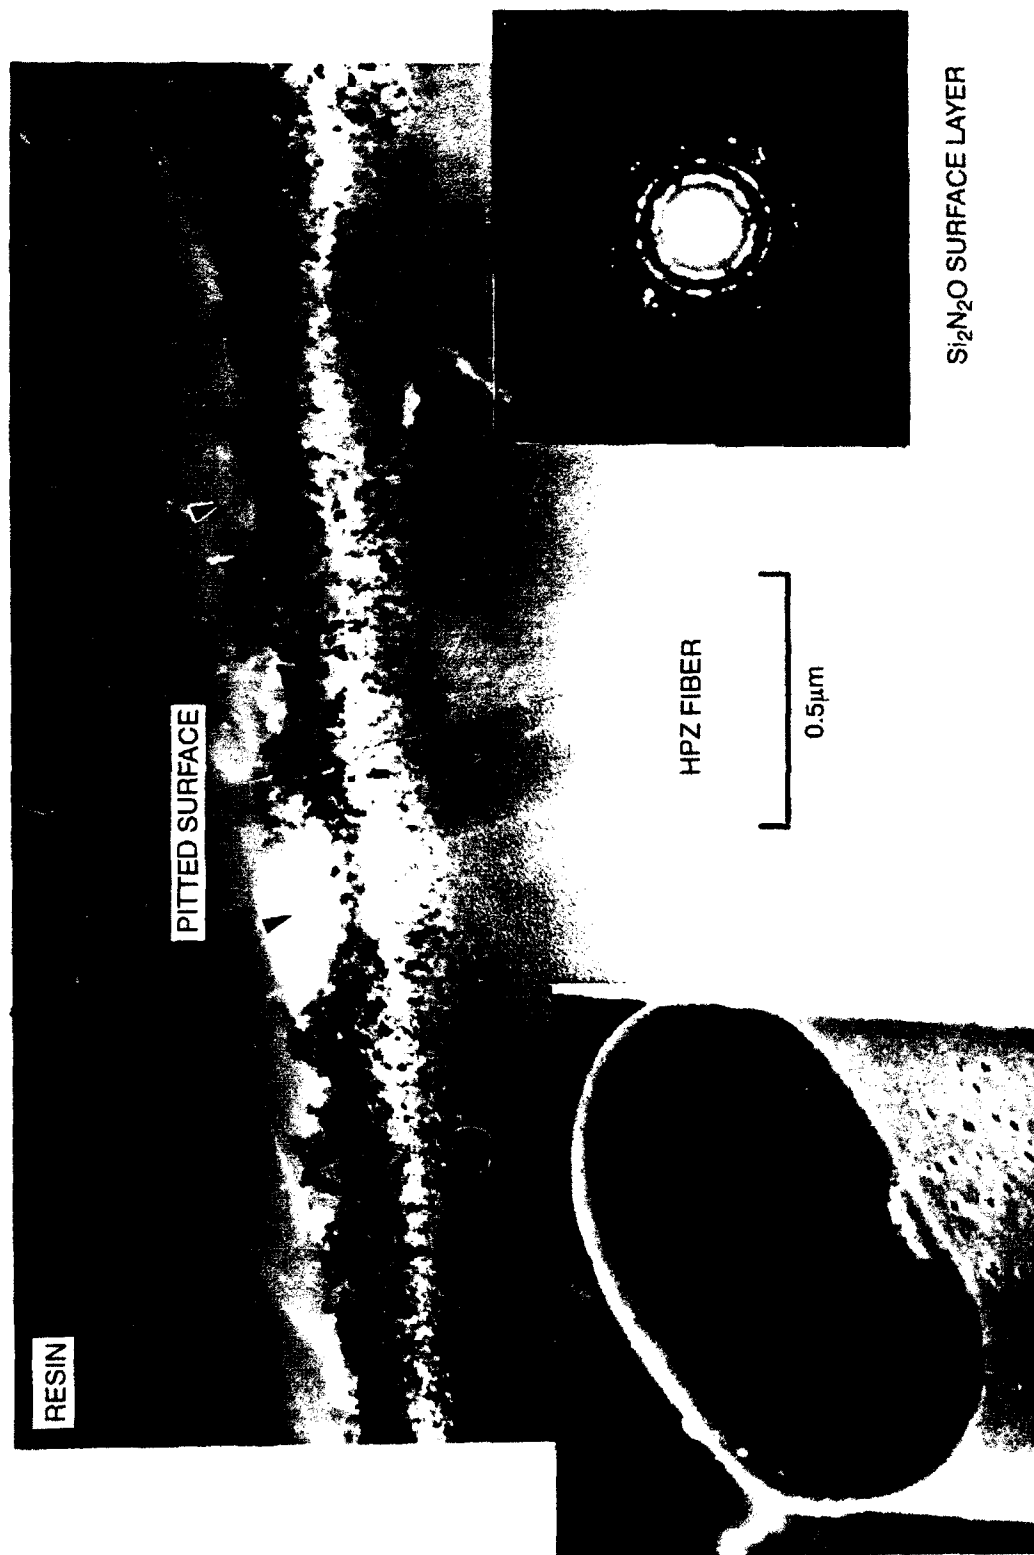
Fig. 10 TEM/SEM/SAED Analysis of HPZ Fiber (Si-C-O-N) Lot #03028013 (1430°C/10 min, N<sub>2</sub>)

The cause of this degradation in tensile strength can be seen in Fig. 10, which shows the fracture surface of a lot #03028013 HPZ fiber after the  $1430^{\circ}\text{C}$ , nitrogen heat-treatment, as well as a TEM thin section of the surface region of this fiber. It can be seen that the fiber has a definite surface layer on it that exhibits a significant number of pits. From the TEM analysis, it is evident that the oxygen rich surface layer has crystallized to a rather uneven layer of crystalline silicon oxynitride ( $\text{Si}_2\text{N}_2\text{O}$ ).

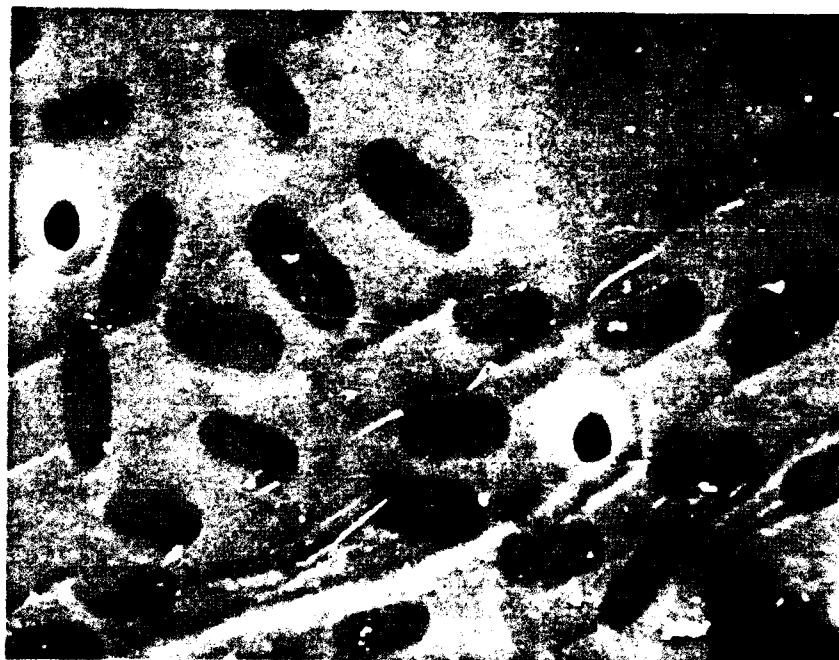
Fig. 23 RT Fracture Surface of BMAS Matrix/HPZ Fiber Composite #349-91

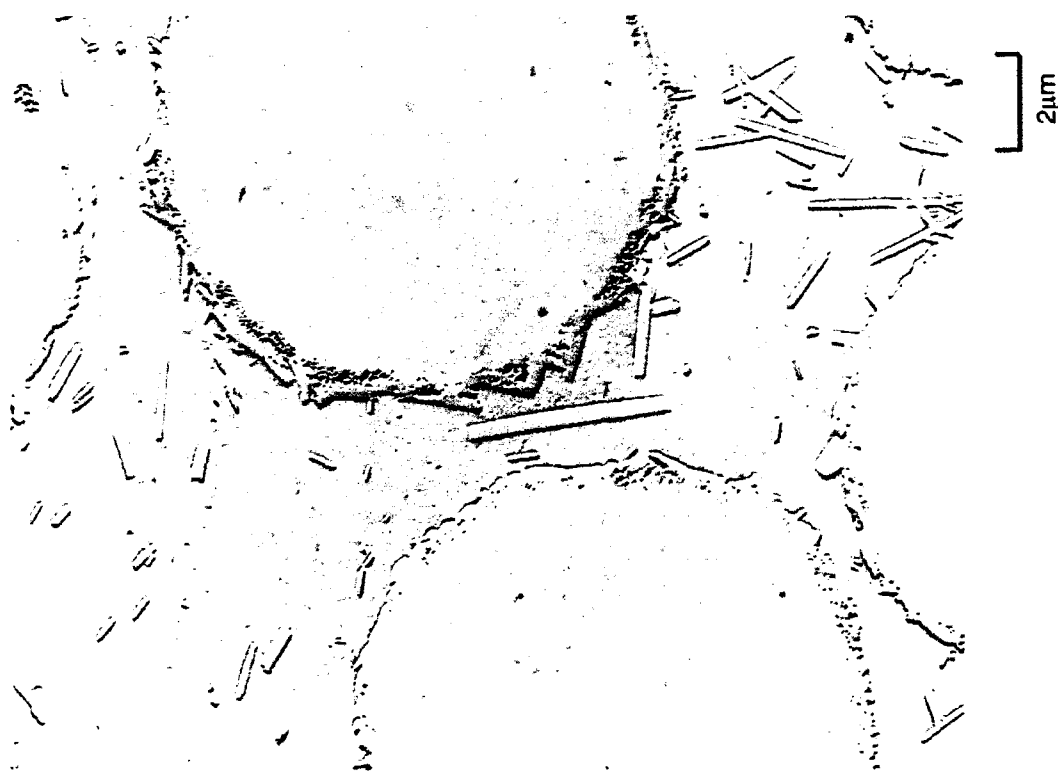
Fig. 26 Optical/TEM Replica Micrographs of Transversely Sectioned BMAS/TONEN Si<sub>3</sub>N<sub>4</sub> Fiber Composite-#269-92 (As-Pressed)

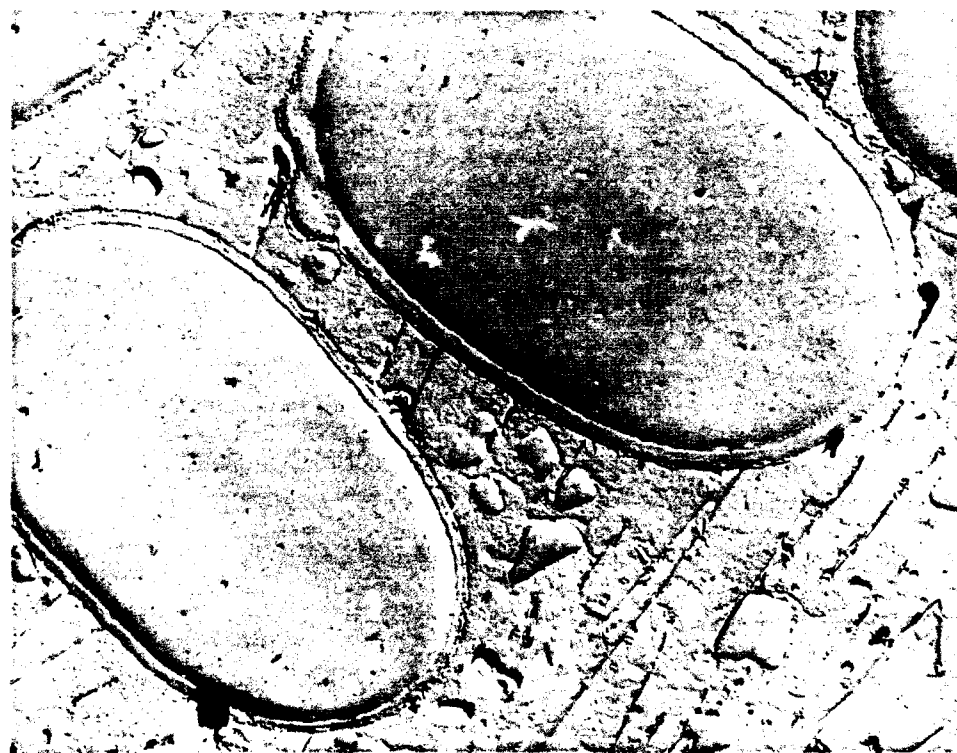
LESS FREQUENT, "THUMBNAIL" FIBER REACTIONS

TYPICAL

Fig. 47 TEM Characterization of BMAS/BN Coated/HPZ Fiber Composite-#392-92 (Ceramed)

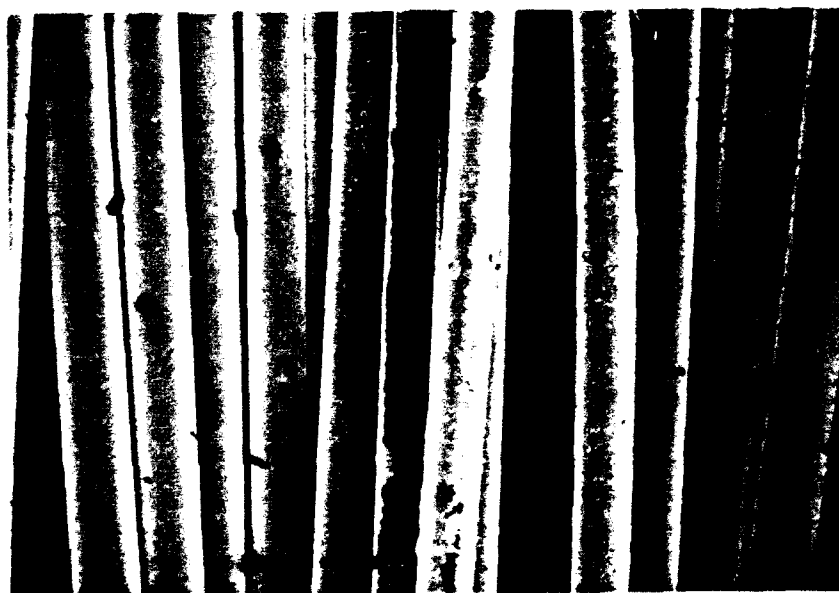
(A) SURFACE VIEW: SOME FIBER BREAKAGE

(B) AREAS OF COATING DAMAGE <5%

**Fig. 59 Orthogonal Woven Fabric with SiC/BN Coated Fiber**
