Technical Report GL-93-6

# **Geogrid Reinforced Base Courses for Flexible Pavements for Light Aircraft: Test Section Construction, Behavior Under Traffic, Laboratory Tests, and Design Criteria**

by *Steve L. Webster*  
*Geotechnical Laboratory*

Prepared for Federal Aviation Administration

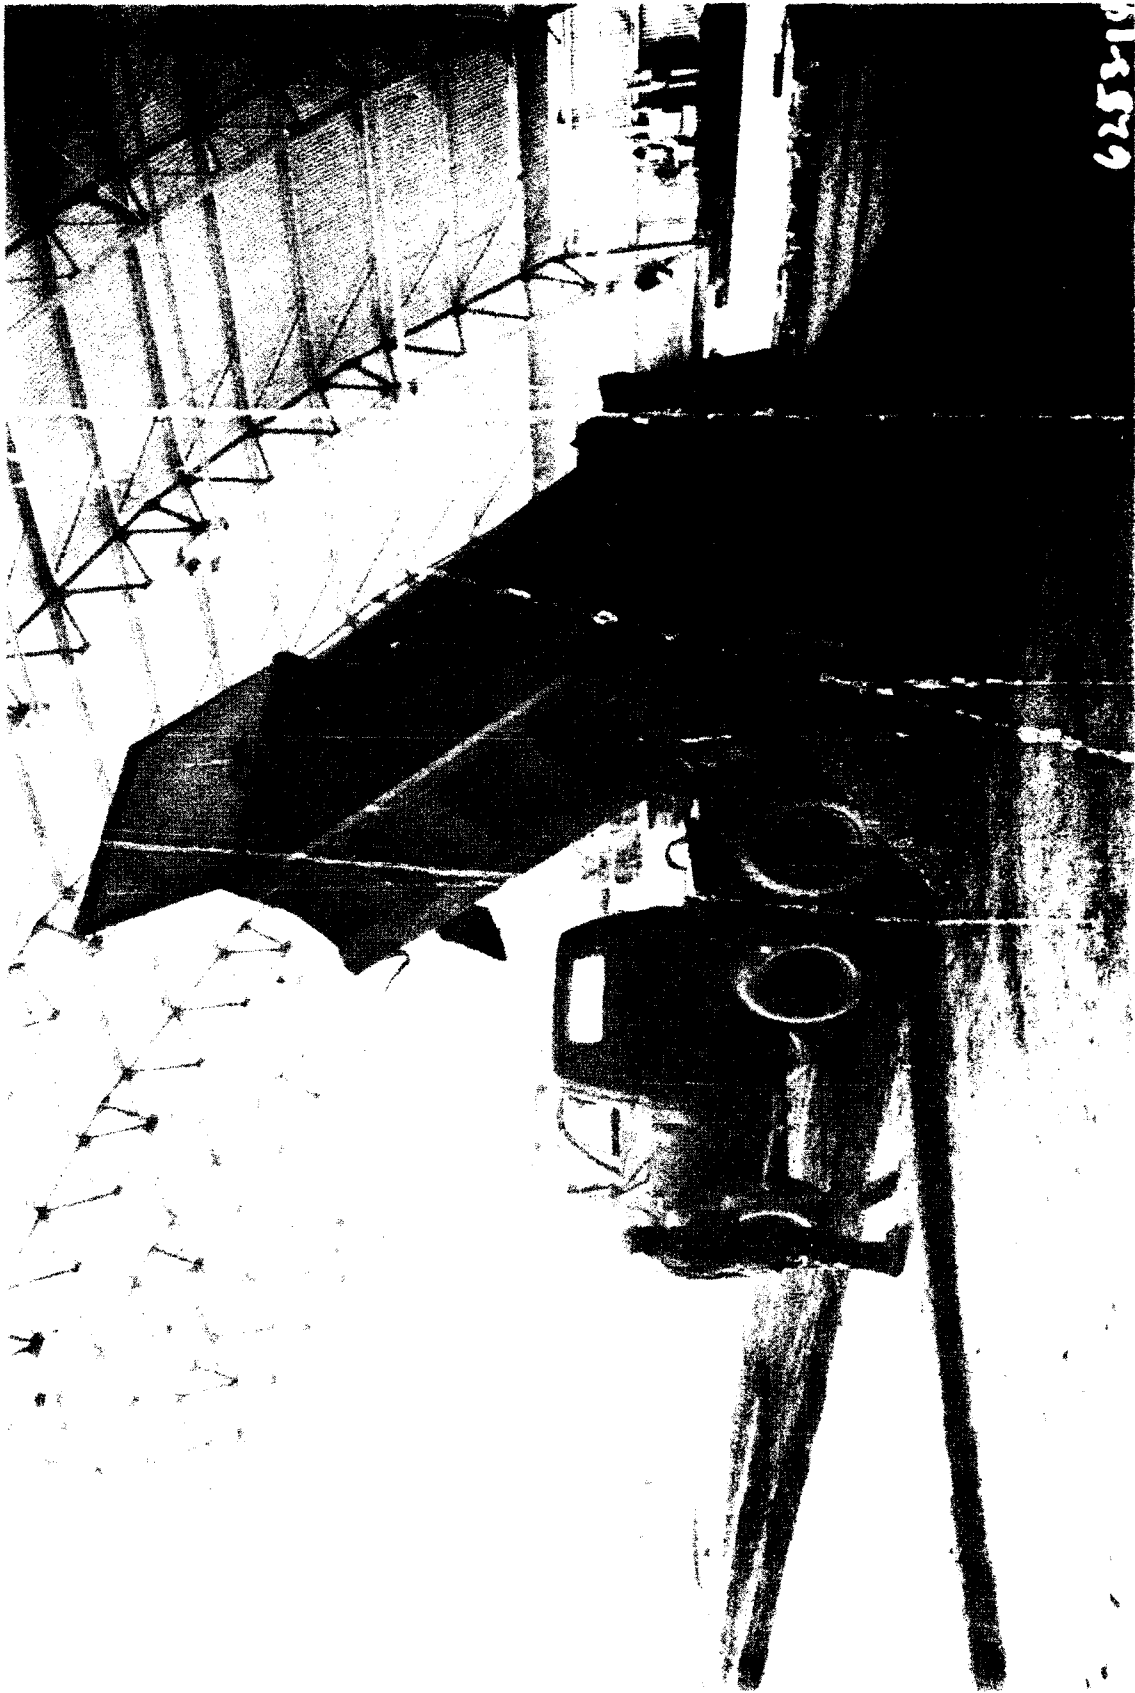
Figure 15. Geogrid installed on the subgrade

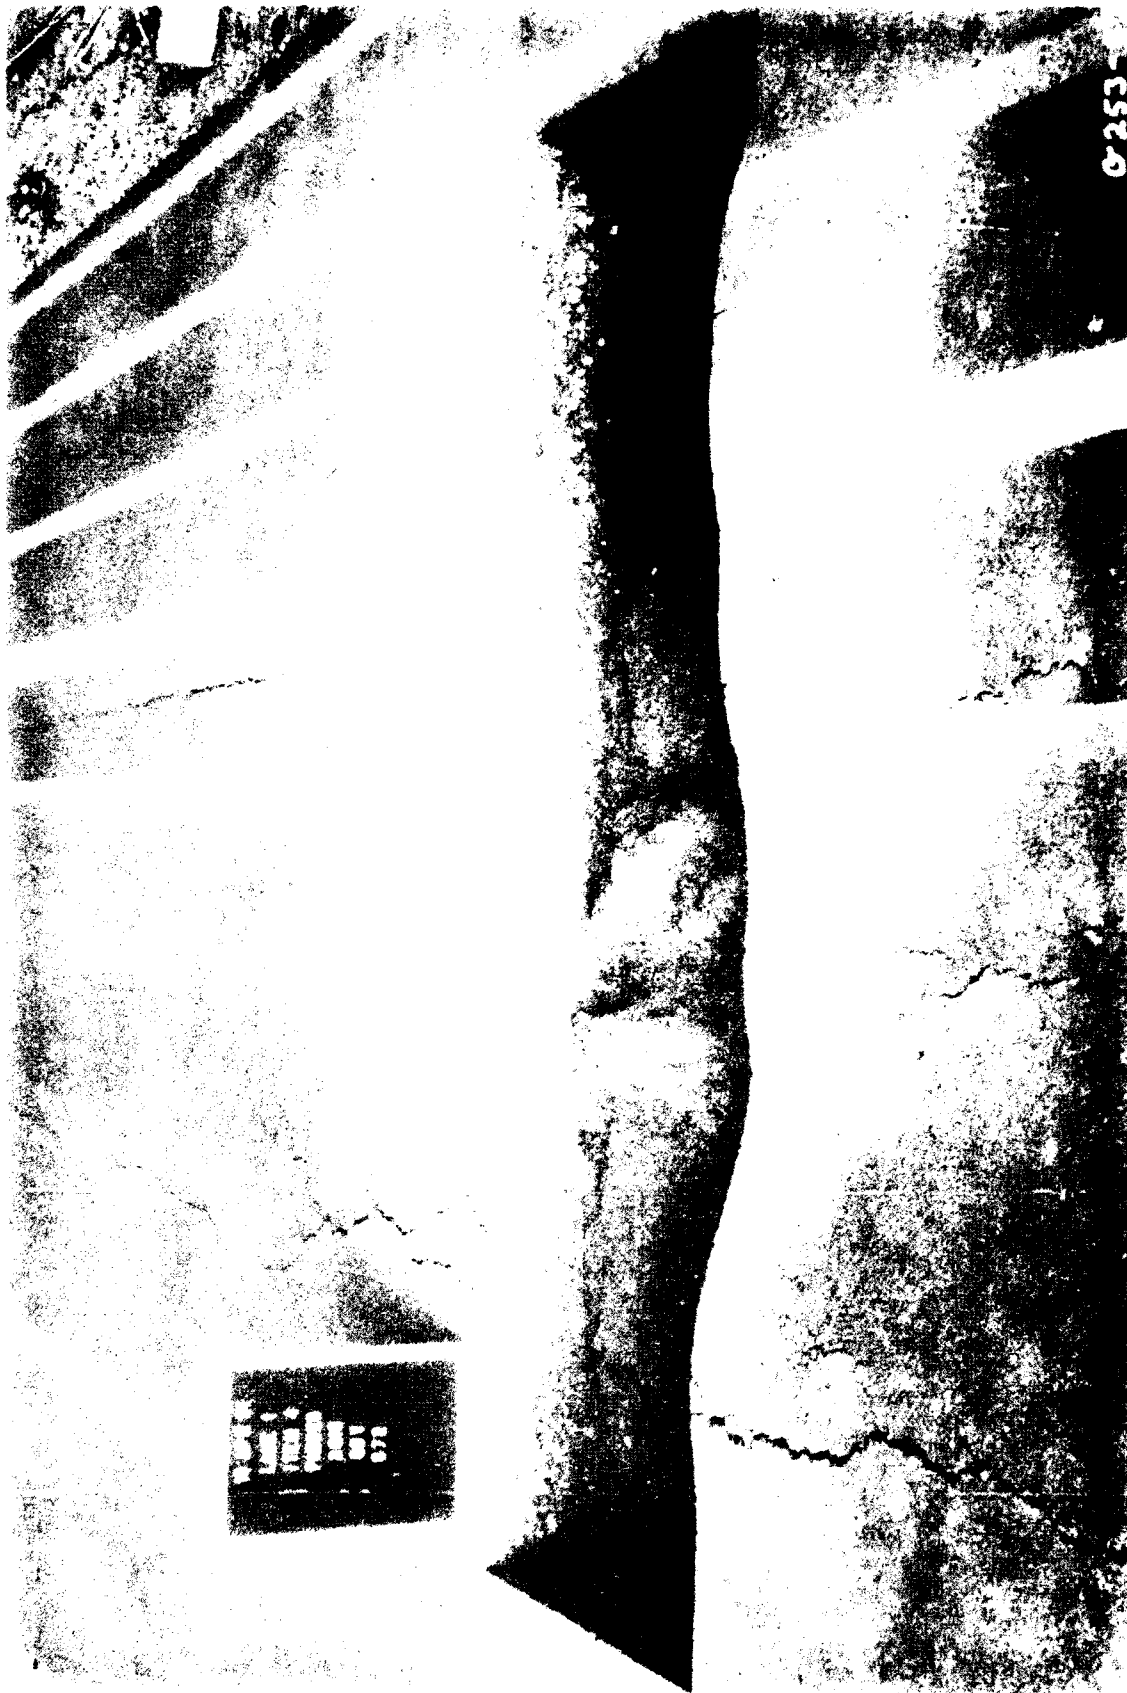
Figure 10. Lane 1, Item 4, the portion of AC surface removed

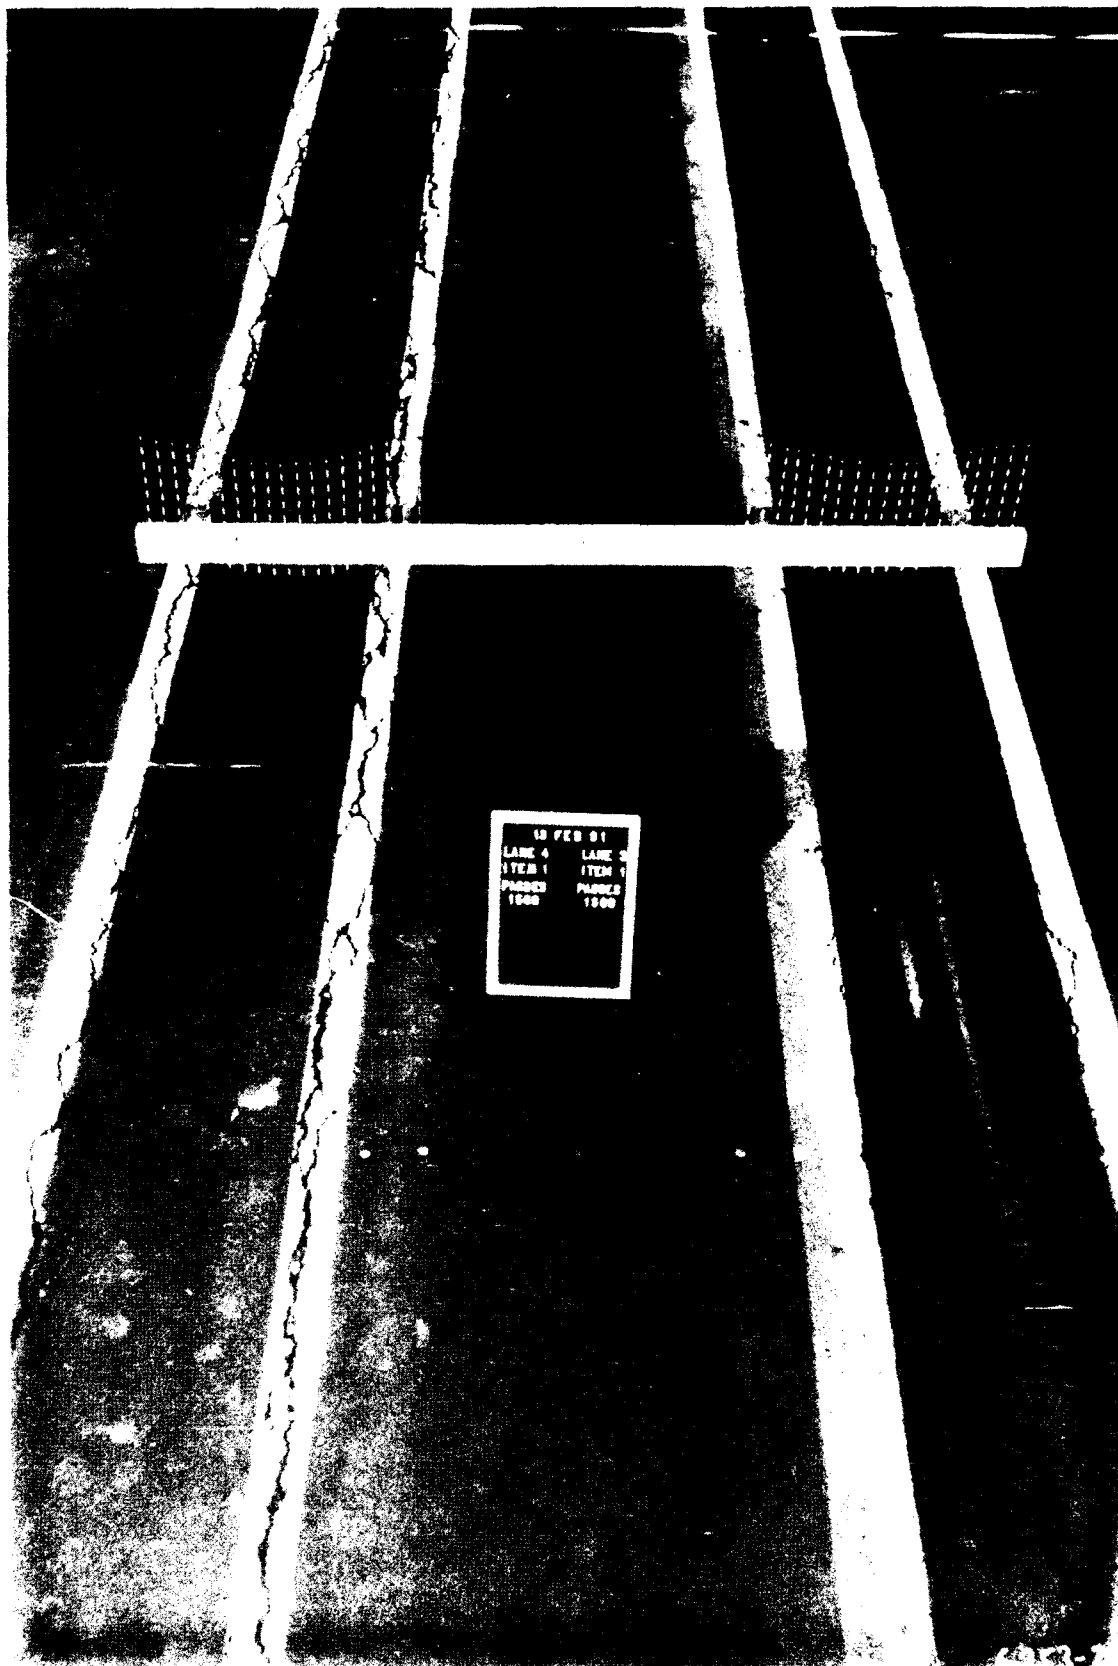
Figure 92. Trench in Lane 1, Item 4 after a portion of subgrade removed

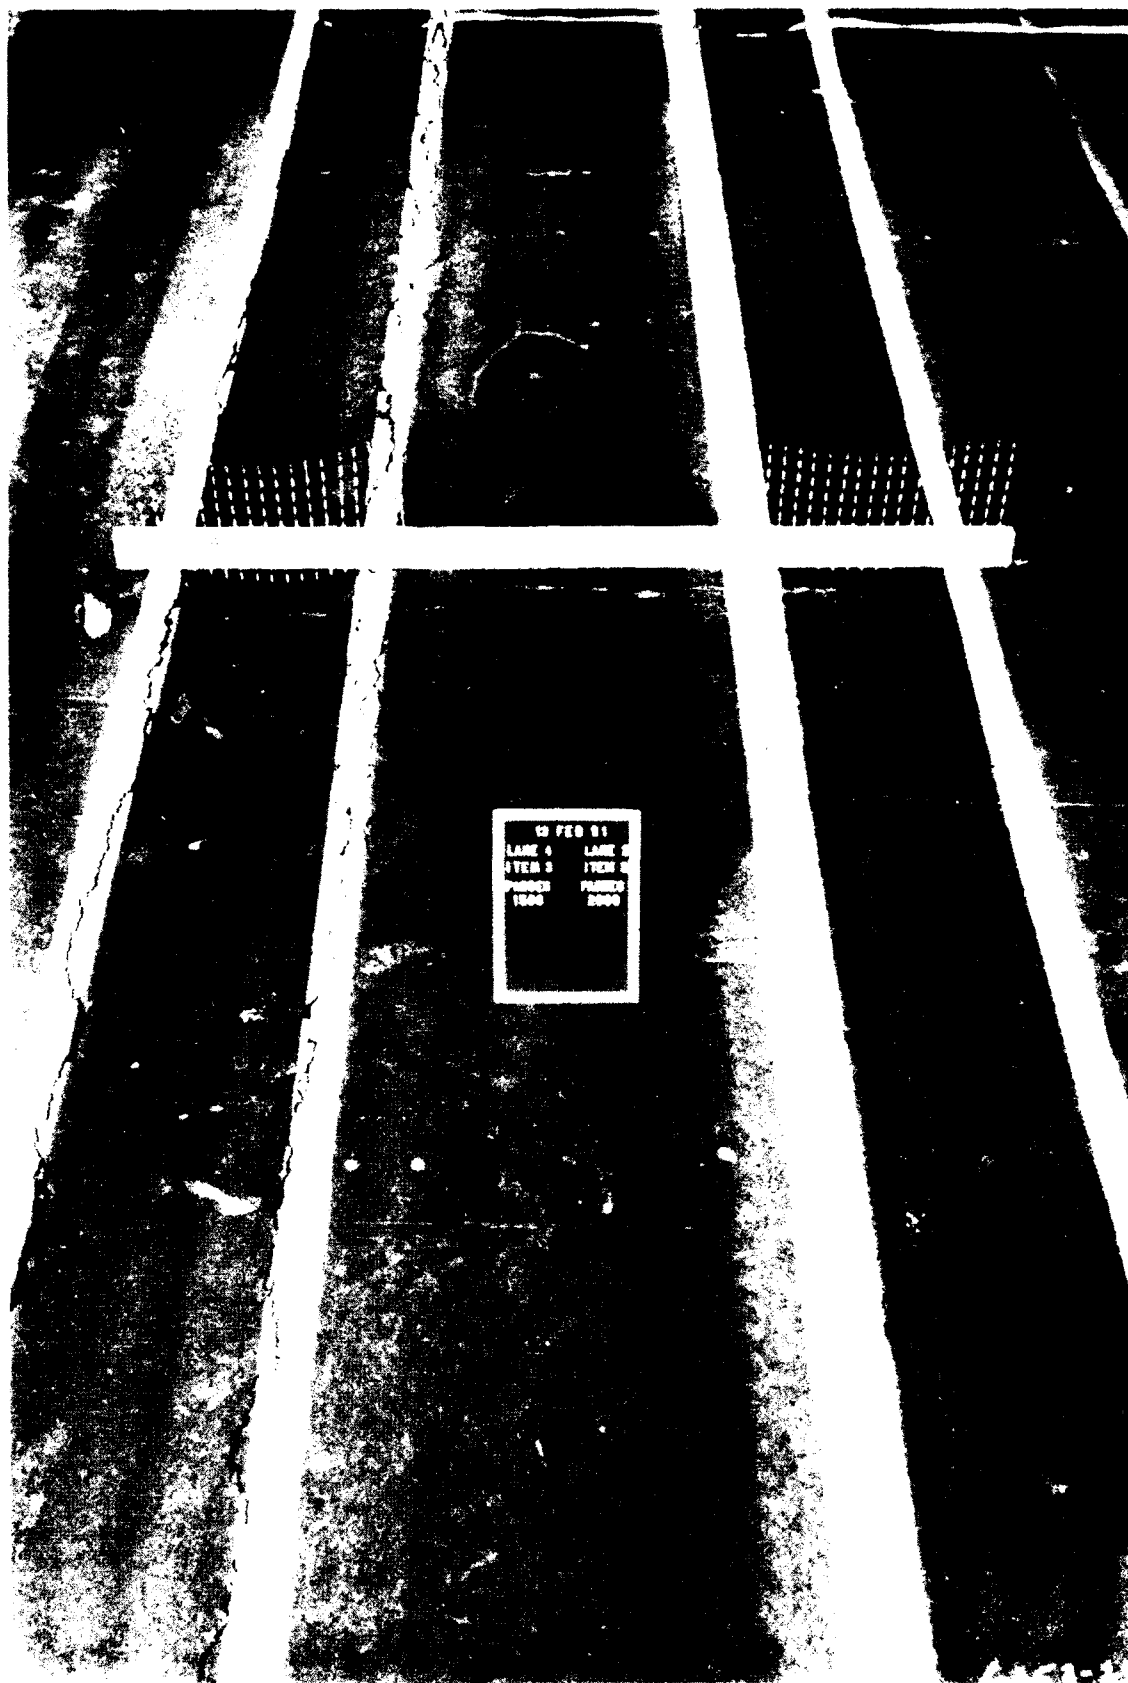
Figure 54. L412 (Miragrid 5T) on left and L312 (SS-2 mid-base)  
after 1500 passes

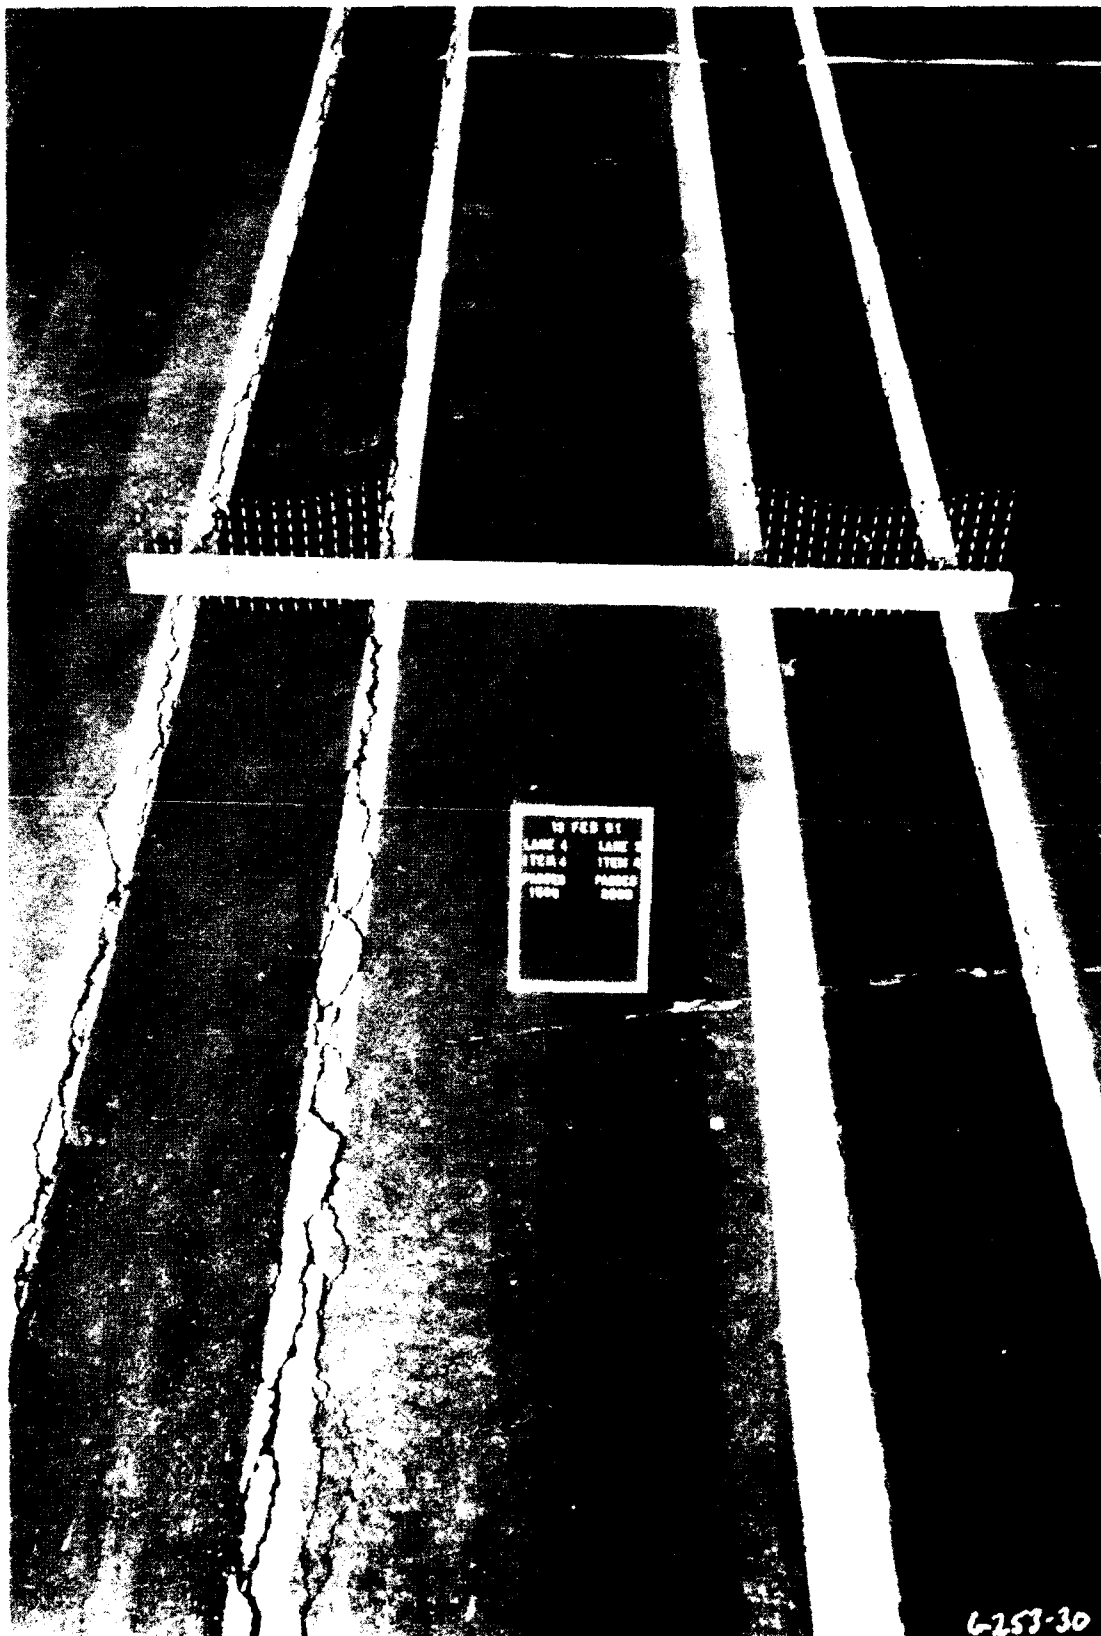
Figure 55. L413 (Fortrac 35/20-20) on left after 1500 passes and L313 (SS-2) on right after 2000 passes
