NASA  
Contractor Report 191079

# Sikorsky Aircraft Advanced Rotorcraft Transmission (ART) Program— Final Report

March 1993

Prepared for  
Lewis Research Center  
Under Contract NAS3-25423

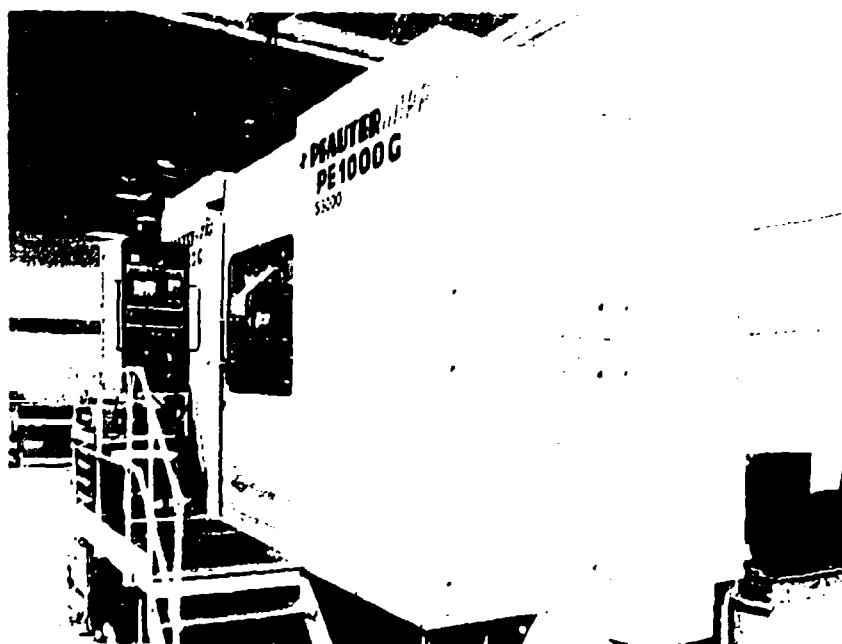
Figure 86. Phauter Kapp Grinding Machine

The spur gears and double helical gears were ground on the Phauter Kapp Grinder as shown in Figure 86. This machine is a form grinder and is designed to use cubic boron nitride (CBN) cutting wheels as shown in Figure 87. CBN is a form of "imitation diamond" and is the next hardest material next to a natural diamond. On a relative hardness scale, it is much harder than silicon nitride used in current state-of-the-art grinding wheels. The advantage of CBN wheels is two fold: (1) The wheel is so hard that there is very little wear. There is no wheel dressing but rather the wheel is sent back for replating after a number of gears are ground which can reach to 50 or 100 gears or more, and (2) The majority of the heat generated in the grinding process is transferred to the wheel rather than to the part being ground as in conventional grinding because of the differences in specific heat of the material hence there is little chance of grinding burns. Since there is less

chance of grinding burn damage, deeper cuts can be taken. Profile modifications are manufactured into the wheel which is unique to the part being manufactured and can not be used for any other part. The numerical control permits off axis corrections such as lead modification and root line modification which can of course vary across the face. Crowning, for example, is obtained by "feeding in" at the ends of the teeth.
