NASA  
Technical Memorandum 106103  
AIAA-93-2298

# Evaluation of a Vibration Diagnostic System for the Detection of Spur Gear Pitting Failures

Prepared for the  
29th Joint Propulsion Conference and Exhibit  
cosponsored by the AIAA, SAE, ASME, and ASEE  
Monterey, California, June 28-30, 1993

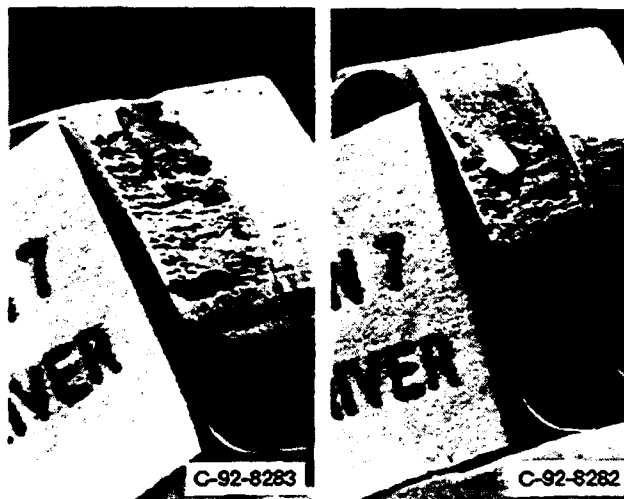
Figure 12.—Gear tooth fatigue spalls for test run B.

tooth (tooth 4) on the gear pair was producing a higher dynamic load. This tooth was found to have fairly sizable fatigue spall, as shown in Fig. 12.

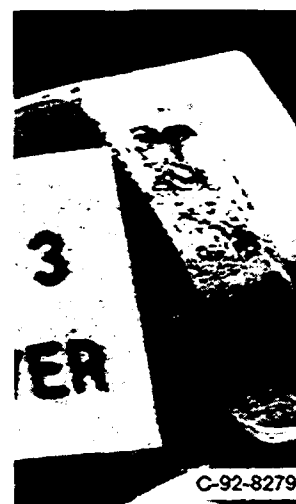
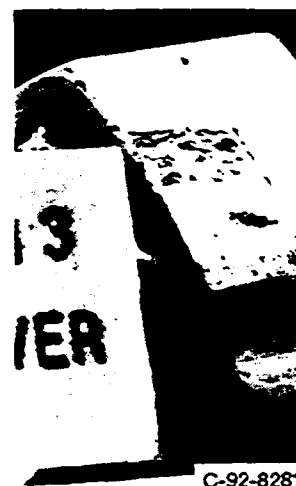
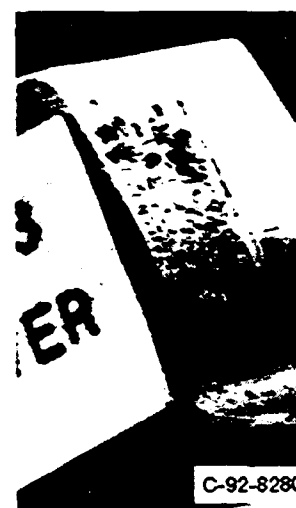
Figure 15.—Gear tooth fatigue spall for test run C.

Figure 15 shows the failed gear teeth from test run C. Three adjacent teeth on this gear have fatigue spalls and another tooth (not shown), four teeth ahead of these, has a fairly large fatigue spall. Several plots of the time-synchronous-averaged signal for this test give some indication of failures on more than one tooth and at the locations where the fatigue spalls occurred on the gear.
