FINAL REPORT  
APRIL - NOVEMBER 1992

REPORT NO. 92-14

CARISTRAP EVALUATION

VALIDATION ENGINEERING DIVISION  
SAVANNA, ILLINOIS 61074-9639

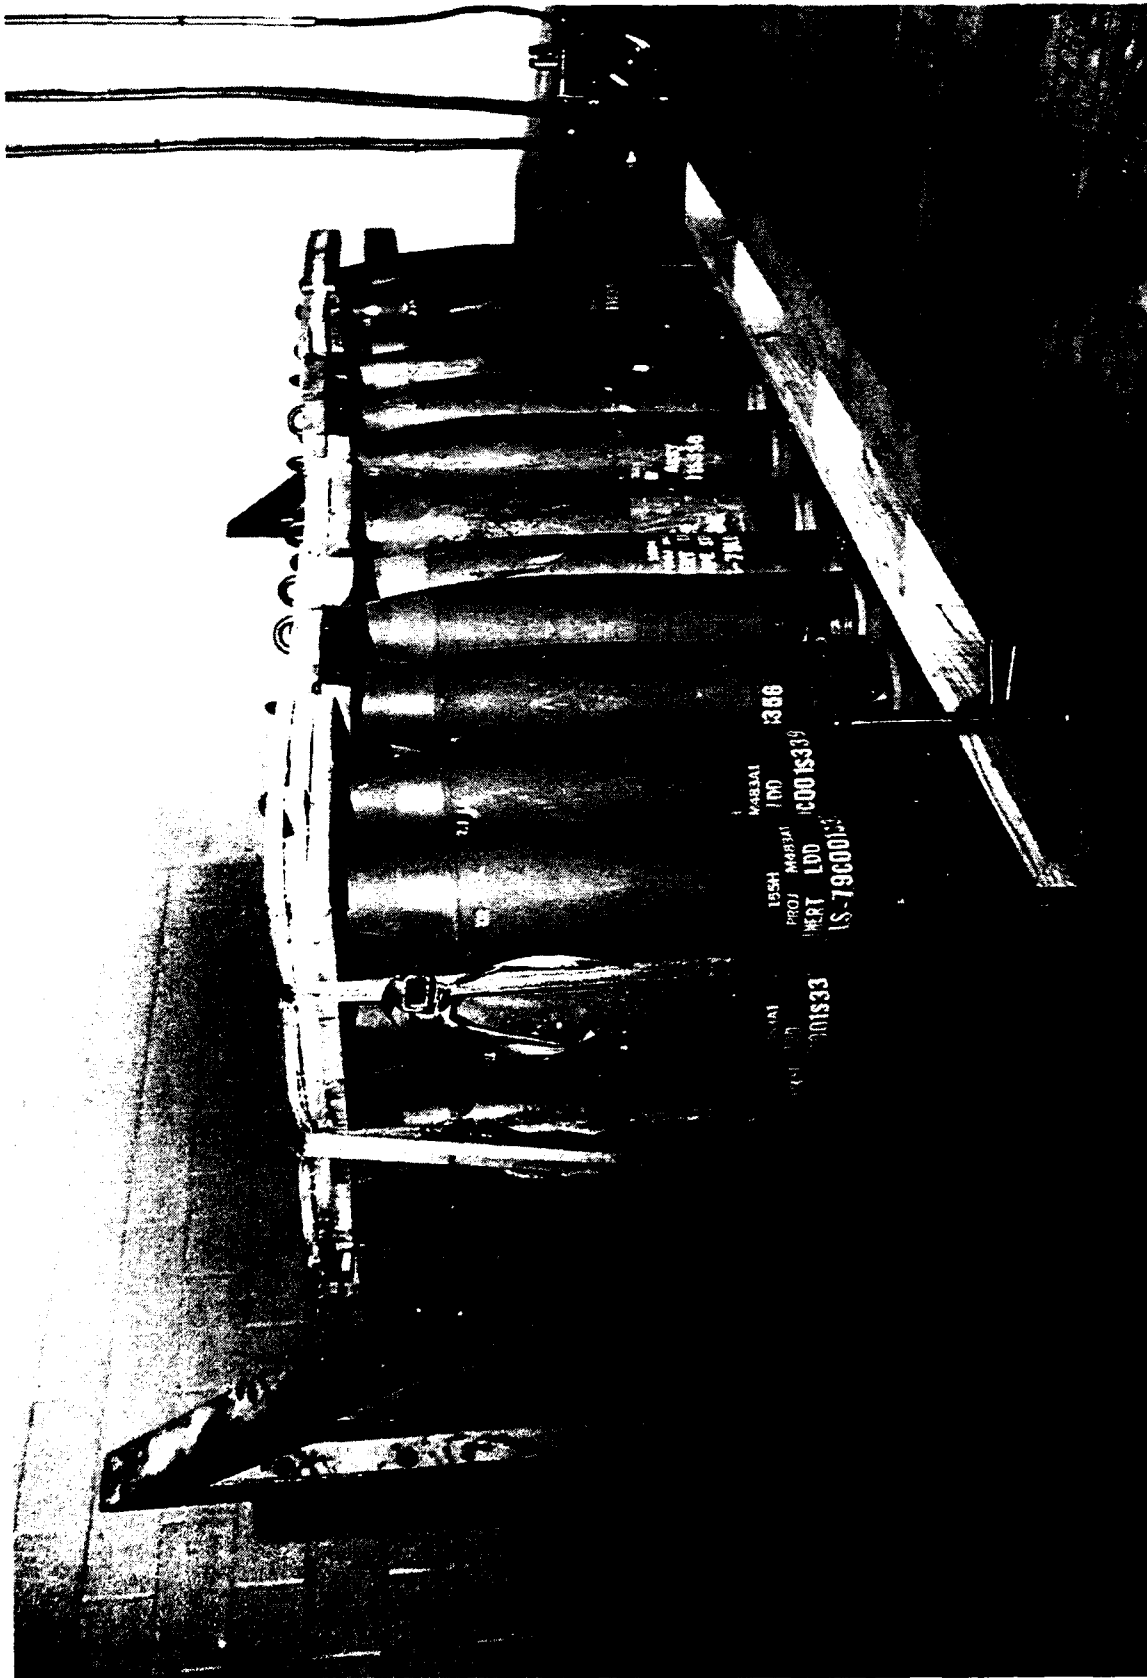
Photo No. AO317-SCN92-2341. This photo shows the vibration table loaded with six 155mm projectile pallets for the perpendicular orientation of the truck transportation simulation.

first 10 minutes of the perpendicular orientation, 5 Caristrap samples had been severed and 2 more were partially severed. The pallets were then rotated to the orientation with the row of six pallets parallel to the direction of motion (see page 7-9). During the second orientation, the first Caristrap sample was severed after only 2 minutes and 20 seconds of vibration. The test was stopped at this point to prevent the projectiles from being dislodged from the pallets. A more detailed inspection revealed an additional four broken Caristrap samples and one partially cut Caristrap. An accurate estimate for the mileage lifetime of the Caristrap on 155mm projectiles was not determined due to the fact that an equal amount of vibration was not obtained in the parallel orientation that had been obtained in the perpendicular orientation.

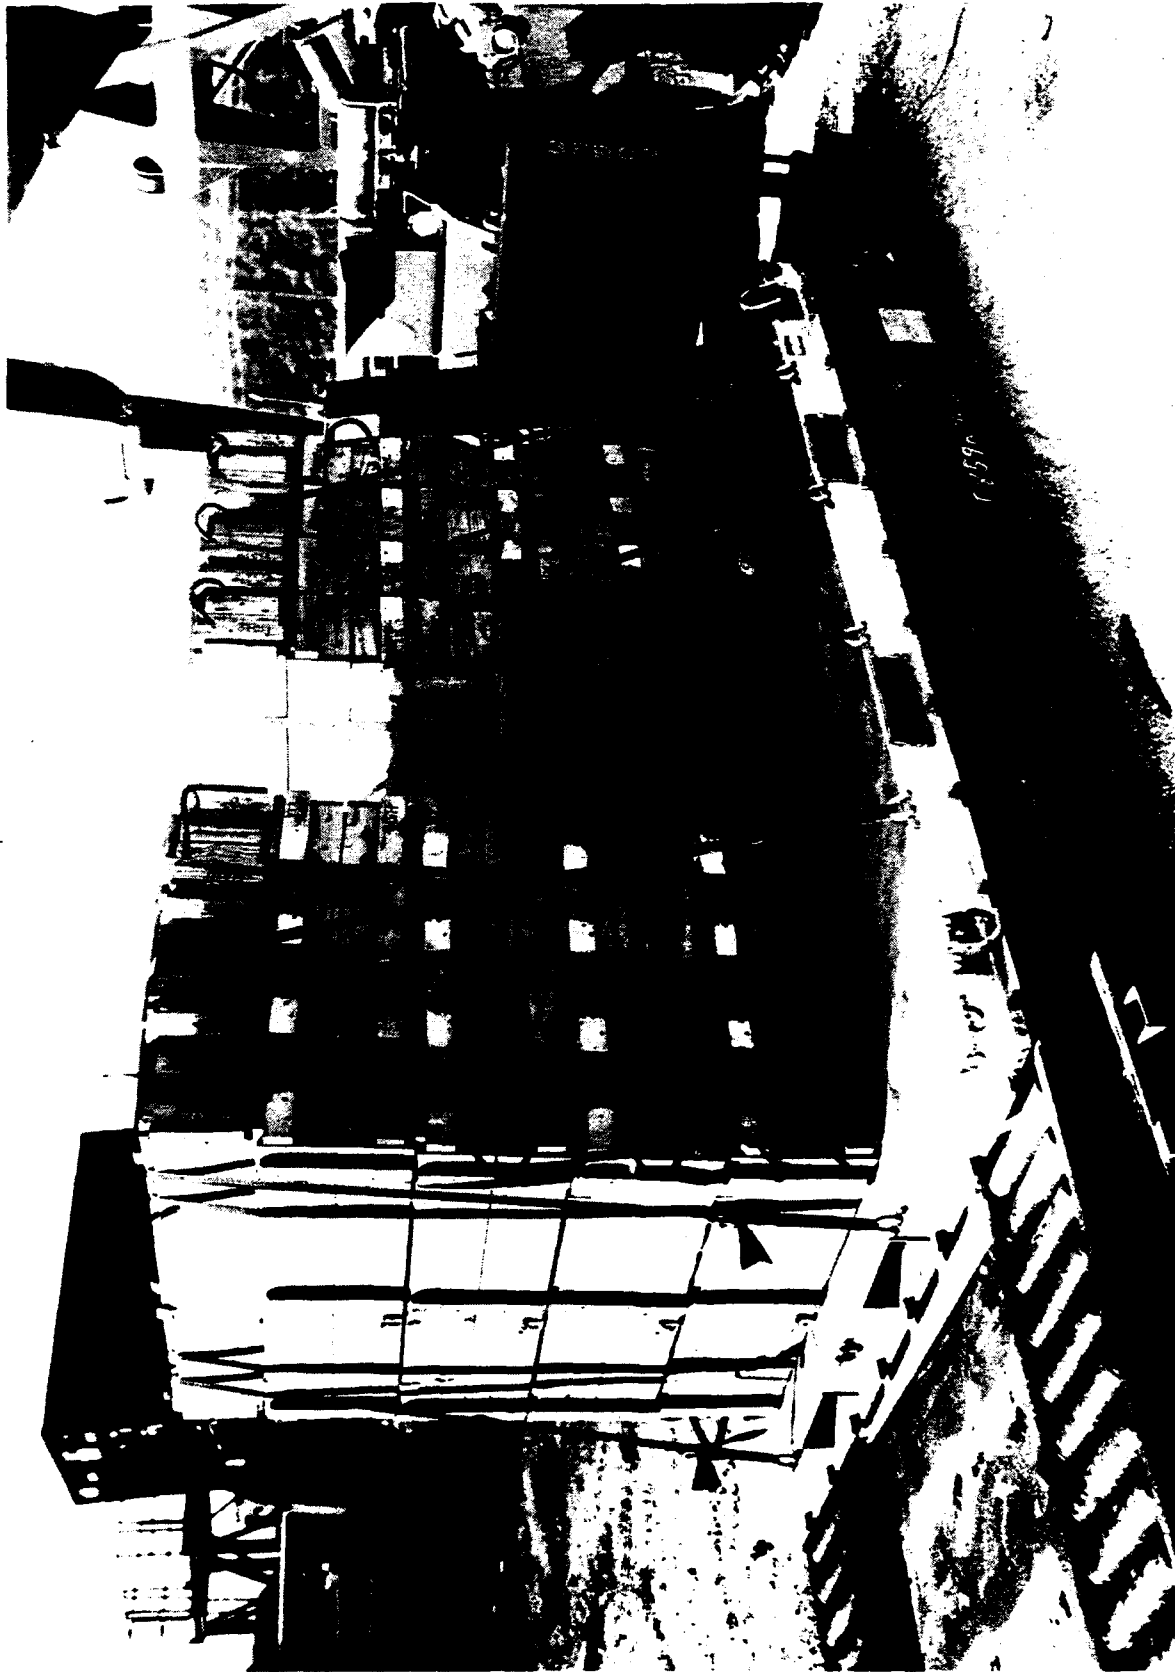
| Photo No. AO317-SCN92-2853. This photo shows the ULARP loaded with Cobra Load II prior to inline-impact testing. |

**D. ULARP EVALUATION.** A ULARP load consisting of thirty-eight 2.75-inch rocket containers and sixteen 20mm containers was assembled and tied down with 11 Caristrap samples on a 463L/INTEX pallet (see pages 7-13 through 7-17). During the evaluation, the bundling strap around the 20mm ammunition containers was severed. The pallet was still considered to have passed the incline unloading test and the road hazard tests due to the fact that the containers were still secured to the pallet by the Caristrap overtop of the containers. In the event the Caristrap was ever used for this particular load, bundling straps that went around each

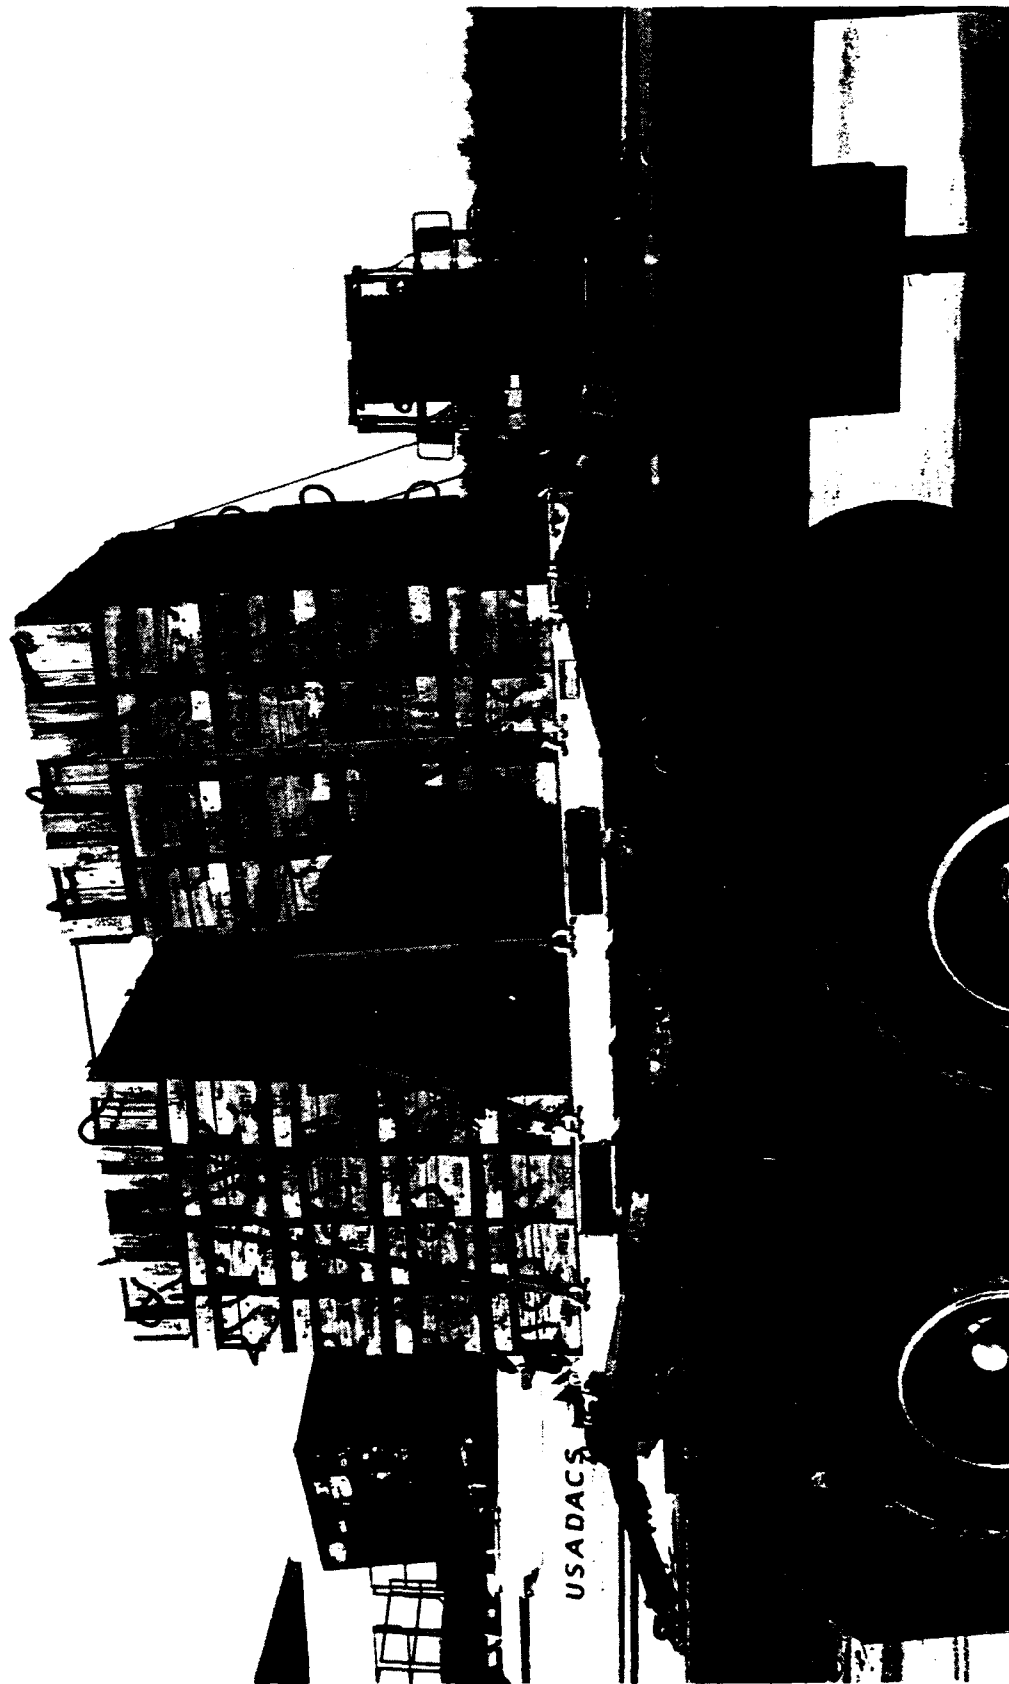
Photo No. AO317-SCN92-195-2860. This photo shows the ULARP attached to the M871 semitrailer prior to transportability testing.

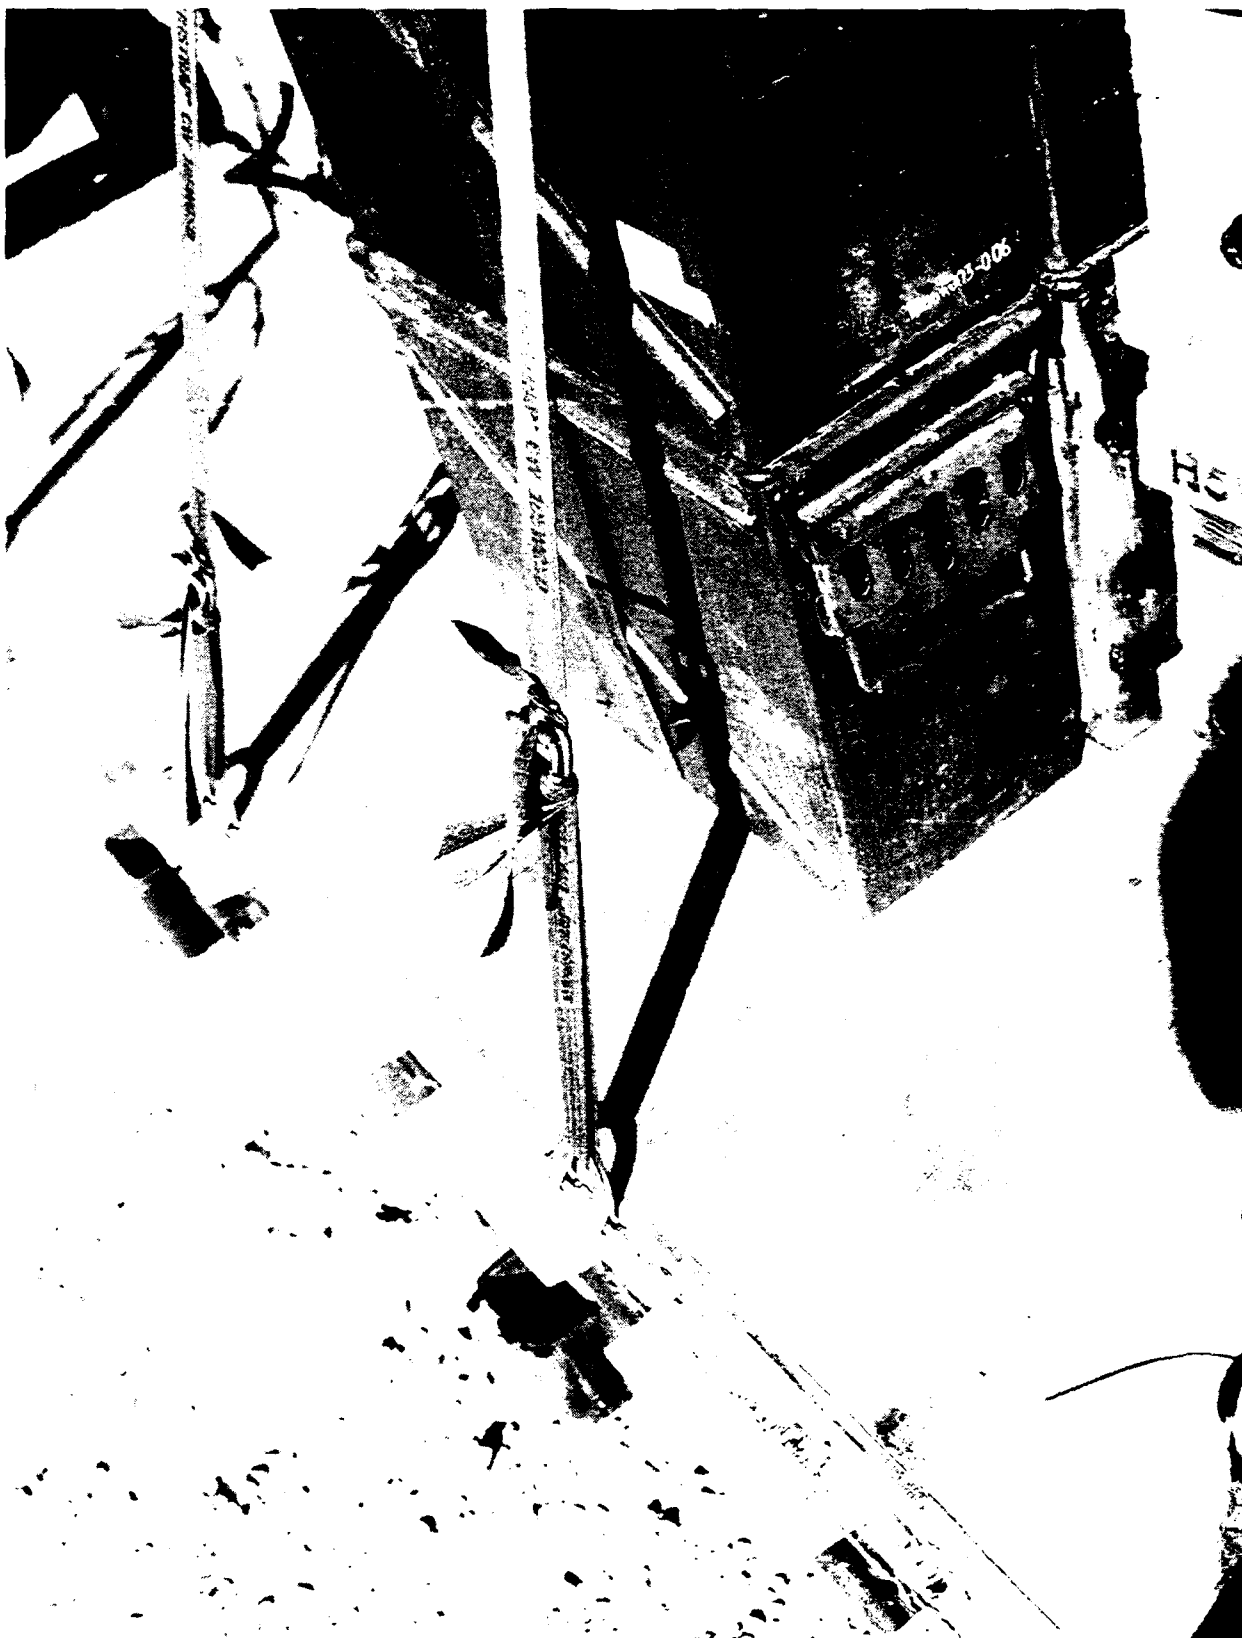
Photo No. AO317-SCN92-195-2849. This photo shows a closeup view of the Caristrap going through the ULARP tiedown anchor.

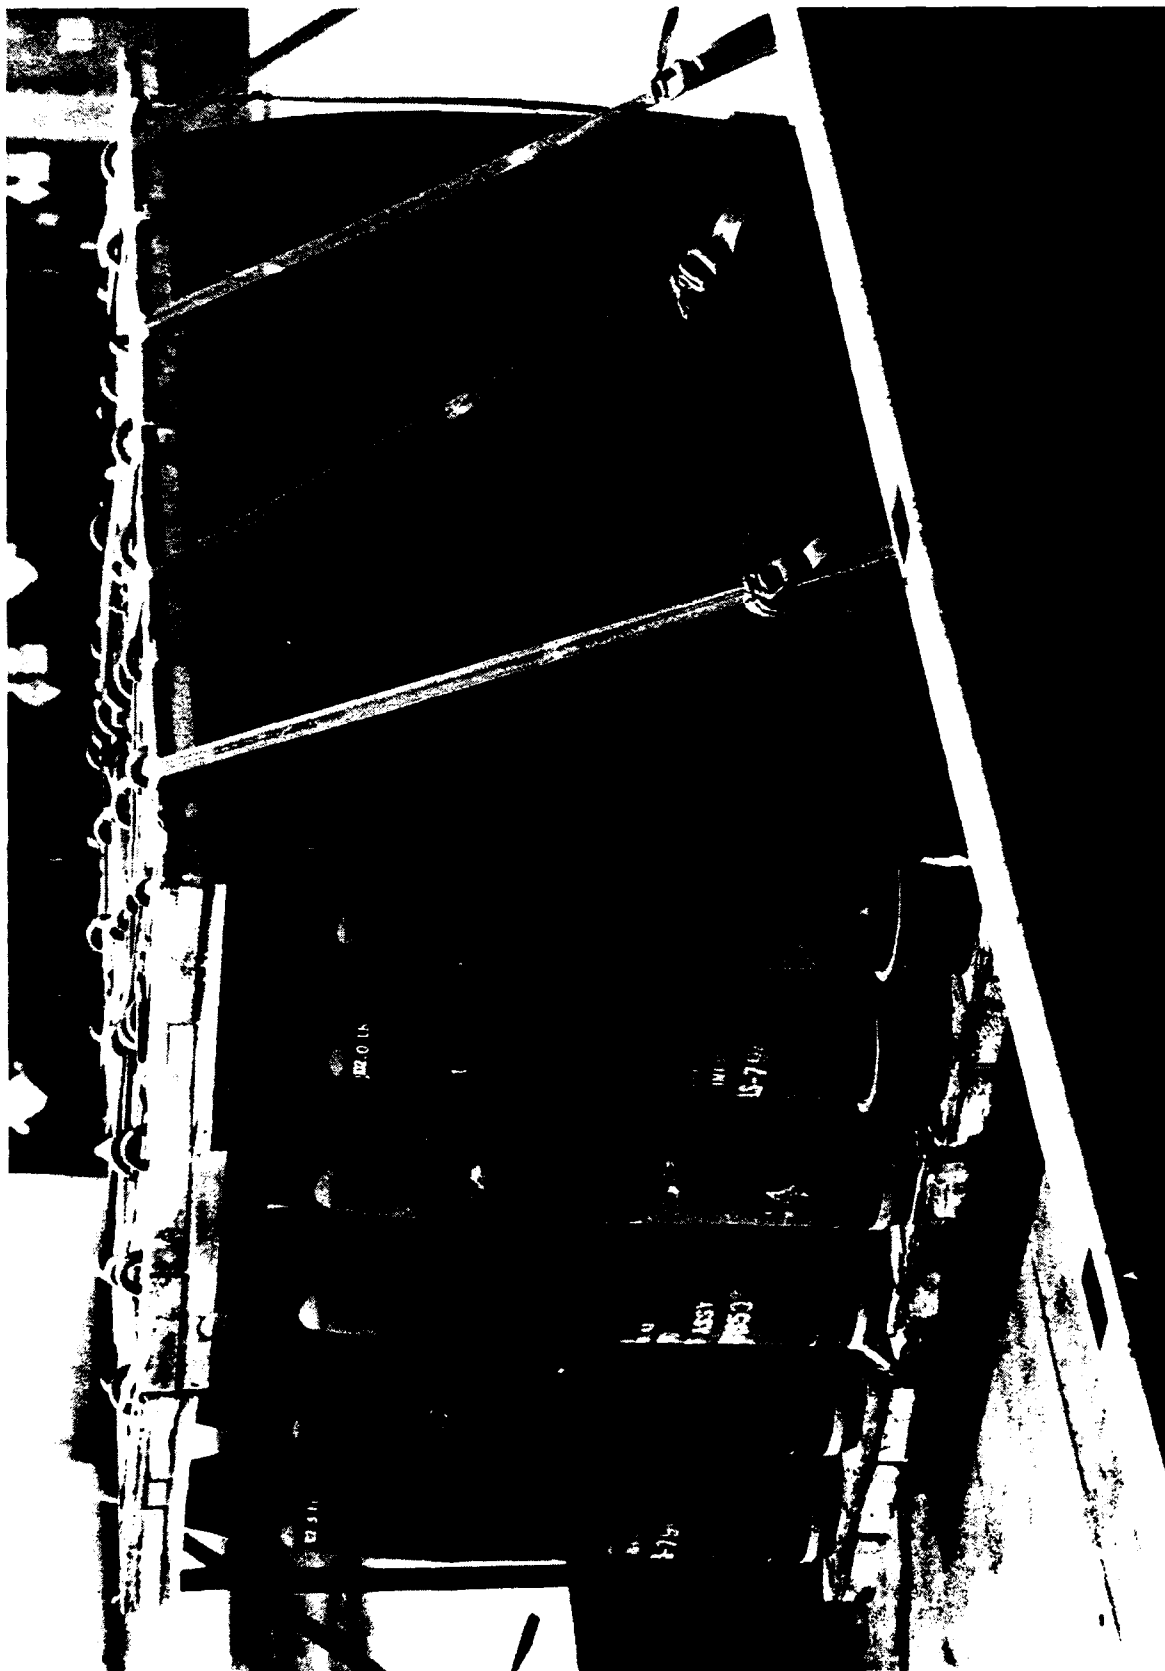
Photo No. AO317-SCN92-195-2967. This photo shows the 155mm projectile pallets that were unitized with metal strapping and tied down with Caristrap samples in a 2-1/2-ton truck.

**1. 155MM PROJECTILES UNITIZED WITH METAL STRAPPING AND TIED DOWN WITH CARISTRAP.** The 155mm projectile pallets were unitized with three metal bands and tied down in an M35 series 2-1/2-ton truck with six Caristrap samples (see pages 7-18 through 7-20). The truck was operated over the road hazard course according to the procedures outlined

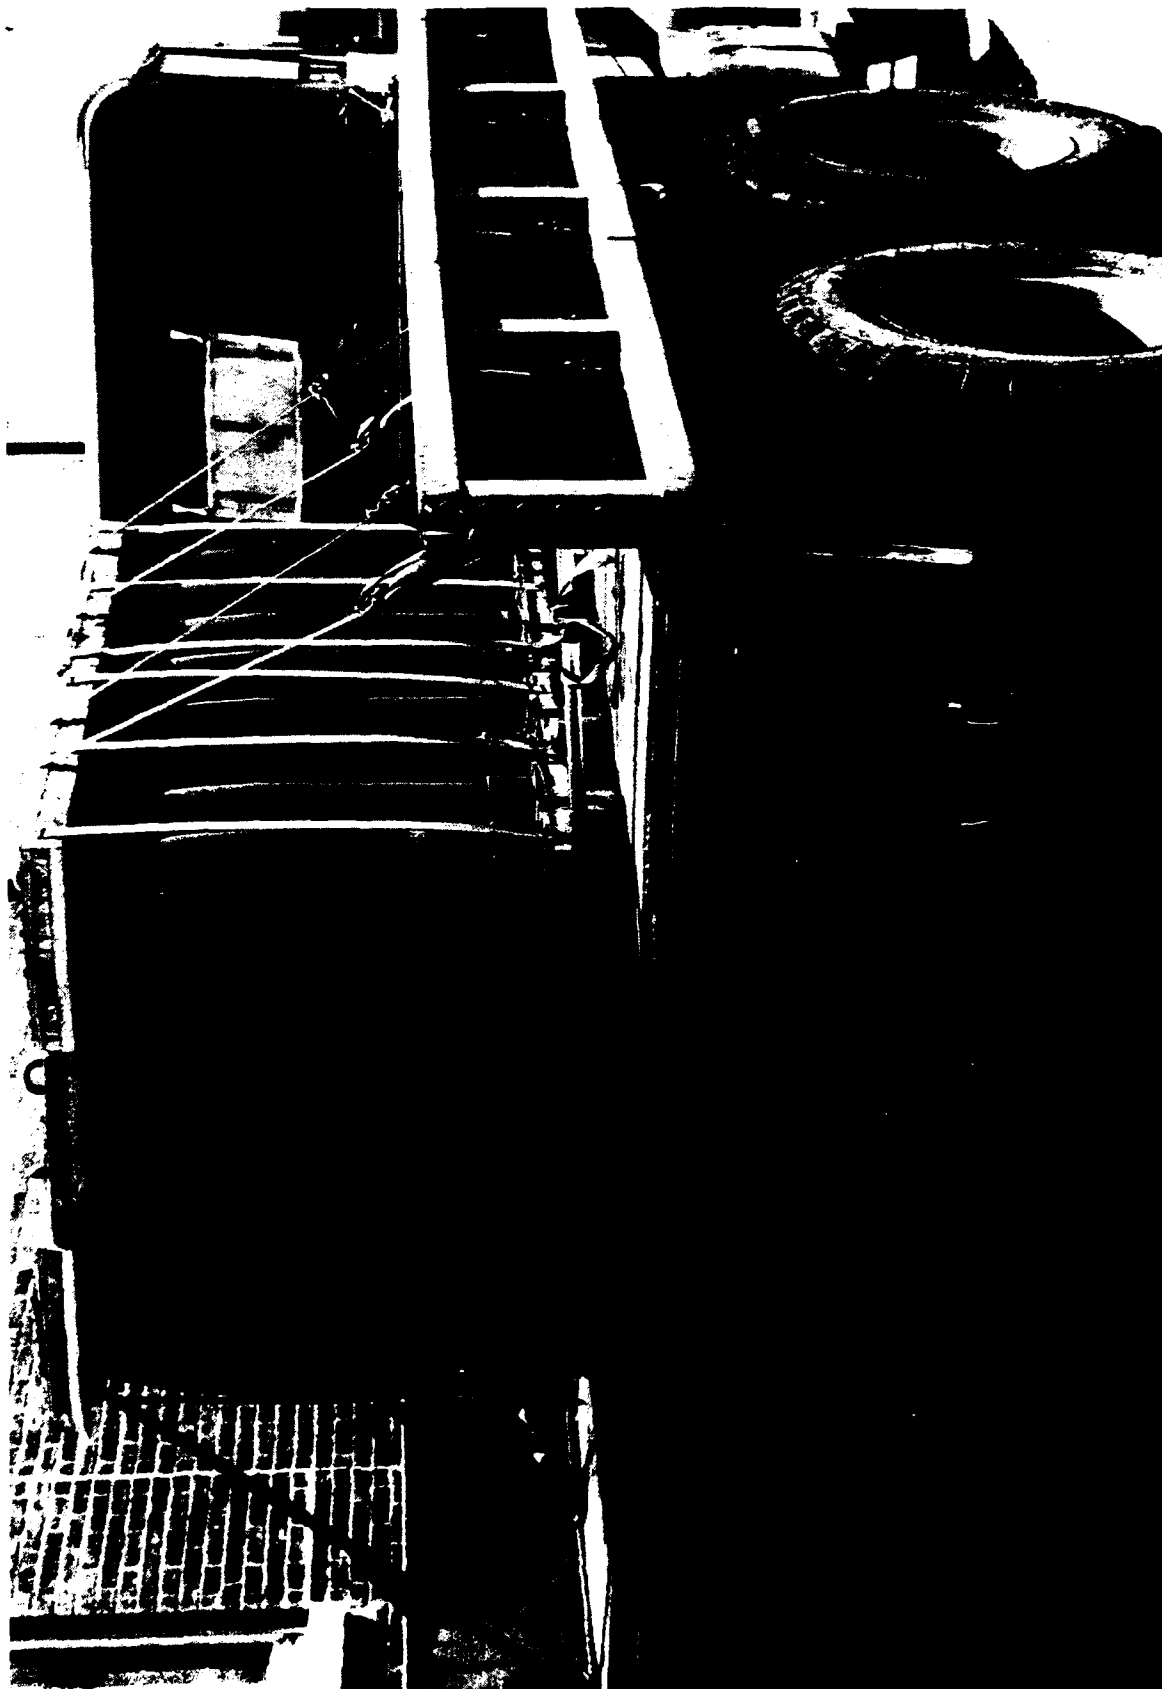
Photo No. AO317-SCN92-195-2965. This photo shows an additional view of the 2-1/2-ton truck loaded with 155mm projectile pallets that were tied down with Caristrap samples.

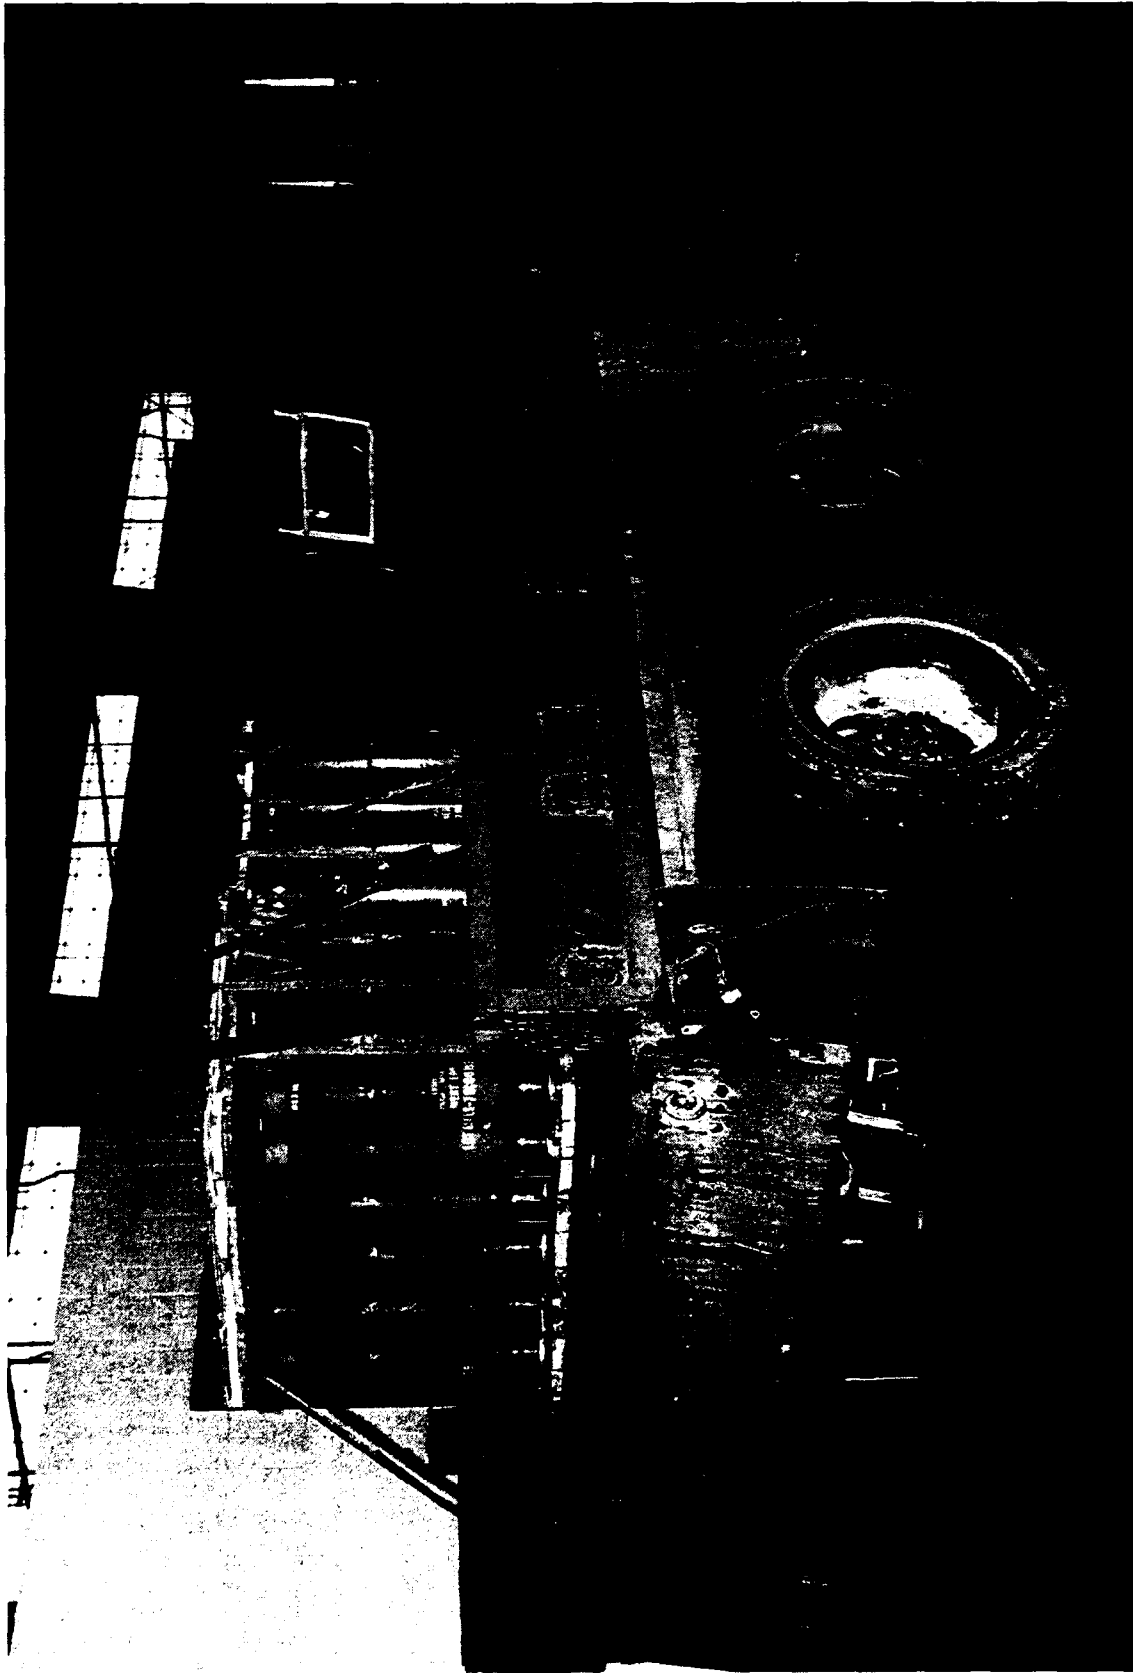
Photo No. AO317-SCN93-22-144. This photo shows the 155mm projectile pallets that were unitized with Caristrap samples and tied down with web straps in a 2-1/2-ton truck.

**2. 155MM PROJECTILES UNITIZED WITH CARISTRAP AND TIED DOWN WITH WEB STRAPS.** The 155mm projectiles were unitized with three Caristrap samples per pallet and tied down in an M35 series 2-1/2-ton truck with six web straps (see pages 7-21 through 7-23). The truck was operated over the road hazard course according to the procedures outlined in part 4. Upon completion of the tests, the Caristrap was inspected and no major abrasions were noted.
