Technical Report HL-93-9  
July 1993

*Flood Control Structures Research Program*

## **Flow Impingement, Snake River, Wyoming**

by *Stephen T. Maynard*  
*Hydraulics Laboratory*

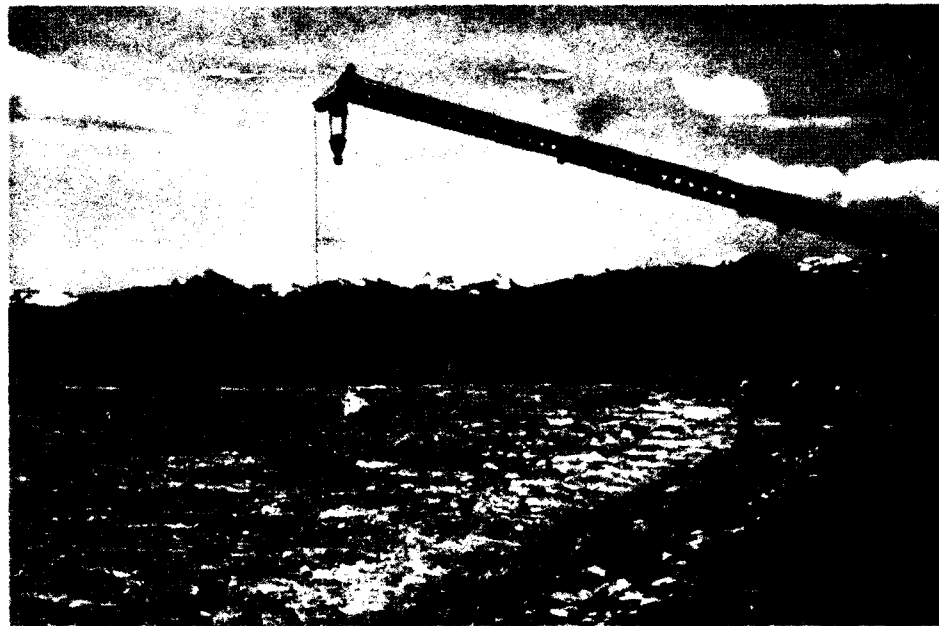
Figure 3. Crane at velocity site B-4, looking downstream

Price and electromagnetic velocity meters were mounted on lead fish and supported by an extendable boom crane that could reach up to 40 ft from the bank line, as shown in Figure 3. Even though the electromagnetic velocity meter could measure velocity in two directions, only the velocity parallel to the orientation of the lead fish was used in this investigation. Initially, a

100-lb lead fish was used, but this was swept too far downstream and a second lead fish weighing 140 lb was attached below the first one.

Future studies should use a single 200- to 250-lb lead fish for the high velocities encountered in this study. When near the bank line in shallow depths, the lead fish exhibited erratic side-to-side movement, which made velocity and depth measurements difficult. A graduated tape was attached both horizontally and vertically to the cable supporting the meter to determine the position of the meter. Bottom position was noted when the fish hit bottom and the cable deflected. Future studies should consider some type of electronic depth meter. The velocity meter had to be frequently raised to prevent damage to the velocity meter from debris. The cable supporting the velocity meter should not be strong enough to pull the crane over if large debris hangs up on the meter.

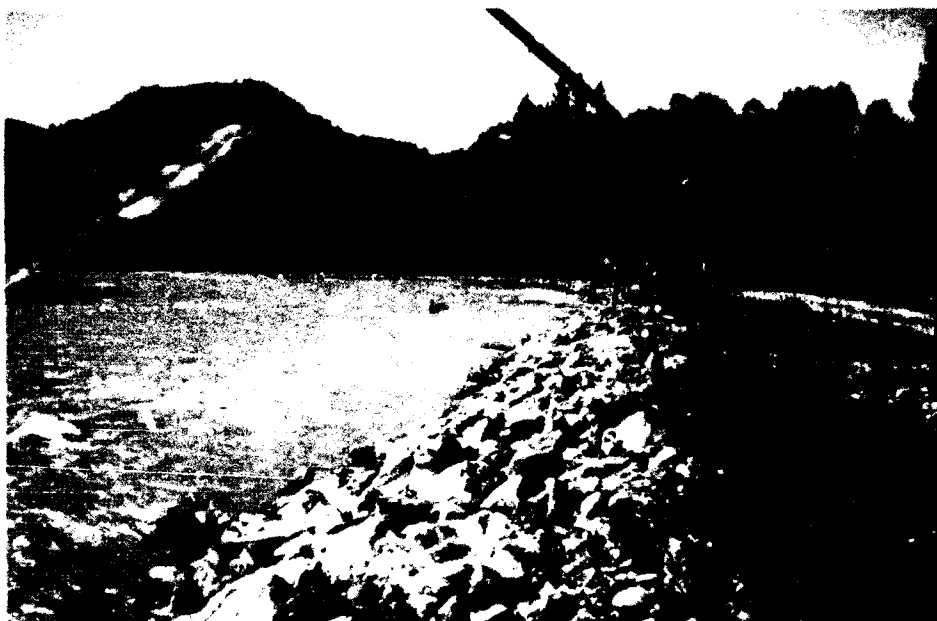
Figure 4. Site A-1, looking downstream

- c. *Site A-1 (7 and 10 June 1991).* Most of the flow in the river was against the levee at this site, but some flow was in channels in the middle of the levees. The impingement angle was about 45 deg and flow was also entering the impingement site from a second channel parallel to the levee on 7 June with a lesser amount on 10 June. Surface float velocities about 30 ft from the bank line averaged 11 ft/sec between sta 4+00 and 6+00. Velocities and water-surface elevations were similar on 7 and 10 June, but some scour occurred between 7 and 10 June at sta 4+00. Measurement of riprap size at site A-1 showed an average  $W_{50}$  of about 150 lb. Riprap size was not measured at other locations, but surveys by the U.S. Army Engineer District, Walla Walla, in 1987 show the average size to be less than 100 lb.

The two types of impingement sites that were observed on the Snake River were dependent on the alignment of the levee. Velocity sites A-1, A-2, B-4, D-1, D-2, and E-1 were impingement sites where the levee was straight. Velocity sites B-1 and E-2 were sites in a curved part of the levee having a outer bank line radius of 300-500 ft. In most cases the typical site had a wide, shallow approach channel that gradually converged toward the impingement site. The angle of the approach flow ranged up to 70 deg. Plates 3-10 show schematics of the impingement sites. Figures 4-8 show impingement sites.

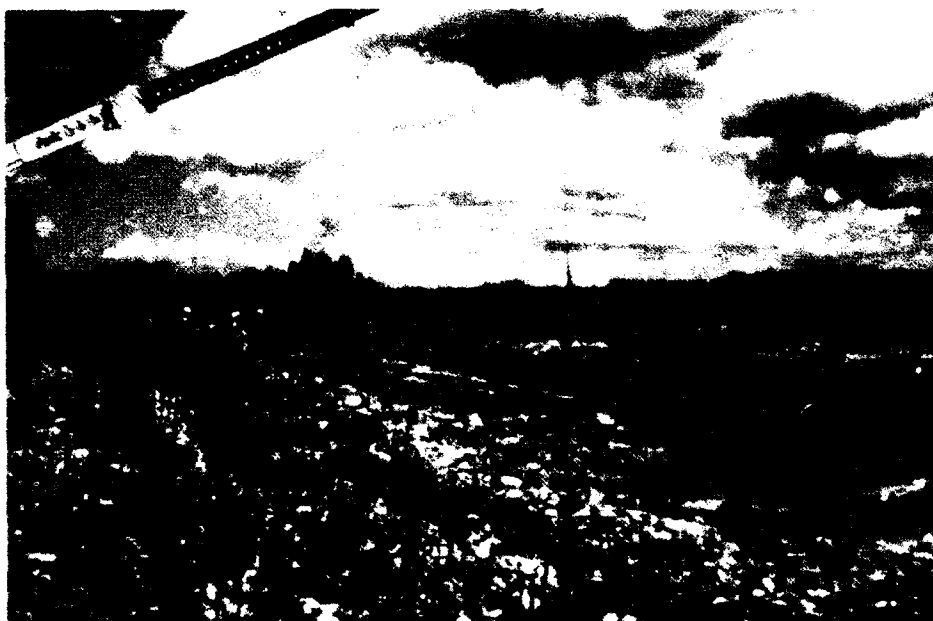
Figure 5. Site A-2, looking upstream

- d. *Site A-2 (7 and 10 June 1991).* At this site, a significant amount of the riverflow was in other channels away from the levee. The impingement angle at this site was about 60 deg. Surface float velocities on 7 June were about 13 ft/sec between sta 4+00 and 6+00. Significant differences in the flow impingement were evident from 7 June compared to 10 June indicating the dynamic nature of braided streams. Velocities measured on 10 June were 60-70 percent of those measured on 7 June, and the water-surface elevations had increased by up to 1.5 ft. The maximum impingement point had moved downstream about 200 ft. The cause of these changes was not apparent from the on-ground inspection.

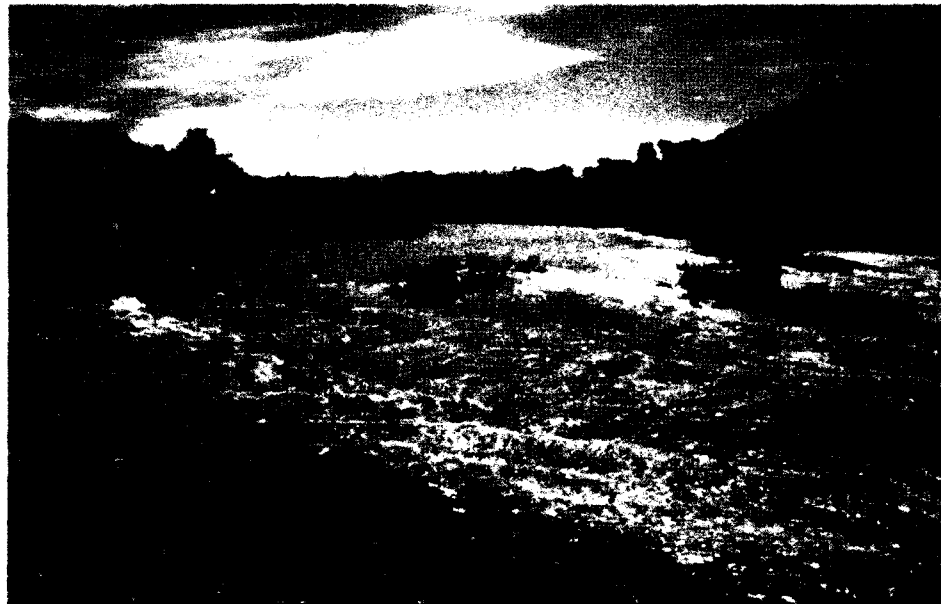
Figure 6. Site B-1, looking upstream

- e. *Site B-1 (8 and 11 June 1991).* A significant portion of the total riverflow was in channels away from the levee at this site. The large impingement angle of about 70 deg resulted from the curved levee alignment. Surface float velocities were as follows:

Side slope velocities on 8 June were relatively large. Velocities at sta 4+50 were much smaller on 11 June than on 8 June indicating some type of change upstream.

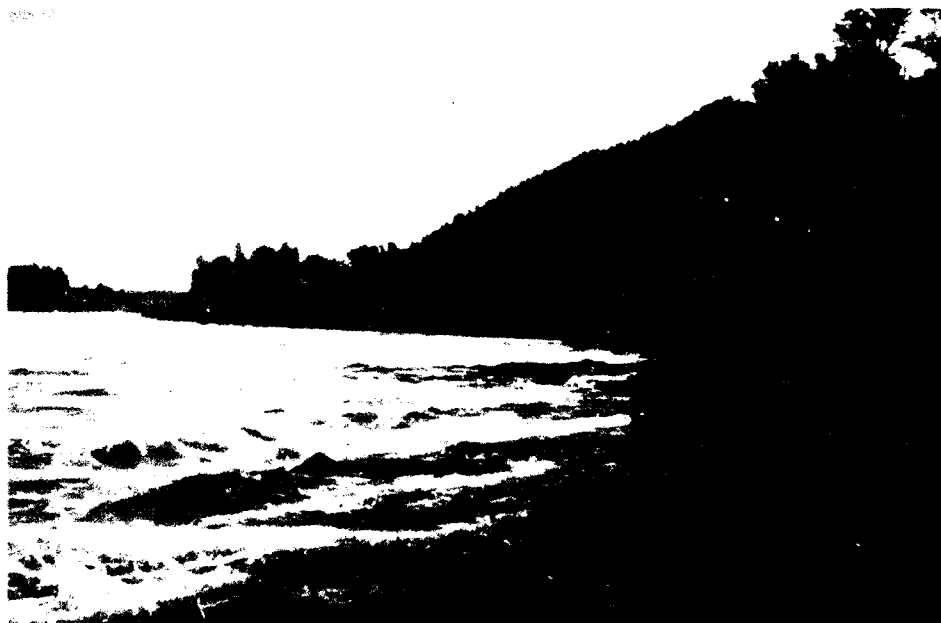
Figure 7. Site E-2, looking upstream

- g. *Site E-2 (12 June 1991).* Most of the riverflow was against the levee at this site, and the curved levee alignment caused an impingement angle of about 60 deg. Surface float measurements were as follows:

Sta 5+70 exhibited relatively large depths at the toe (15 ft) and high velocities up on the side slope (>12 ft/sec).

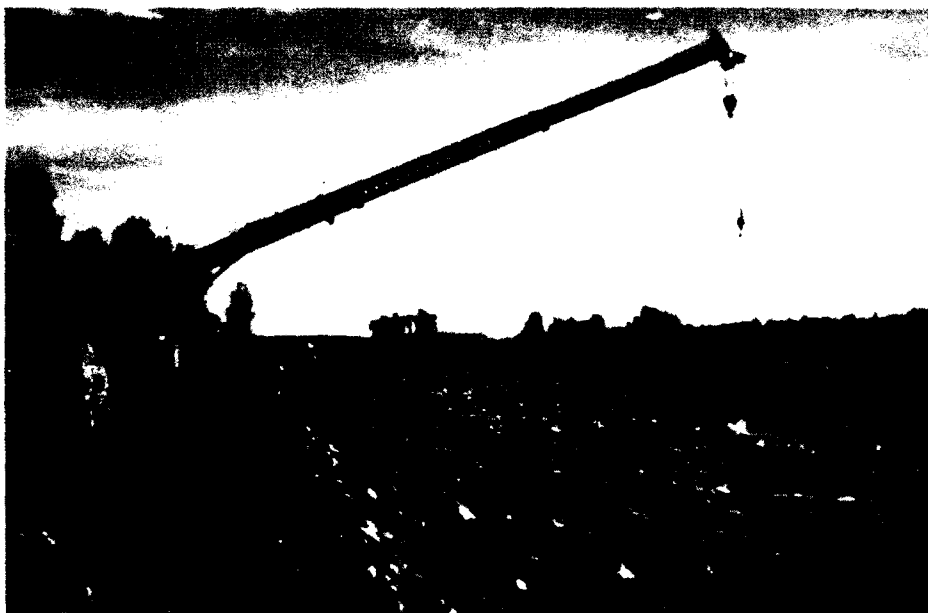
Figure 8. Site B-4, looking upstream

- f. *Site B-4 (8 and 11 June 1991).* Most of the riverflow was against the levee at this site. The flow impingement angle was about 50 deg on a relatively straight levee alignment. Surface float velocities were as follows:

The bottom elevation on 8 June was not determined, and the bottom shown (Plates 27 and 28) is from the 11 June measurements. Water-surface measurements were similar on 8 and 11 June.
