US Army Corps
of Engineers
Construction Engineering
Research Laboratories

USACERL Technical Report FM-93/10
May 1993

Evaluation of Techniques To Eliminate Erosion From Under River Revetment Mattresses

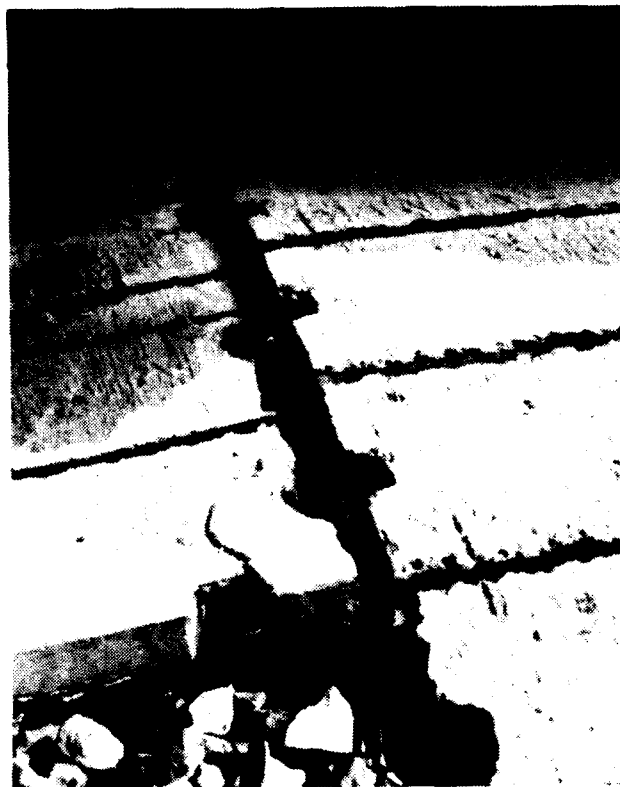
Figure 2. Closeup of a mattress in place.

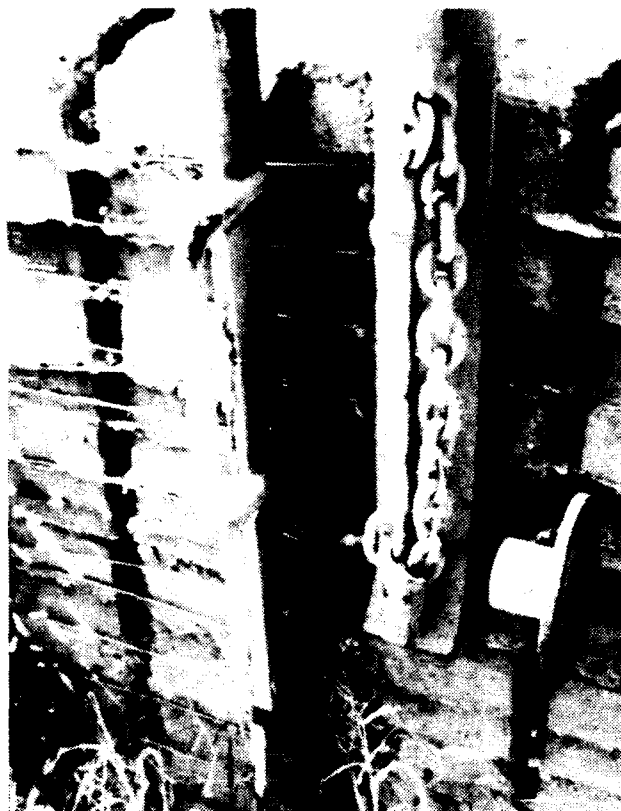
Figure 6. Bracket wires deformed by lift fixture.

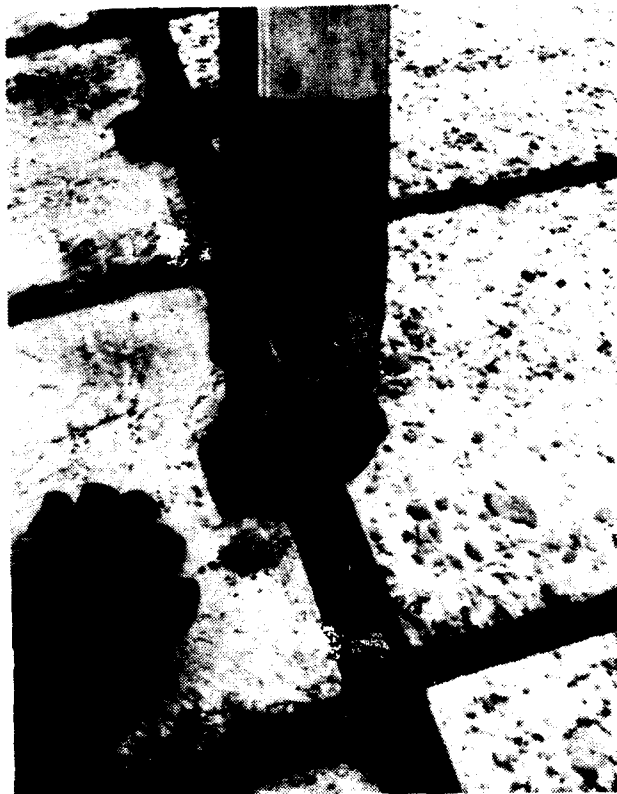
Figure 7. Tying tool used to fasten squares together.

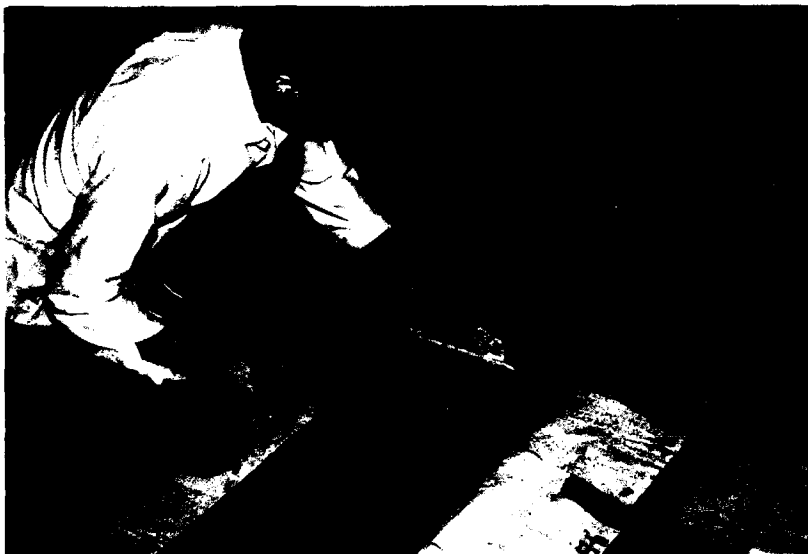
Figure 25. Final smoothing of specimens with trowel.

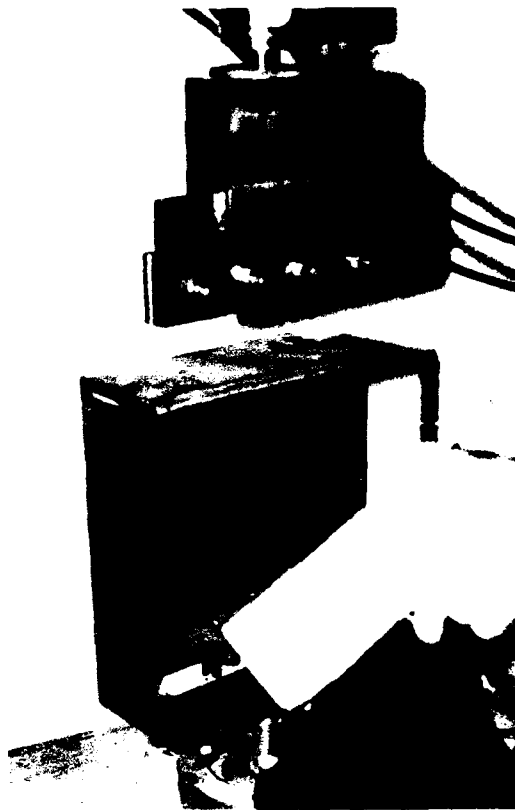
Figure 27. Photograph of saddle used for peel test.

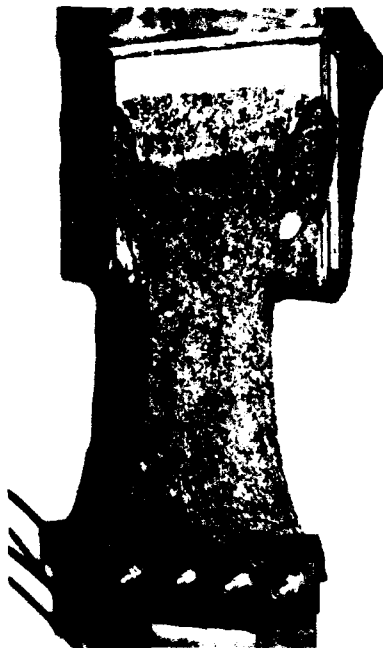
Figure 29. Specimen oriented vertically in saddle.

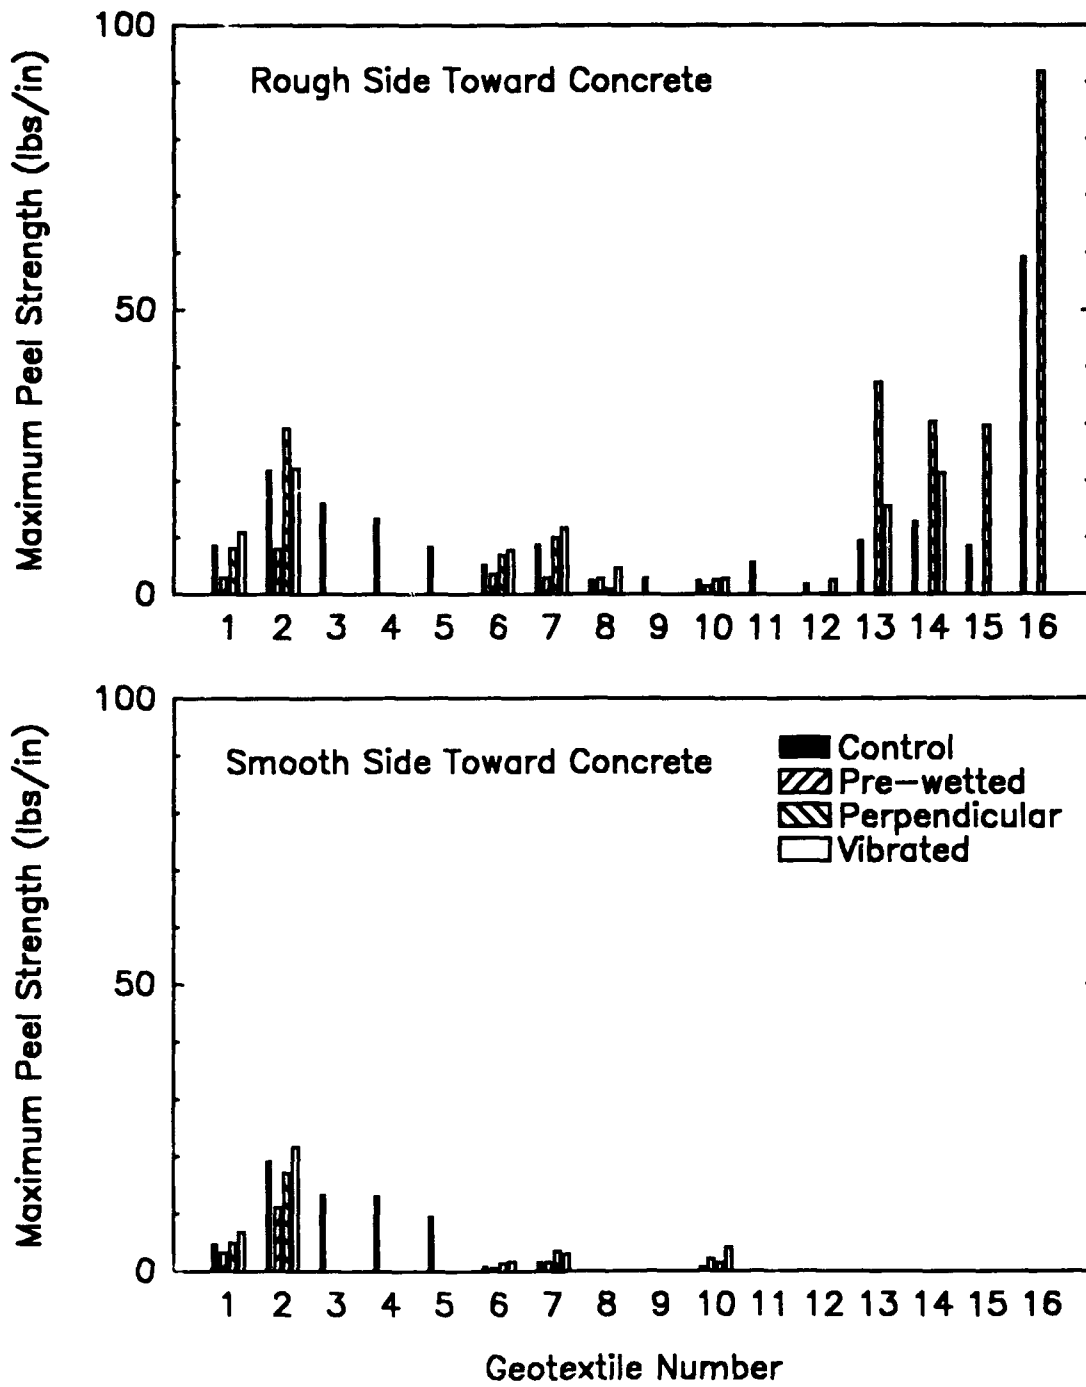
Figure 34. Peel strengths measured for different construction variables.

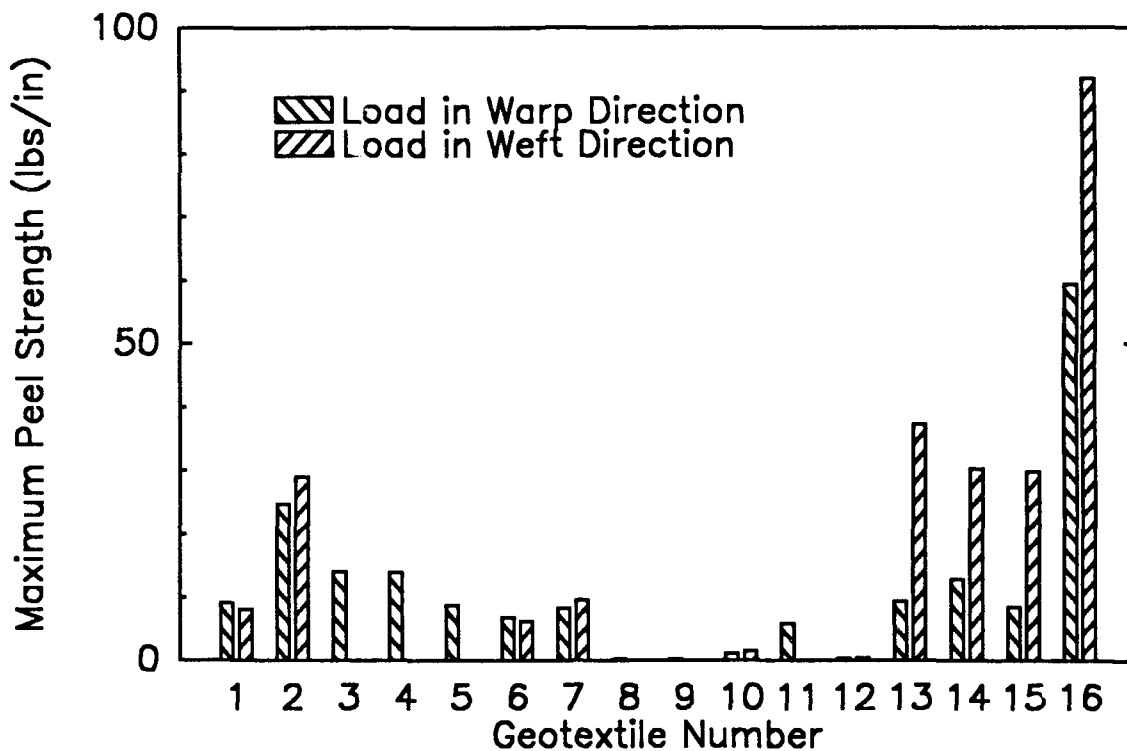
Figure 35. Effect of the direction of load on peel strength.

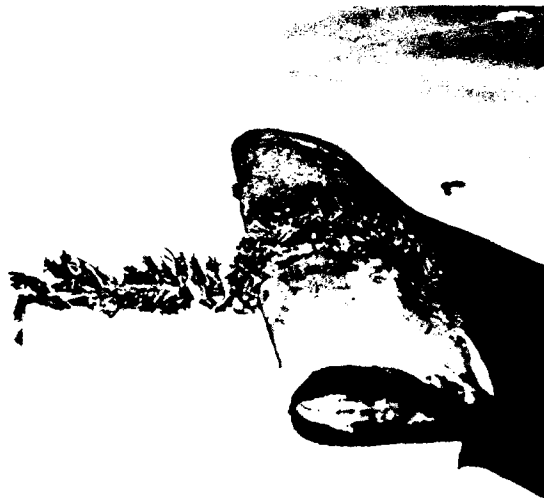
Figure 36. Photograph of failed peel strength specimen for geotextile #13.

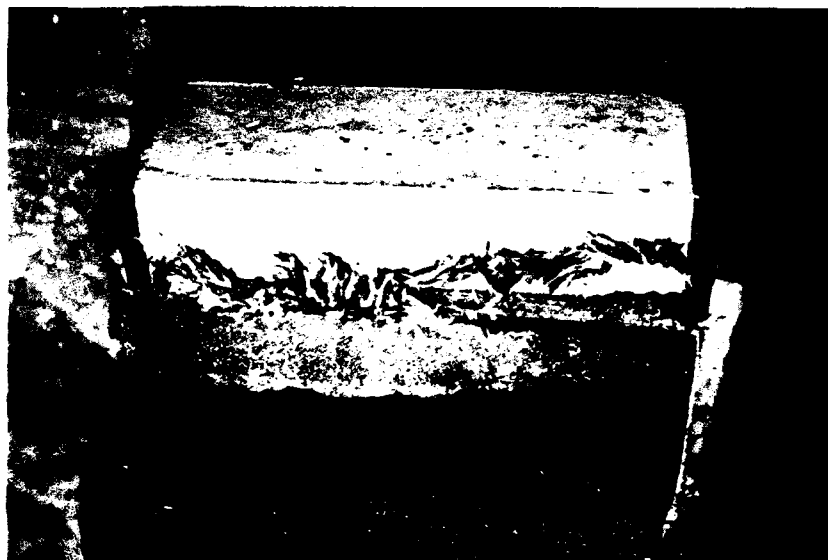
Figure 38. Failure of peel test specimen by fabric tearing at tufts embedded in concrete.

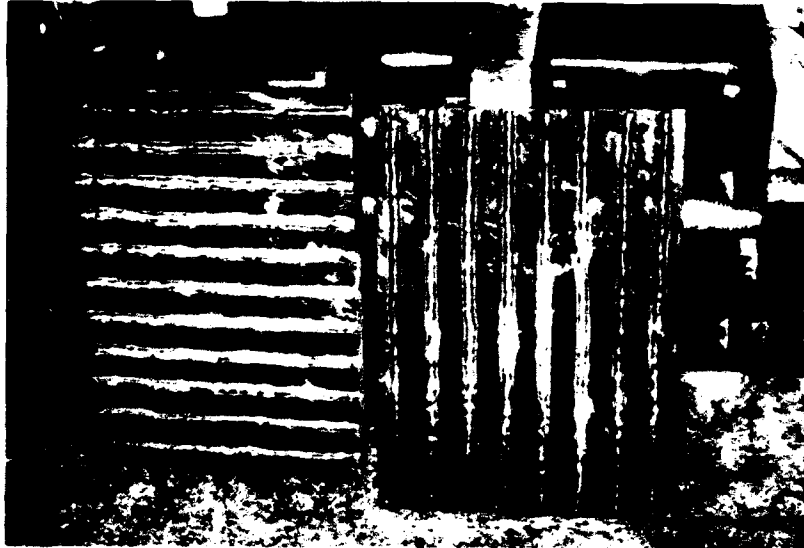
Figure 45. Photograph of welded steel plates used in abrasion test.
