# Fracture Toughness and Stress Corrosion Resistance of U-0.75 wt% Ti

ARL-TR-220

October 1993

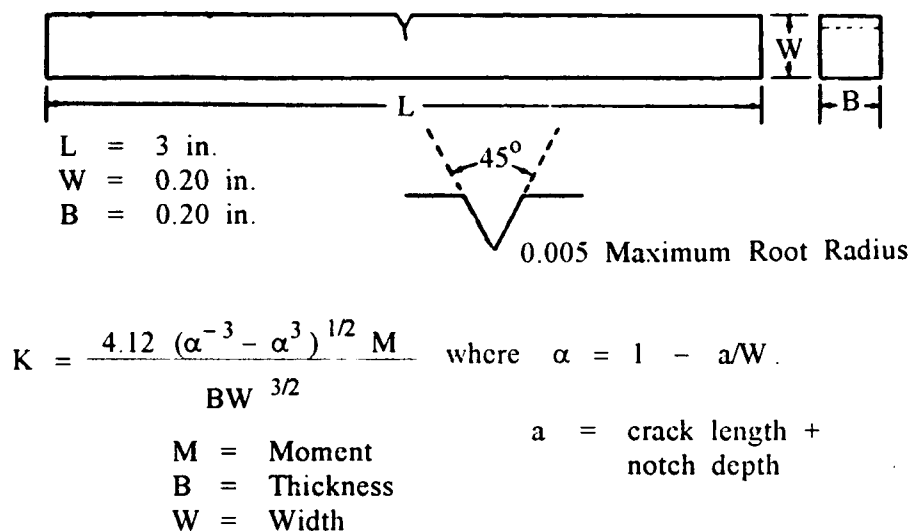
Figure 1. Specimen geometry and equation for K values

The stress corrosion specimens (see Figure 1) which were single edge notch specimens (3.0 x 0.20 x 0.20 in.) were cut with the long dimension parallel to the direction of maximum grain flow and notched so that crack growth and fracture would occur in the radial direction.

The procedure for  $K_{IC}$  measurement involved three-point bend testing of notched specimens that had been precracked in fatigue. Load versus displacement across the notch was recorded autographically. The  $K_{IC}$  value was calculated from the load corresponding to a 2% increment of crack extension by equations which have been established on the basis of elastic stress analysis of bend specimens. The detailed procedure is described in ASTM E 399-74. The method for  $K_Q$  measurement employed a Charpy specimen provided with a sharp notch terminating in a fatigue crack tested in three-point bending. The maximum load in the test was recorded and the nominal crack strength was determined from this value as well as the original dimensions of the specimen

The method for stress corrosion measurements follows. The test uses a precracked bar stressed as a cantilever beam. A sharp notch is machined across the rectangular bar specimens at mid-length, and is sharpened by fatiguing. The specimen is held in a rack horizontally with the precracked central portion surrounded by a plastic bottle which contains the environment. One end of the specimen is clamped to the mast of the rack and the other end to an arm from which weights are suspended. On evaluating the alloy, the specimen is first stressed in air at increasing loads until it fractures. The data are reduced to stress intensity using the Kies equation (see Figure 1). Having established stress intensity for dry conditions ( $K_{IC}$ ), a specimen is similarly tested in distilled  $H_2O$  and NaCl solutions at a somewhat lower stress intensity. If the specimen did not fail within an hour, the stress intensity was increased by approximately 3% each succeeding hour until failure occurred and the time required for rupture noted. Additional specimens were stressed at decreasingly lower stress intensities for 1000 hours or until failure occurred to give a more valid value for  $K_{Isc}$ , which was determined from a plot of stress intensity versus time to failure.  $K_{Isc}$  is the threshold stress intensity value for the onset of cracking.

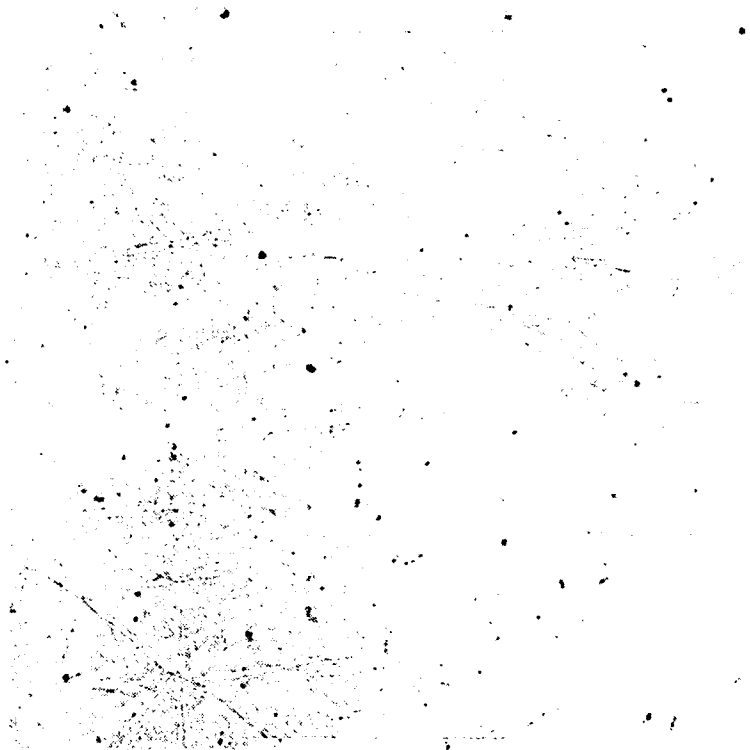
Figure 3. U-0.75 wt% Ti (RF) lower nose section - solution treated at 800°C for two hours, 850°C for one-half hour, vertically water quenched 18 inches per minute, aged (lead bath) for 16 hours at 350°C Mag 100X

The microstructure of an XM833 penetrator is shown at both the nose section from the bar entering the water first on vertical quenching (see Figure 3) and at the tail, or rear, portion of the bar which entered the water last (see Figure 4). The microstructure in Figure 3 is essentially martensitic with evidence of incipient slack quench at the grain boundaries and small voids, particularly in the central area are observed. The tail, or rear, views show a more pronounced slack quench and even larger voids, particularly in the central areas (see Figure 4).

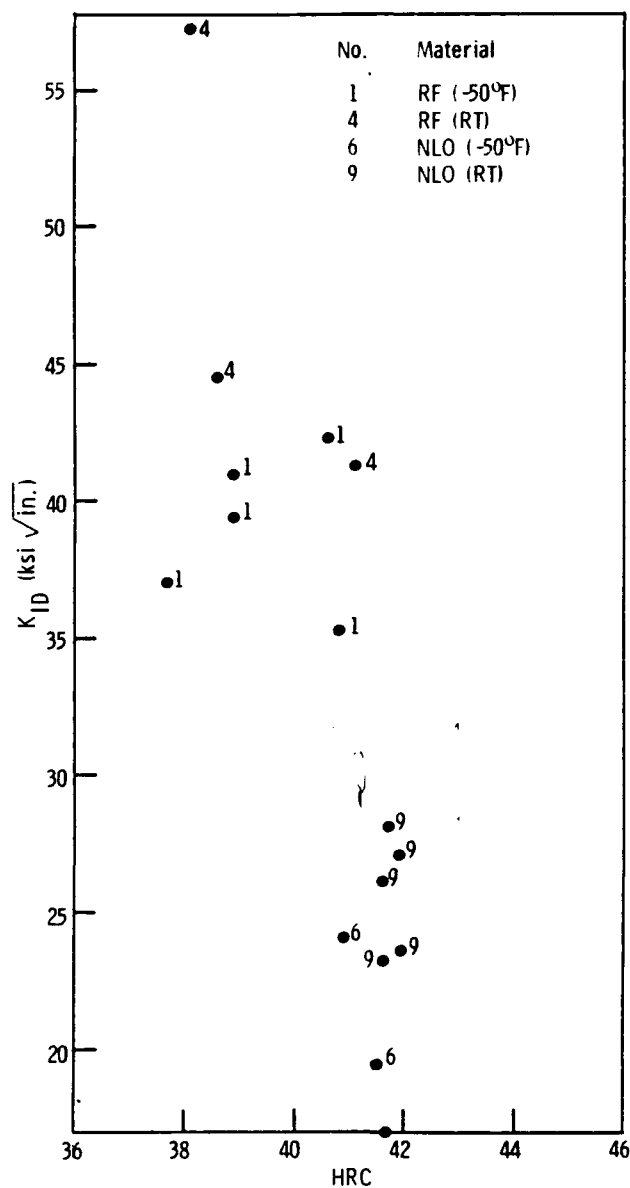
Figure 7. Dynamic fracture toughness of aged U-0.75 wt% Ti RF and NLO penetrators versus HRC

Figure 7 shows a plot of dynamic fracture toughness  $K_{ID}$  versus HRC hardness values for individual specimens of the NLO failed XM774 penetrator lots and the Rocky Flats XM833 penetrator lots. The slightly softer XM833 penetrator lots had significantly higher dynamic fracture toughness values than those of the NLO XM774 penetrator lots. All dynamic fracture toughness values of specimens from RF XM833 penetrator lots were greater than  $35 \text{ ksi}\sqrt{\text{in.}}$ . The NLO XM774 penetrator lots were below  $30 \text{ ksi}\sqrt{\text{in.}}$ . The  $K_{ID}$  data were in good agreement with the  $K_{IC}$  and  $K_Q$  values.

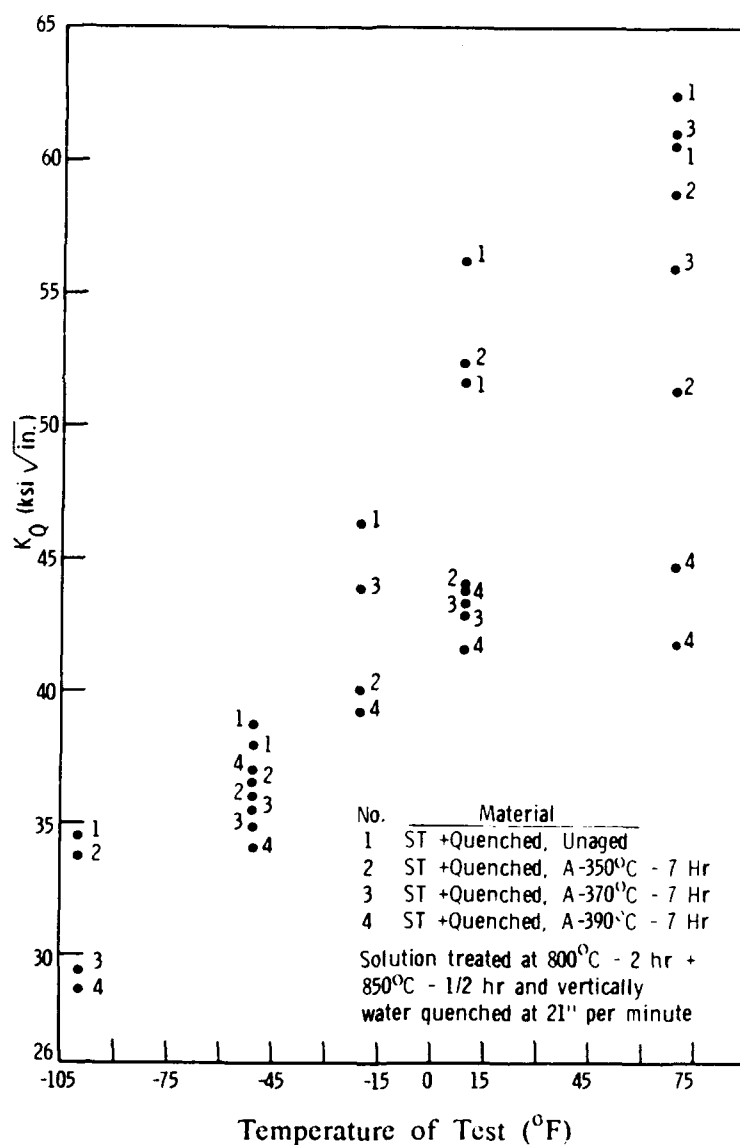
Figure 8. Fracture toughness of aged U-0.75 wt% Ti NLO bars versus temperature of test.

Fracture toughness ( $K_{Ic}$ ) of the above mentioned materials were determined utilizing precracked Charpy specimens at test temperatures ranging from -100°F to 70°F. The data are recorded in Table 4 and plotted in Figure 8. It should be noted that a limited number of specimens were available for test. Generally, fracture toughness increased with test temperature. The unaged alloy (solution treated and quenched) gave the highest fracture toughness values. As the aging temperature increased, fracture toughness decreased. The bars aged at 390°C gave the lowest fracture toughness values. Fracture toughness ( $K_{Ic}$ ) values were greater than 35 ksi√in. for all aged bars at the -50°F and higher test temperatures. These data show that the fracture toughness of the NLO material can be substantially improved by changing the heat treatment procedure from solutionizing in NUSAL and fully plunge quenching in oil to solutionizing in vacuum and vertically quenching in water

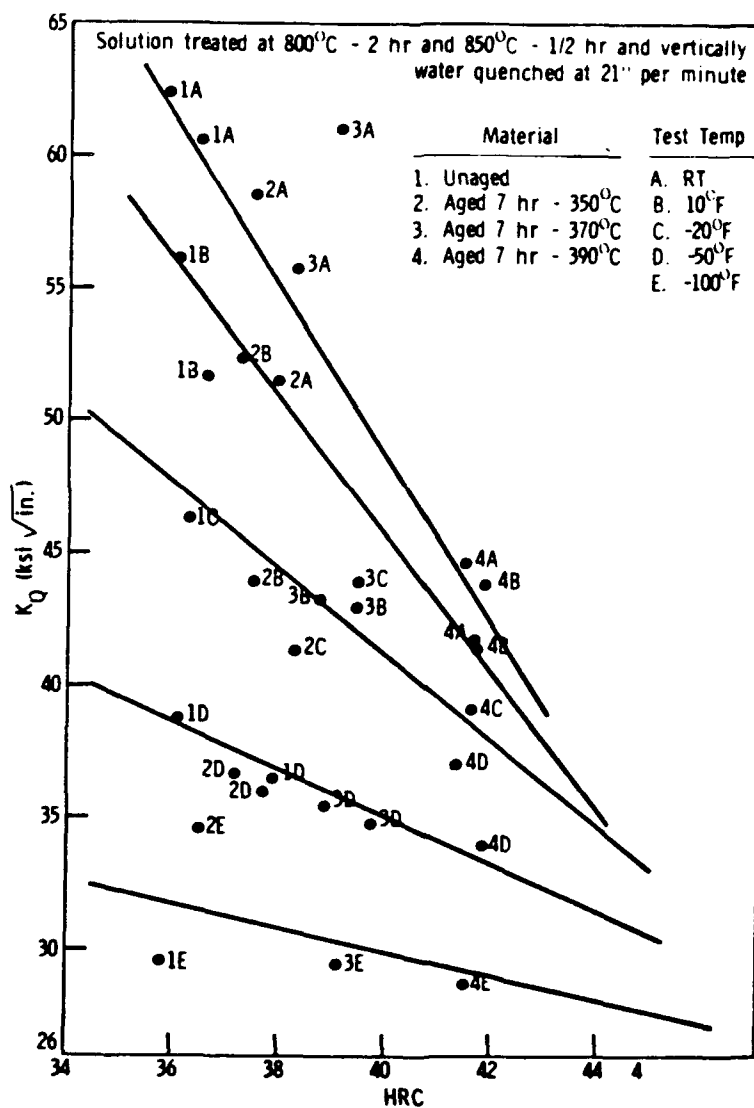
Figure 9. Fracture toughness of aged U-075 wt% Ti N<sub>2</sub>O bars (Charpy -  $K_Q$ ) versus HRC.

Figure 9 plots fracture toughness ( $K_Q$  ksi $\sqrt{\text{in.}}$ ) versus HRC hardness for the unaged and aged bars. Room temperature fracture toughness values decreased significantly with increase in HRC hardness and aging temperature. At the  $-50^\circ\text{F}$  and  $-100^\circ\text{F}$  test temperatures the rate of decrease of fracture toughness values with increase in HRC hardness and aging temperature decreased markedly.

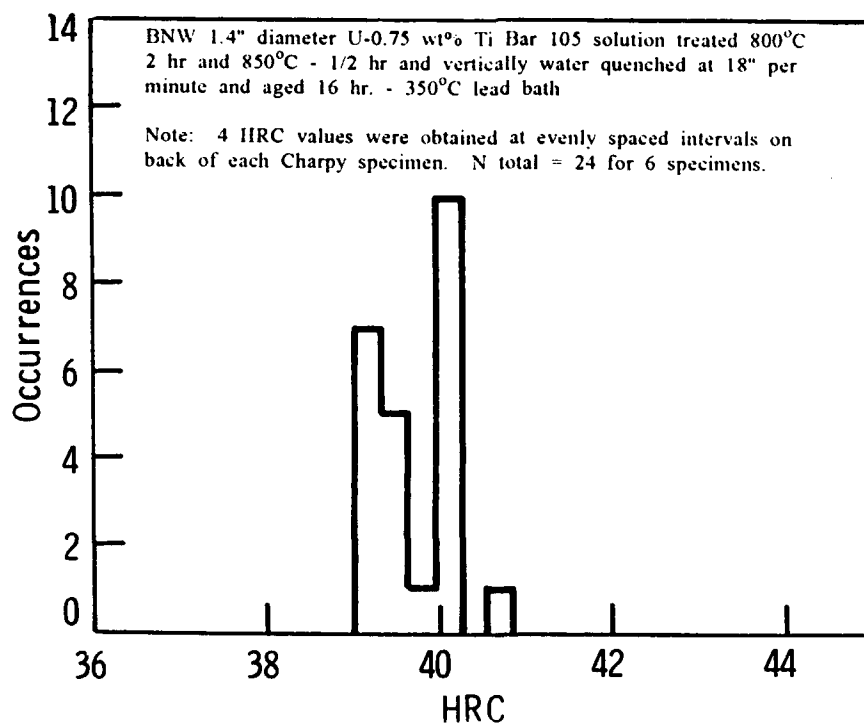
Figure 10. Frequency of Rockwell C readings versus HRC.

The bars were heat treated to a narrow hardness range (39 HRC to 40 HRC) as illustrated in the histogram for a typical bar (see Figure 10).

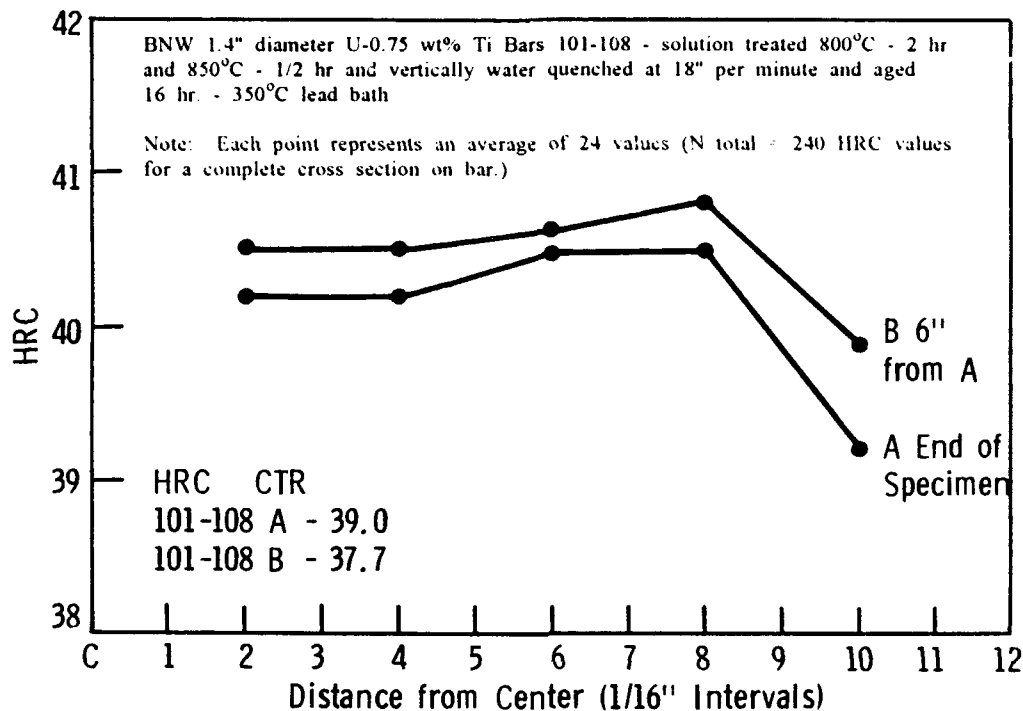
Figure 11. Transverse Rockwell C Hardness versus distance from center.

Figure 11 summarizes HRC traverse data taken across the diameter of transverse sections for six bars at 45° angles at the vertically water quenched end, marked A (first hits H<sub>2</sub>O), and 6 in. from the end, marked B. The bars at position B were slightly harder than at position A. The central areas of the bars were quite uniform in hardness and slightly softer.

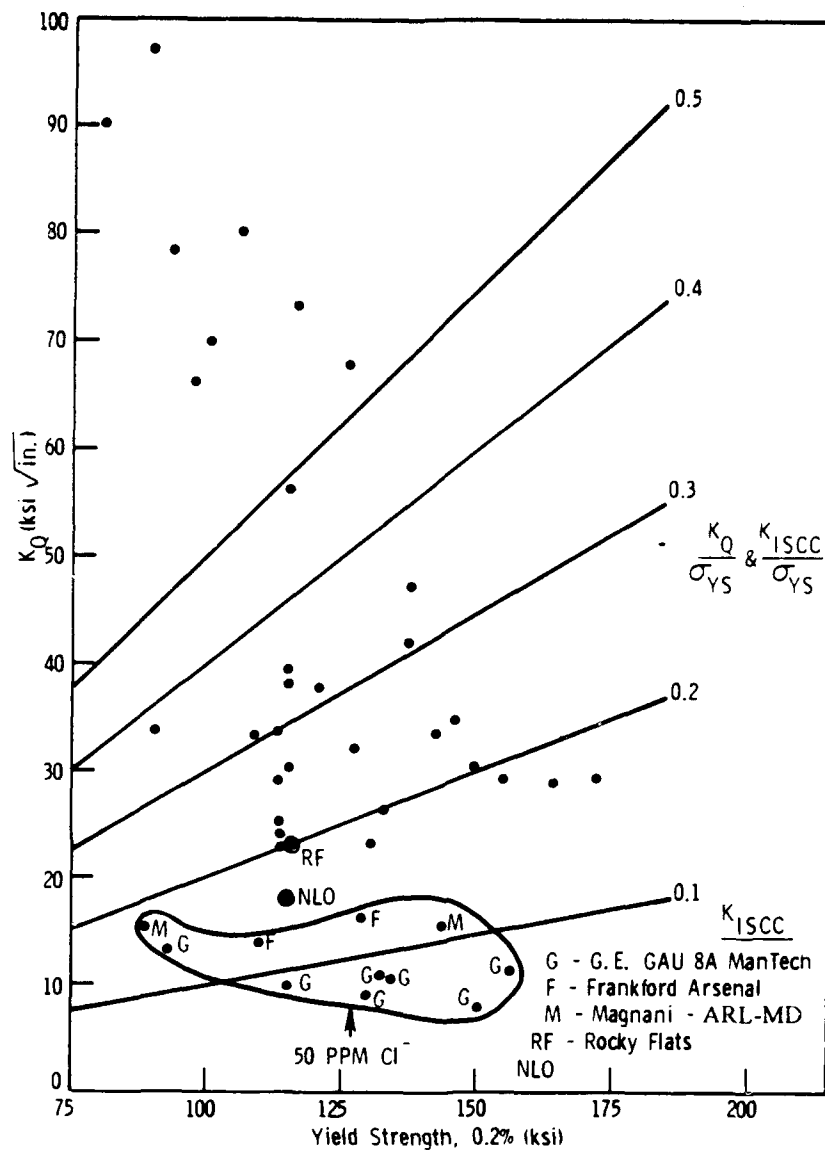
Figure 14. SCC and  $K_Q$  RAD for U-0.75 wt% Ti alloys

The RAD shown in Figure 13 superimposes  $K_{Isc}$  data on the fracture toughness data displayed in Figure 14. The envelope shown contains earlier  $K_{Isc}$  data obtained in 50 ppm Cl- solution and represents different sources of material, laboratories, and processing procedures. The data reported in Table 8 are shown above the envelope and the highest  $K_{Isc}$  of  $23 \text{ ksi}\sqrt{\text{in}}$  which is in good agreement with other published data (9,11) represents a critical flaw size of 8 mils for crack propagation in the chloride solution. The other data represent tolerance to even smaller critical flaw sizes.
