WL-TR-93-4054

**X-RAY COMPUTED TOMOGRAPHY  
FOR EMERGING AEROSPACE MATERIALS  
AND PROCESSES DEVELOPMENT**

Boeing Defense & Space Group  
P.O. Box 3999  
Seattle, WA 98124-2499

Interim Report for Period September 1991 to May 1993

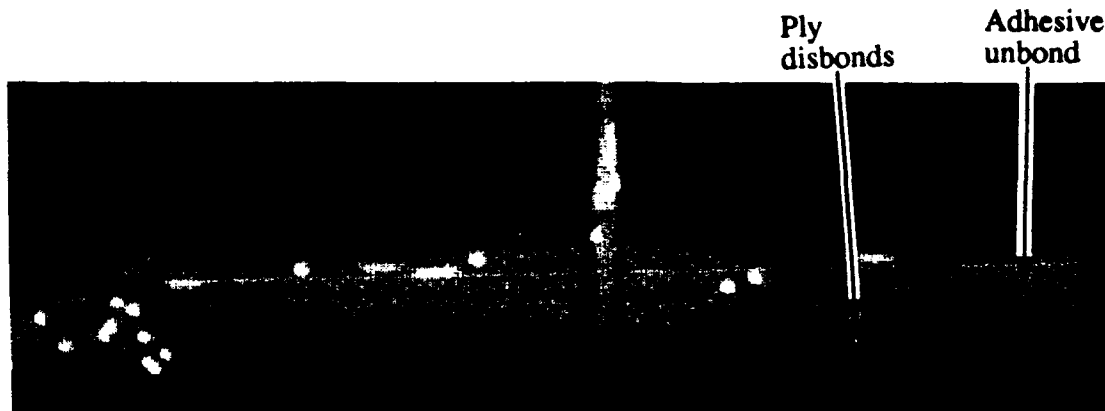
Figure 3.1.2-3 Example CT image from trial 2 showing unbonds and ply disbonds.

For the second trial the adhesive layer was doubled. Small grooves were cut into the second spar at the adhesive interface which decreased, but did not eliminate the bridging of the spar over the thermocouple wire. The bridging and lack of bonding were more isolated. A "glitch" in the temperature controller caused overheating of the bondline. An obvious "browning" of the adhesive was observed by visual inspection of the edge of the bond. CT analysis of this second spar/skin configuration revealed disbonding of the skin at various plies due to thermal breakdown of the composite. It also showed various areas where good bonding was not achieved. Figure 3.1.2-3 is an example of a CT image which indicated these features.

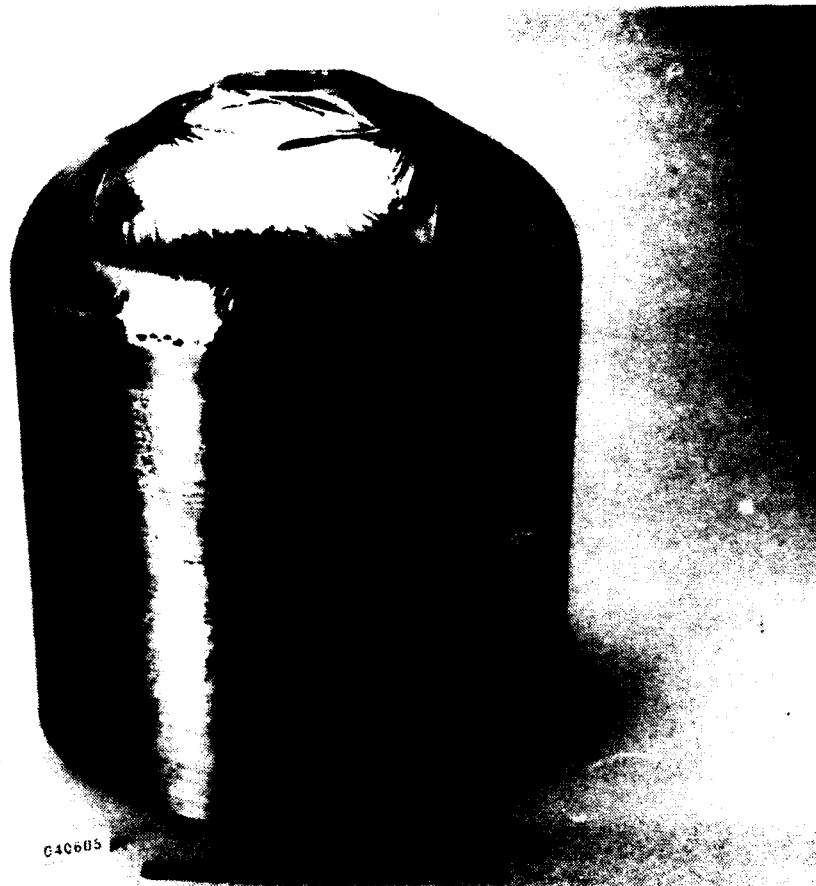
**Figure 3.4.2-1 Composite filament wound bottle with a foam core.**
