TECHNICAL REPORT ARCCB-TR-93036

**FATIGUE LIFE ASSESSMENT OF  
155-MM M284 CANNON TUBES**

MICHAEL J. AUDINO

OCTOBER 1993

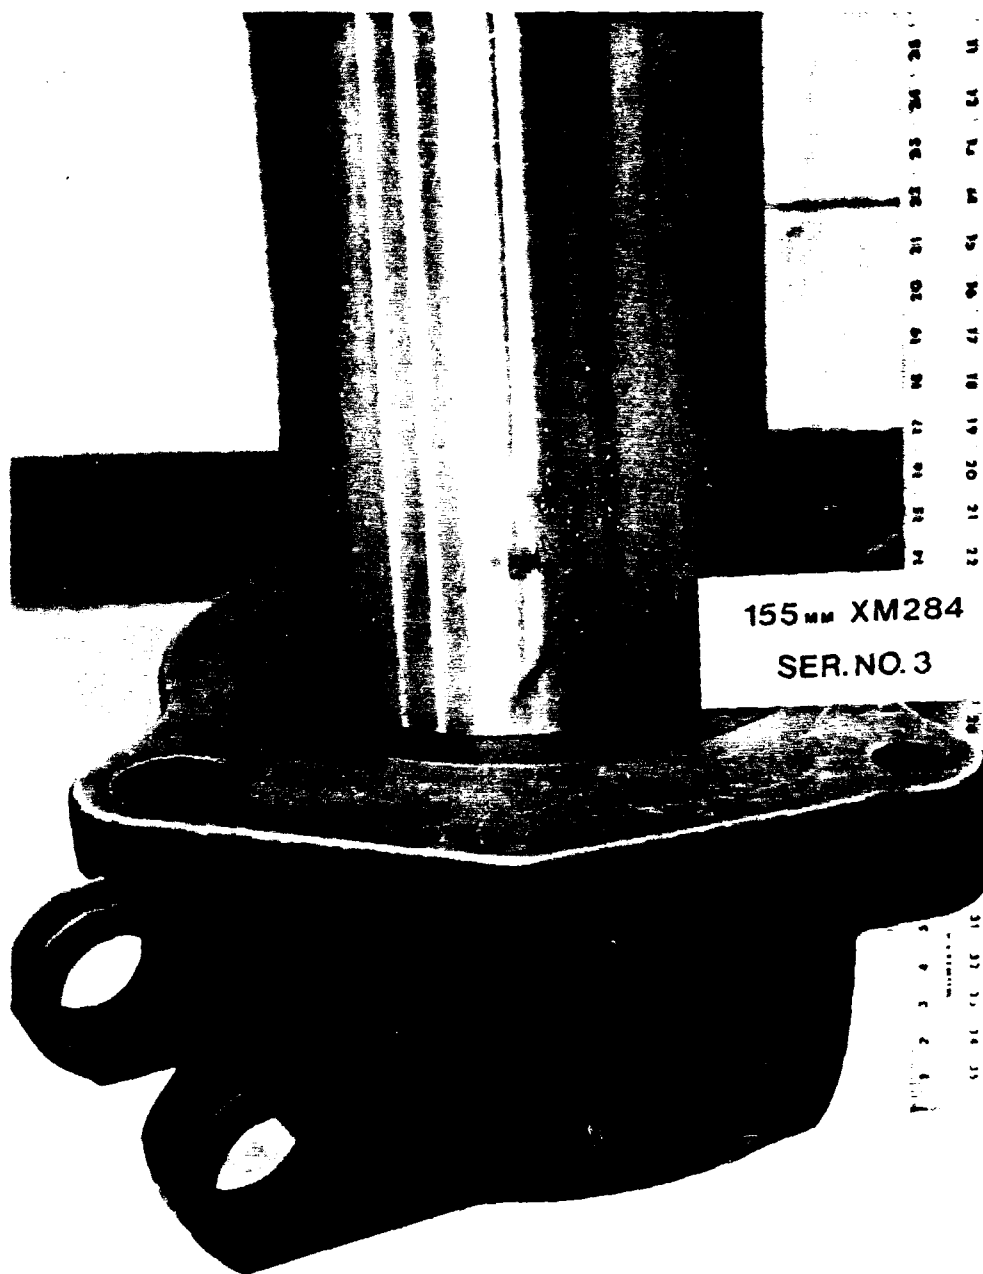
Figure 12. 155-mm XM284 Tube SN3 failure location.

As Table 2 demonstrates, four of the test samples failed in the torque keyway, while the remaining three samples failed in the charge notch region. Tube SNs 1, 5, 9, and 11 failed in the torque keyway. All of these tubes experienced uncontrolled, running cracks at the time of failure, as has been observed with 155-mm M185 tubes. Of the charge notch failures, Tube SNs 2 and 3 failed in a ductile mode with steady crack growth, while Tube SN825 experienced an unexpected running crack emanating from the charge notch and continuing to the breech face of the tube. There was no material fragmentation associated with any of the seven failures. Figure 22 illustrates the fatigue crack growth rate for the three tubes that failed from cracks emanating from the bore. All three curves show a similar critical crack depth, though Tube SN825 reached that crack depth much sooner than did Tube SNs 2 and 3.
