Community Environmental Response
Facilitation Act (CERFA) Report

Woodbridge Research Facility
Woodbridge, Virginia

APRIL 1994

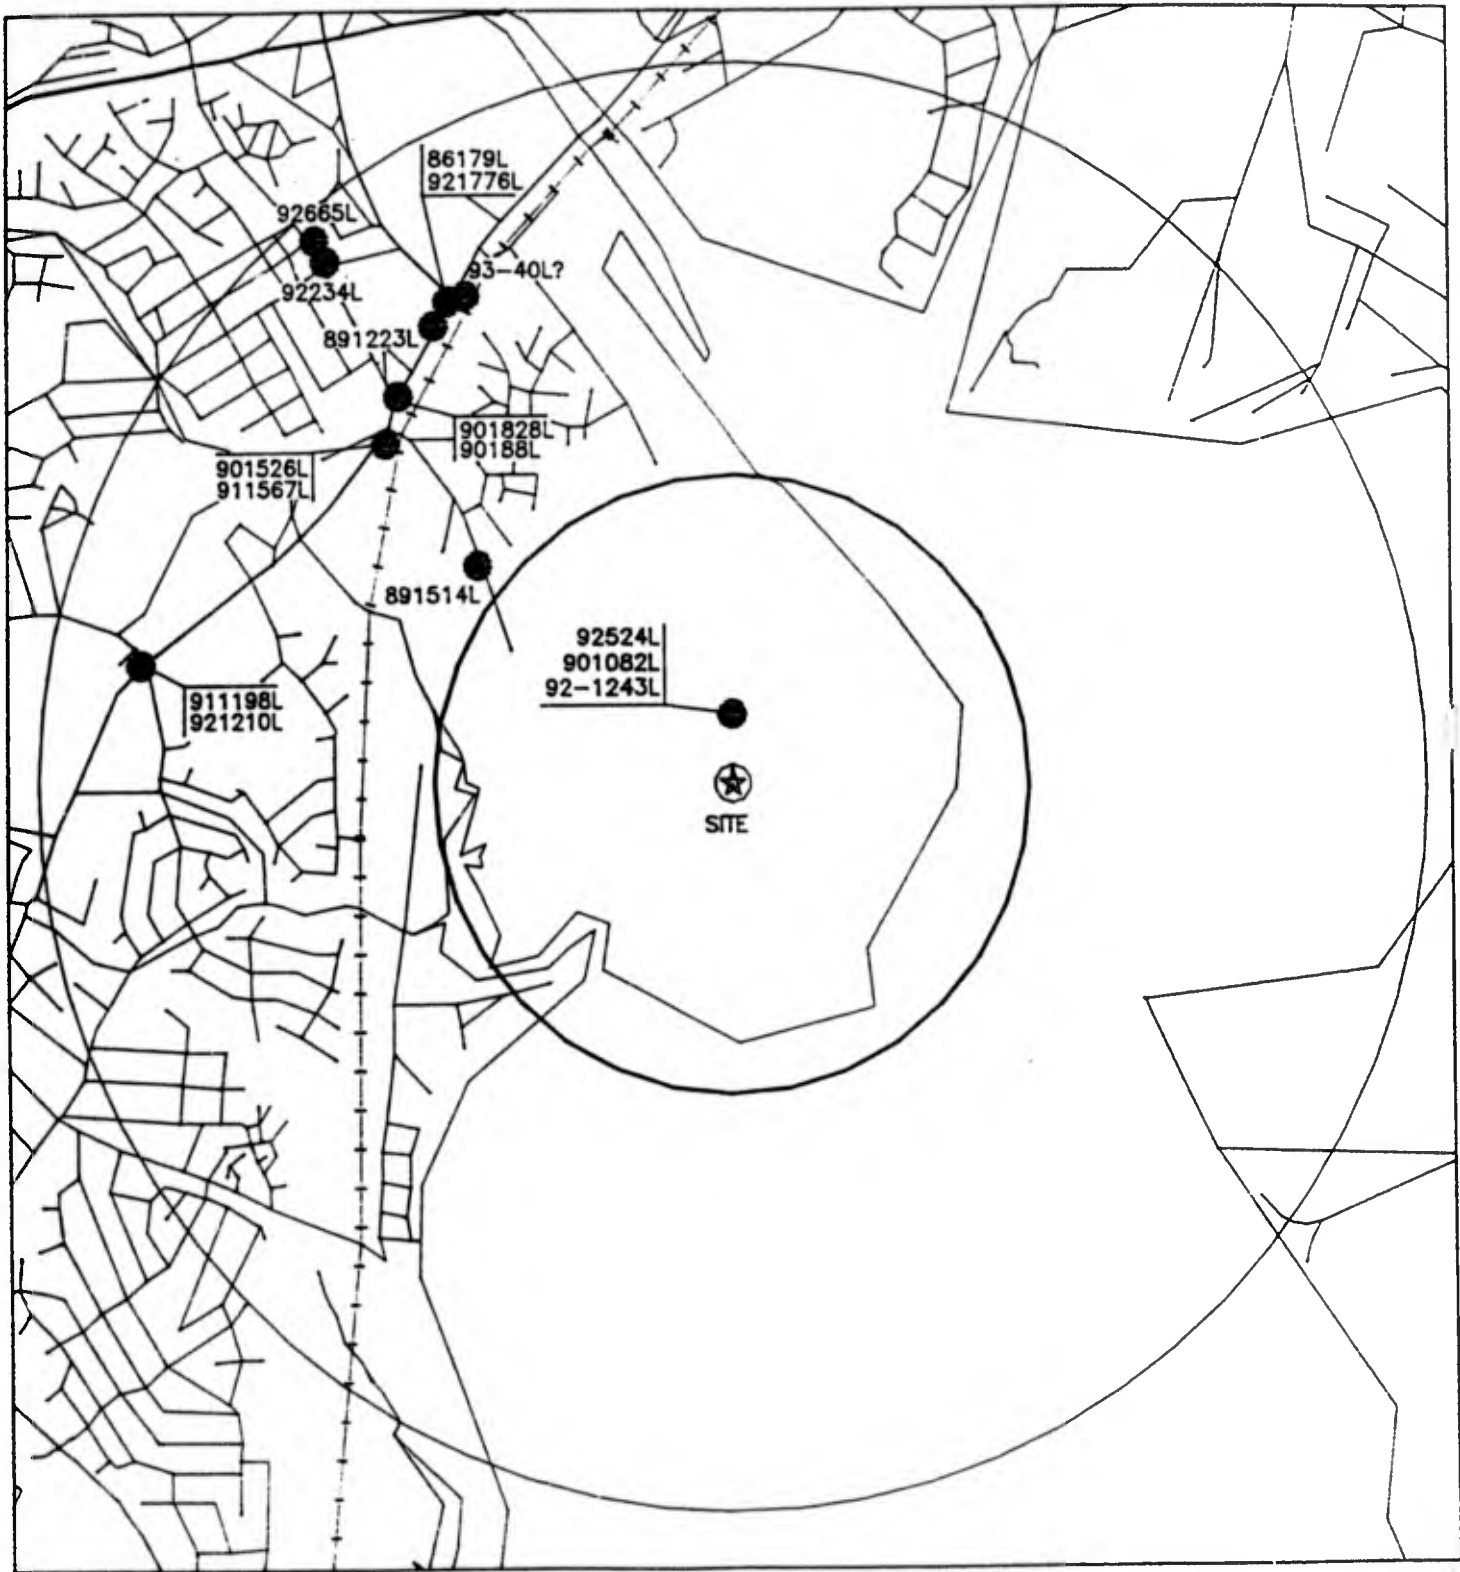
Woodbridge Research Fac. - Woodbridge, VA
 Scale: 1" = 2500' - Leaking Storage Tanks

The database search identified over 33 leaking USTs (LUSTs) or spills within a 1-mile search radius, three of which are on site. The majority of LUSTs and spills were associated with gas stations located along the main highway (Route 1), located half a mile northwest of the site.
