**Community Environmental Response  
Facilitation Act (CERFA) Report**

**Sacramento Army Depot  
Sacramento, California**

Revision 1  
April 1, 1994

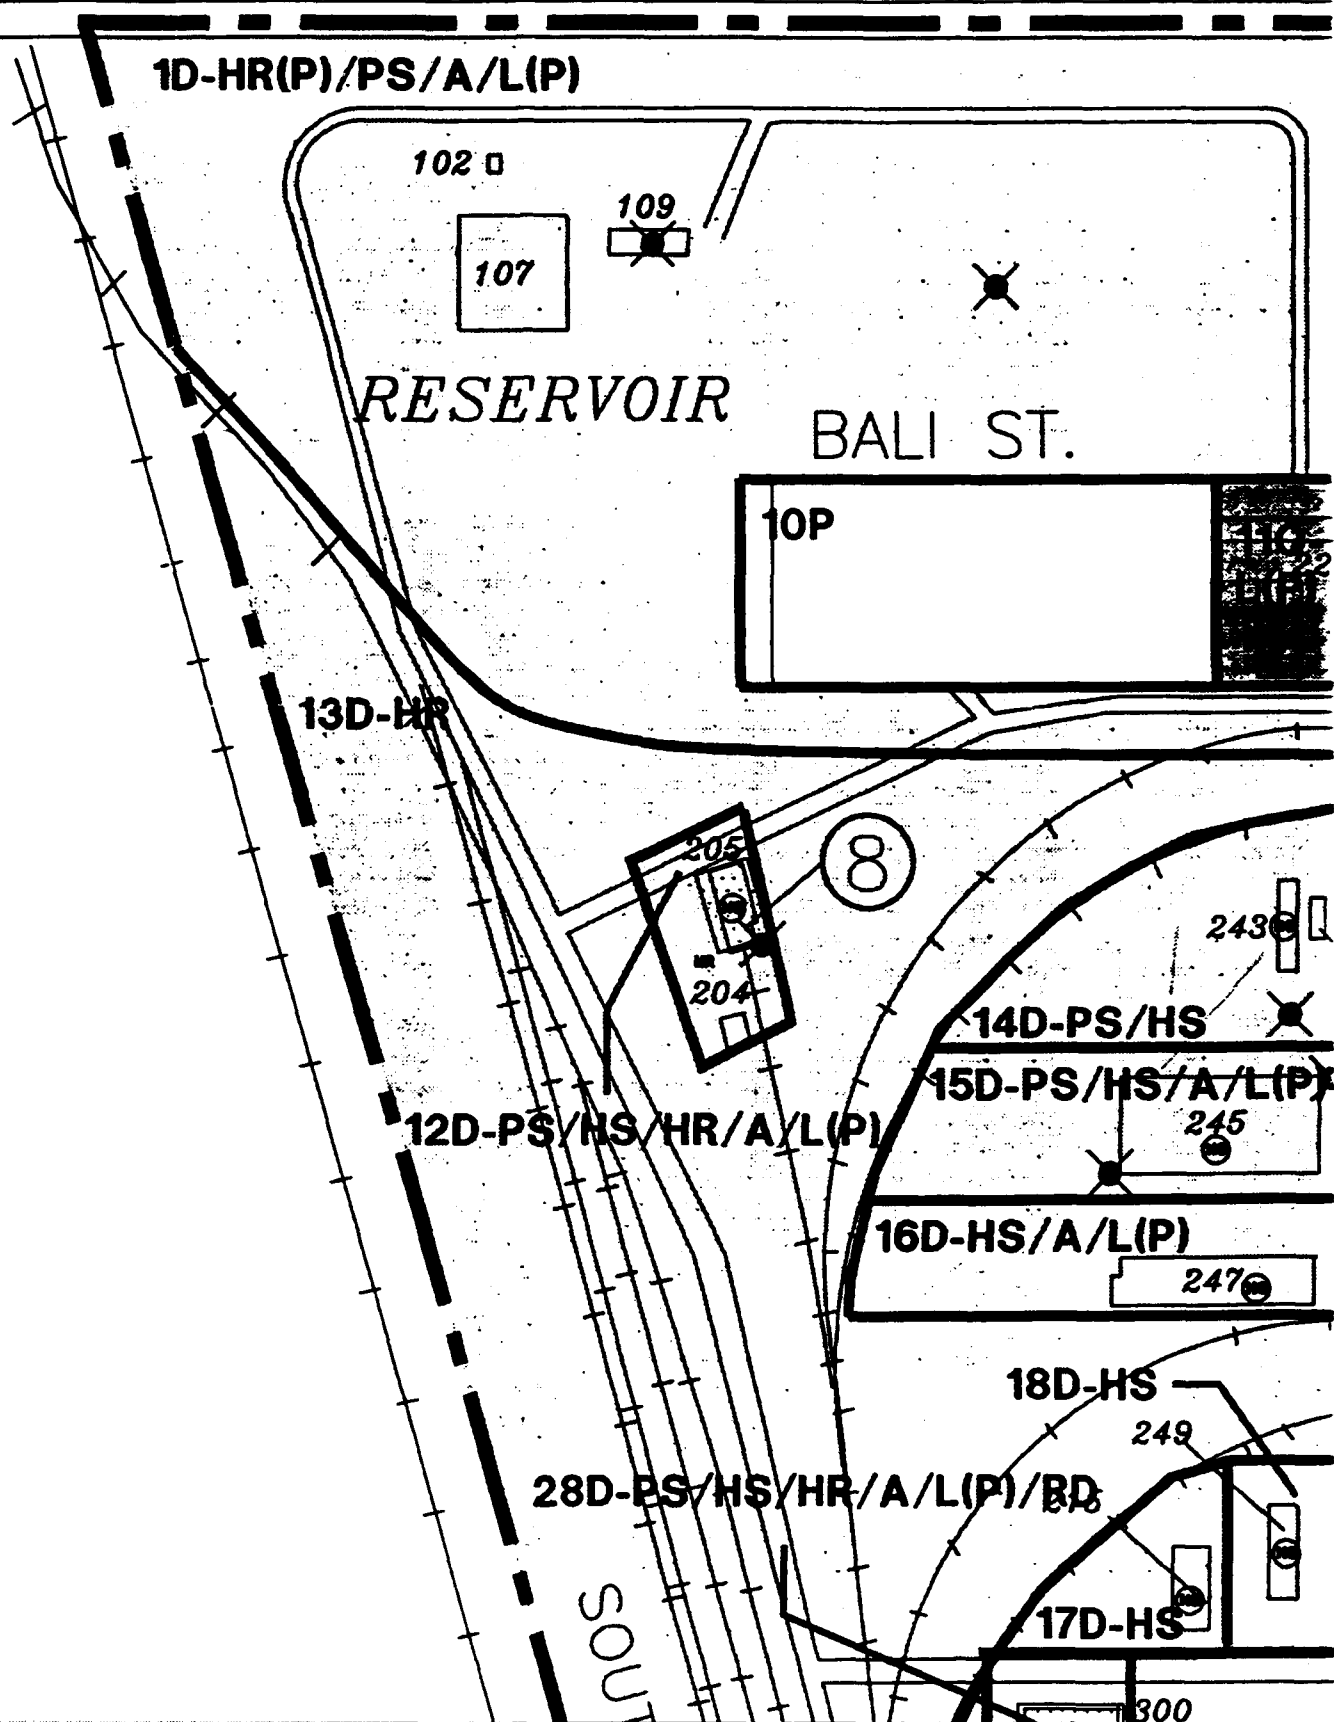
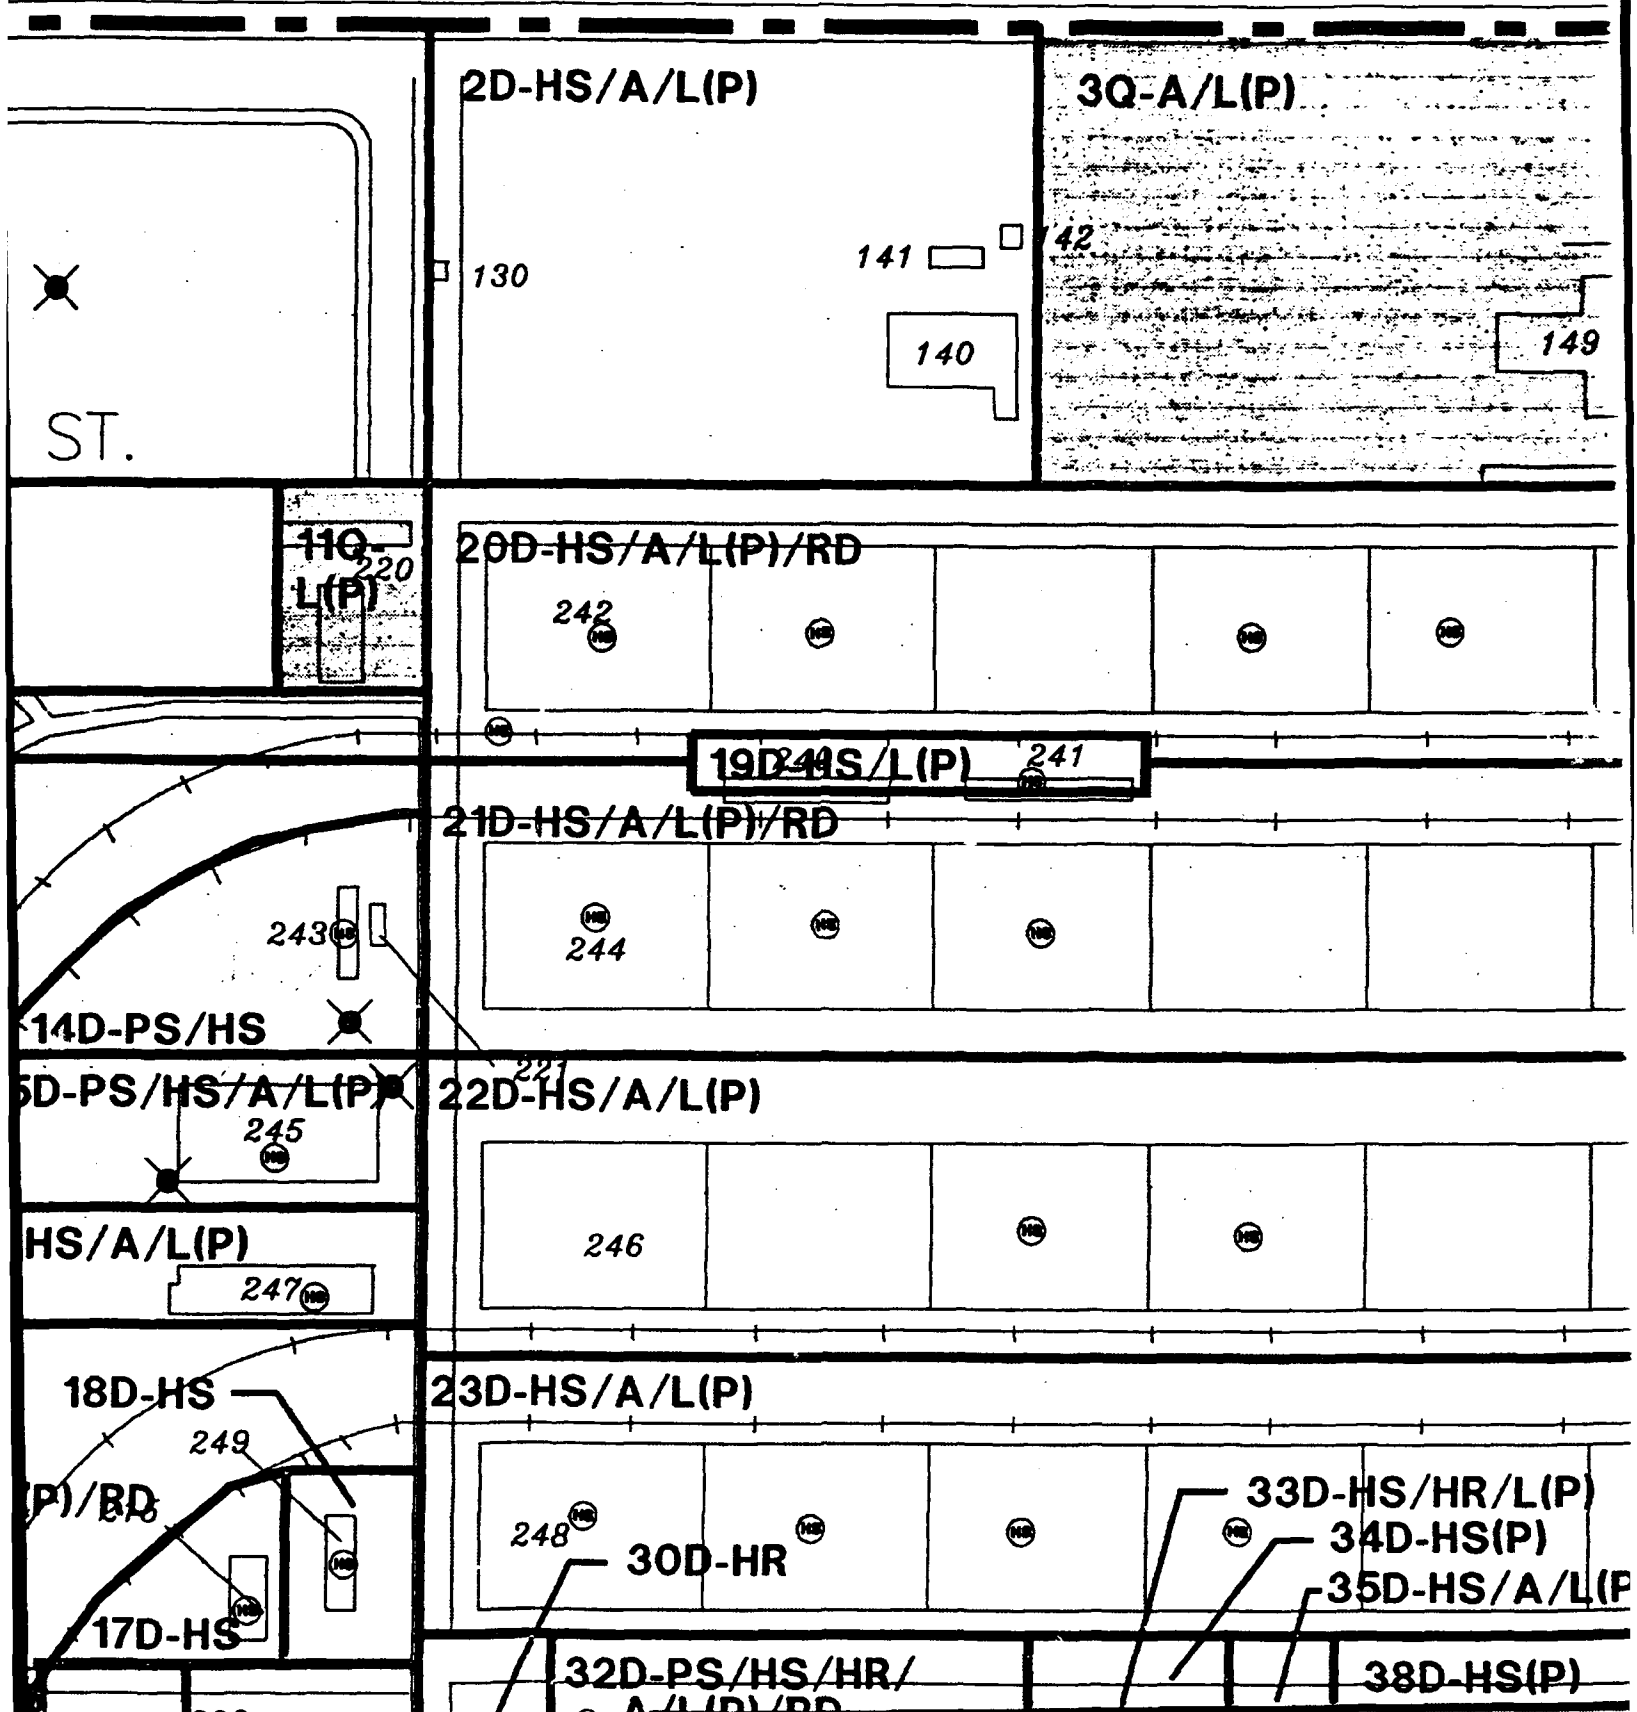
Each of these areas was evaluated with respect to the CERFA assessment criteria; if storage, release, or disposal of hazardous substances or petroleum products or their derivatives had occurred, the area was located on Figure 5-1 and the parcel location from the CERFA parcel map was also noted in the table. Active operations at SAAD where hazardous substances or petroleum products or their derivatives have been handled, generated, stored, or disposed of in the past are also noted in Table 4.1-1 and discussed in Section 3.1.2.

on the parcel Designation map (Figure 5-1). Parcels including locations of any leaking PCB-containing transformers would be categorized as CERFA disqualified because that release would prevent the parcel from being considered uncontaminated. Normal use of PCBs in transformers that exhibited no evidence of leaking would not be sufficient to categorize a parcel as either a CERFA disqualified parcel or a CERFA parcel with qualifier because no release or disposal of hazardous substances has occurred; storage areas for out-of-service PCB-containing equipment would be categorized as a CERFA parcel with qualifier.
