**Community Environmental Response  
Facilitation Act (CERFA) Report  
Fort Wingate Depot Activity  
Gallup, New Mexico**

**U.S. ARMY ENVIRONMENTAL CENTER  
ABERDEEN PROVING GROUND, MARYLAND 21010**

**ENVIRONMENTAL RESOURCES MANAGEMENT, INC.  
855 Springdale Drive  
Exton, PA 19341**

11 APRIL 1994

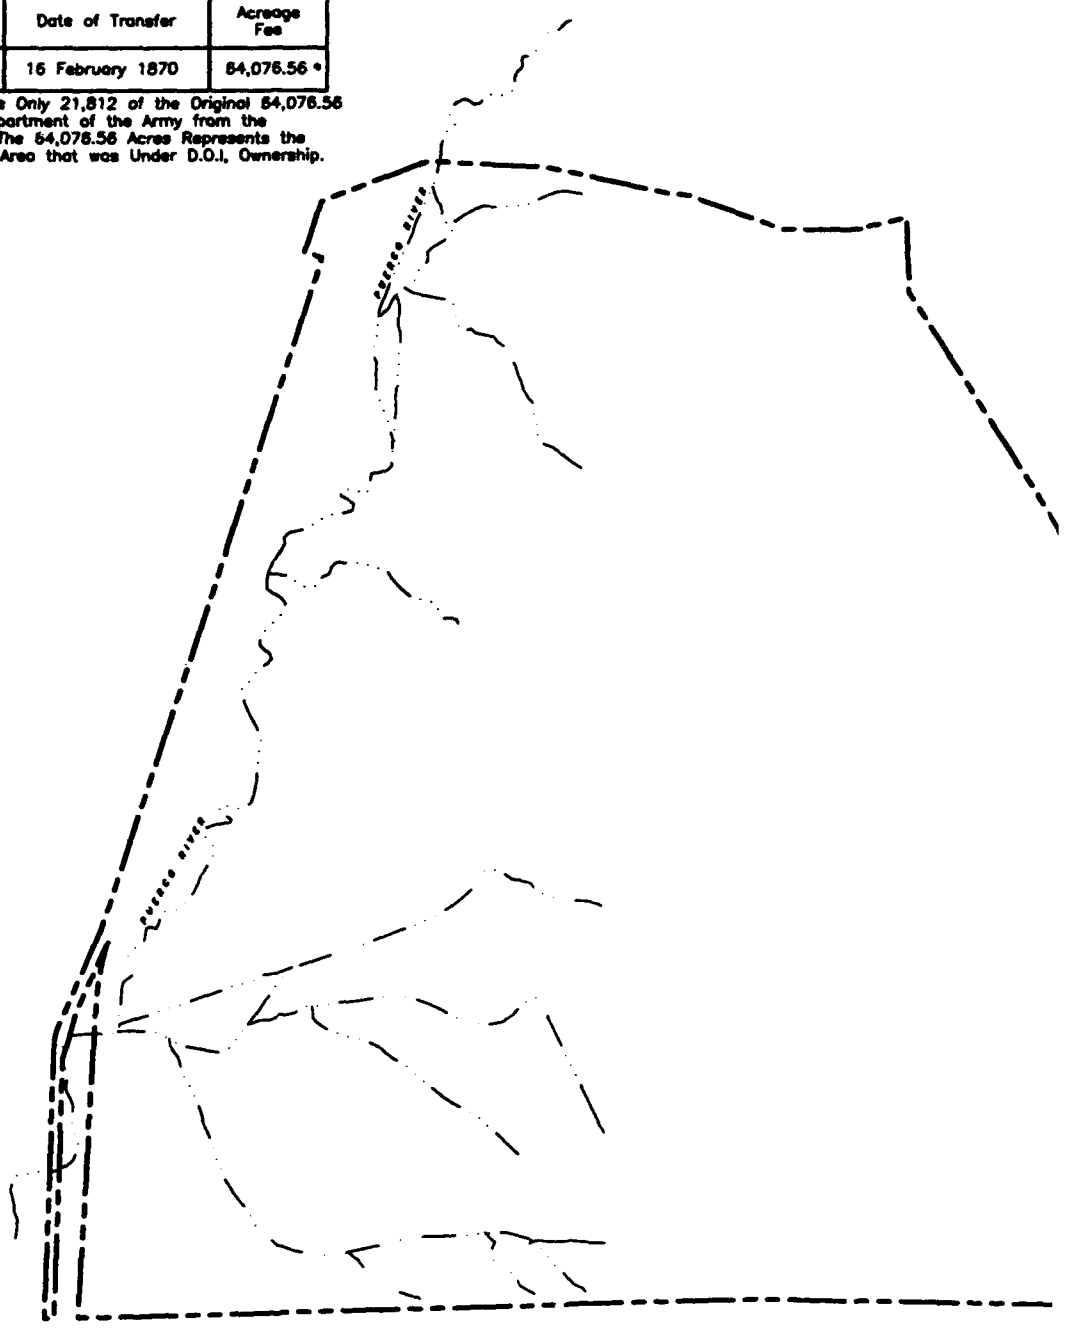
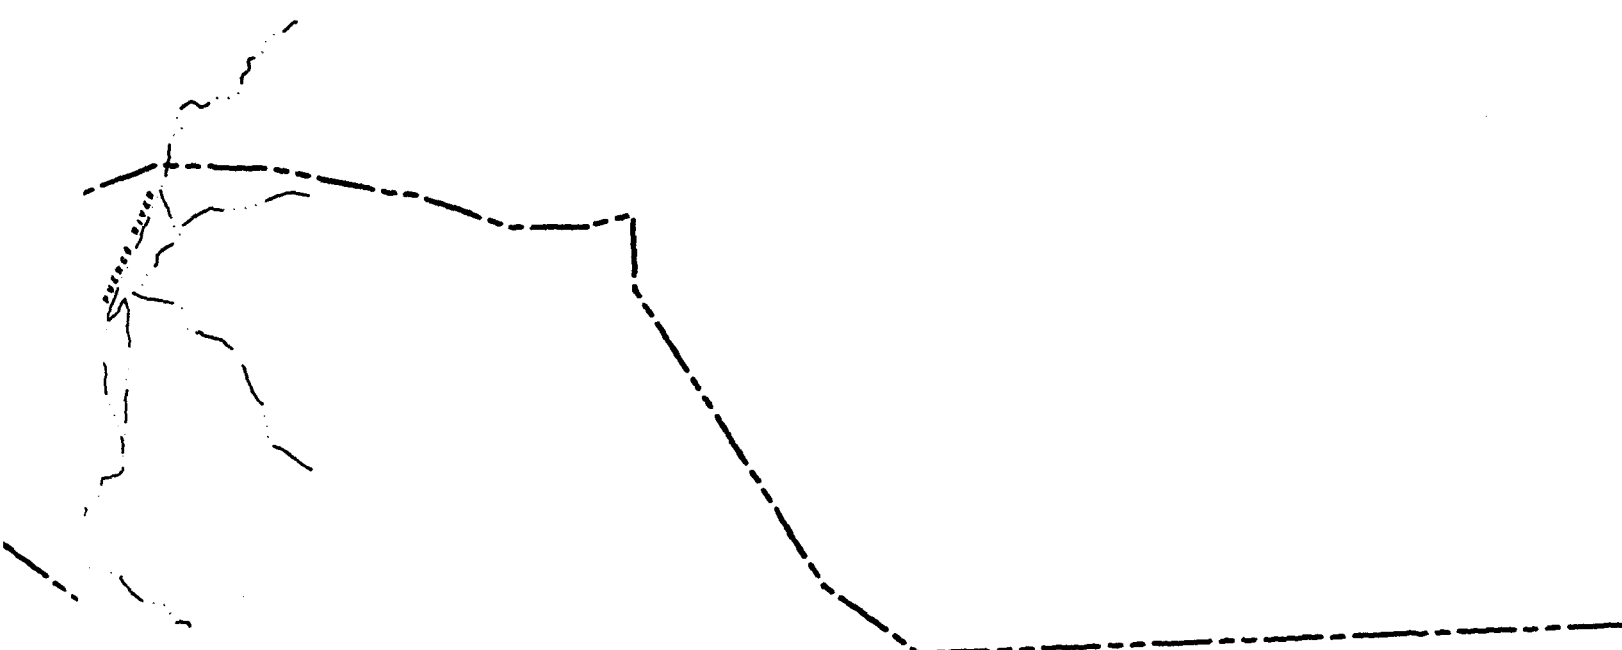
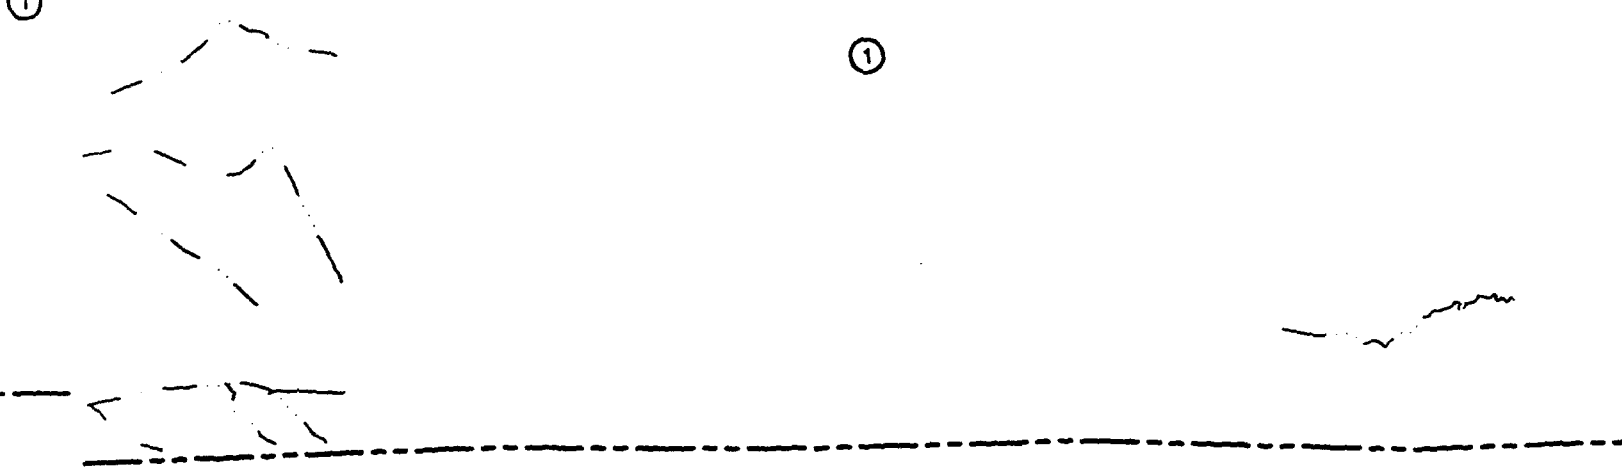
**Figure 5.2-1  
Tract Map  
Fort Wingate Depot Activity  
Gallup, New Mexico**

Tract No.	Name of Previous Owner (Transferrors)	Date of Transfer	Acreage Fee
1	Department of the Interior	16 February 1870	84,076.56 *

Note: \*The Current FWDA Represents Only 21,812 of the Original 84,076.56 Acres Transferred to the Department of the Army from the Department of the Interior. The 84,076.56 Acres Represents the Original 10 Mile by 10 Mile Area that was Under D.O.I. Ownership.

additional information was collected. Previous ownership and the dates of transfer to the Army are indicated on Figure 5.2-1.

The property boundaries and all property transfers including prior ownership information is shown in Figure 5.2-1.
