# 5th Australian Aeronautical Conference

# The Measurement of Dynamic Structural Stresses in a Light Armoured Vehicle

S.J. CIMPOERU, B.E., M.Eng.Sci., GradIEAust,

Ship Structures and Materials Division, Materials Research Laboratory, DSTO Australia.

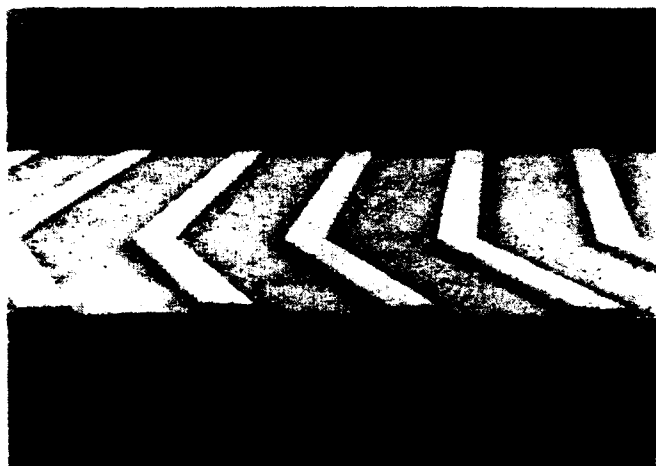
Figure 2: Segment of Herringbone Ripple-Bar Course at Monegetta. The vehicle traversed this course from the left to right.

The test vehicle was trialed by being driven around a selected test circuit at the Monegeetta Proving Ground of the Australian Army Engineering Development Establishment. Table 1 details the component sections of the test circuit. The characteristics of each of the terrain types are self-explanatory, except for the 'Herringbone' Ripple-Bar Course, Fig. 2. This latter terrain is used to simulate the corrugation ripples that are often found in outback roads. The

herringbone ripple-bar pattern simulated roads with corrugations that are off-set from each wheel.
