Miscellaneous Paper CERC-94-15  
August 1994

# Stability Study of the 1978 Jetty Rehabilitation, Yaquina Bay, Oregon, in Response to 1979-1980 Storm Season Waves

by Robert D. Carver, Michael J. Briggs

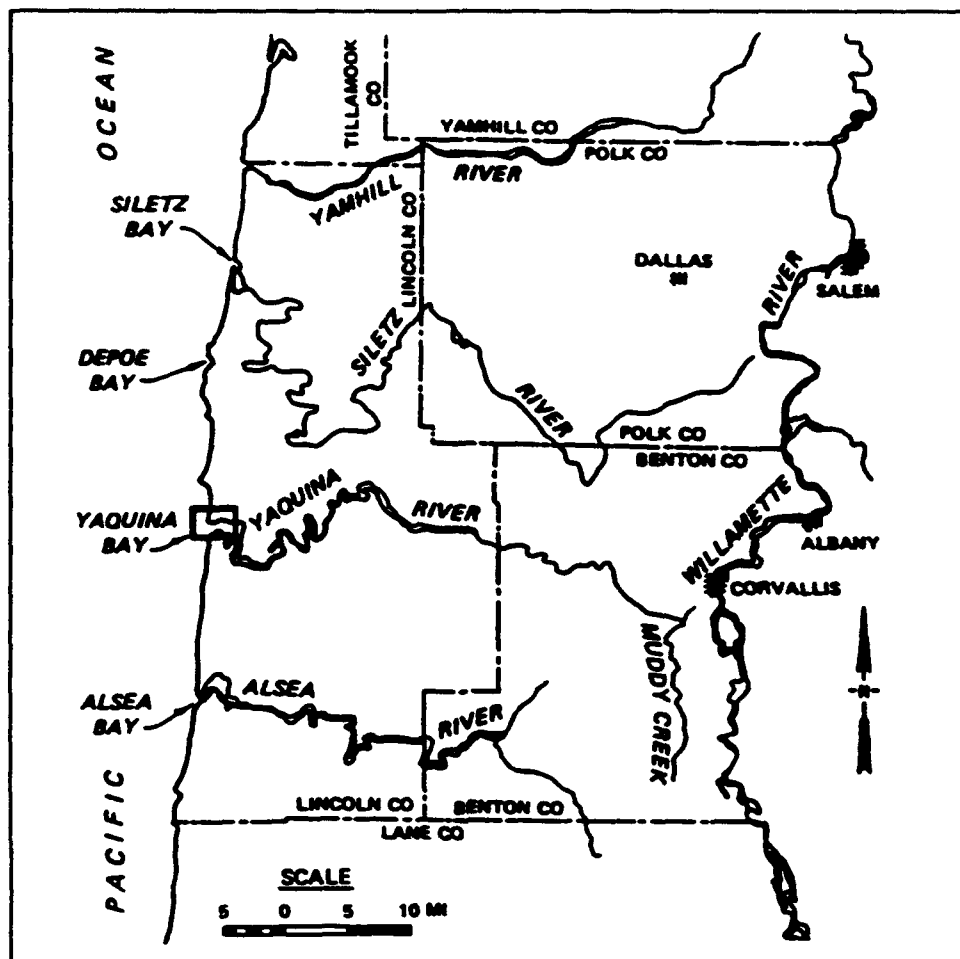
Figure 1. Yaquina Bay, Oregon

Yaquina Bay is an estuary located on the Oregon Coast approximately 110 miles<sup>1</sup> (204 km) south of the mouth of the Columbia River (Figure 1). The bay is fed by the Yaquina River, which drains a predominantly forested watershed of approximately 250 square miles (647 km<sup>2</sup>). Elements of the existing project at Yaquina Bay maintained by the U.S. Army Corps of Engineers include two rubble-mound jetties at the entrance and a 40-ft- (12-m-) deep by 400-ft- (122-m-) wide entrance channel. The jetties, entrance channel, and other project features were constructed to provide safer access for vessels serving the Yaquina River ports of Newport and Toledo, Oregon. Commercial products handled at these ports include lumber, pulp, paperboard, petroleum, and seafood. The Yaquina Bay area is also frequently used by individuals who enjoy recreational fishing and boating.

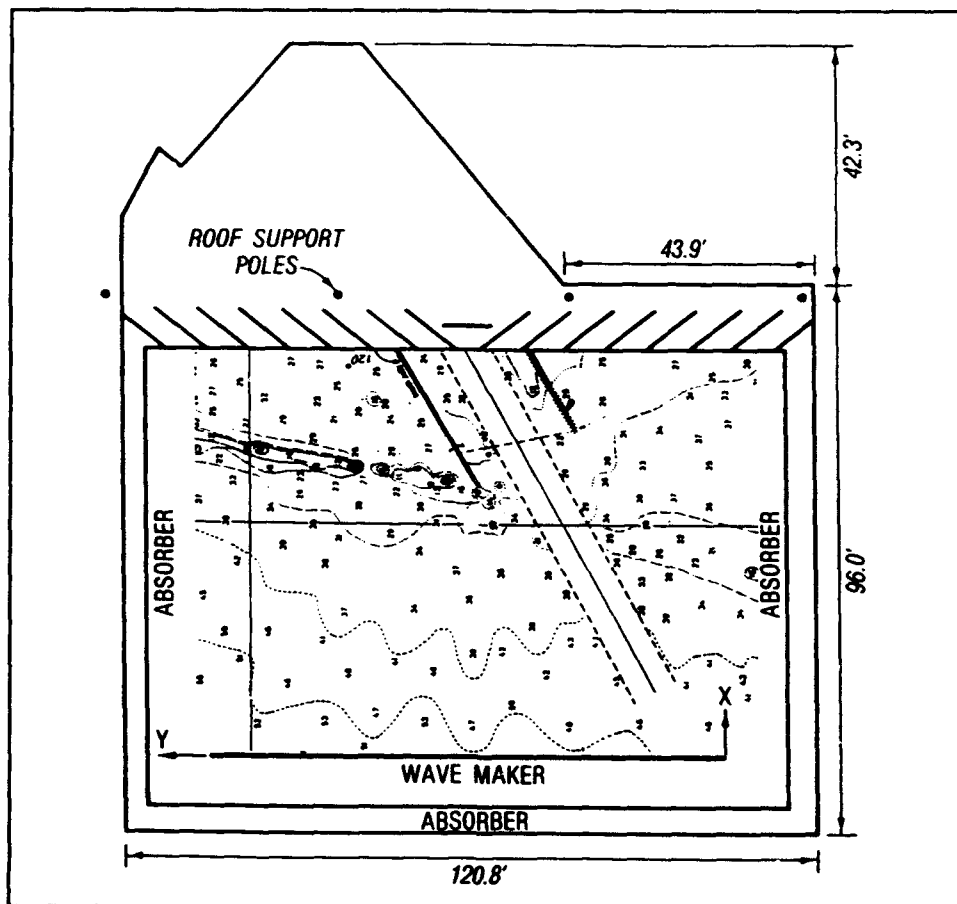
Figure 2. Plan view of physical model

The study was conducted in a 96-ft-long by 121-ft-wide (29-m-long by 37-m-wide) wave basin (Figure 2). Bathymetry was the same as that used in the earlier physical model study of the proposed 1988 rehabilitation (Grace and Dubose 1988). No additional surveys or verification of the nautical charts

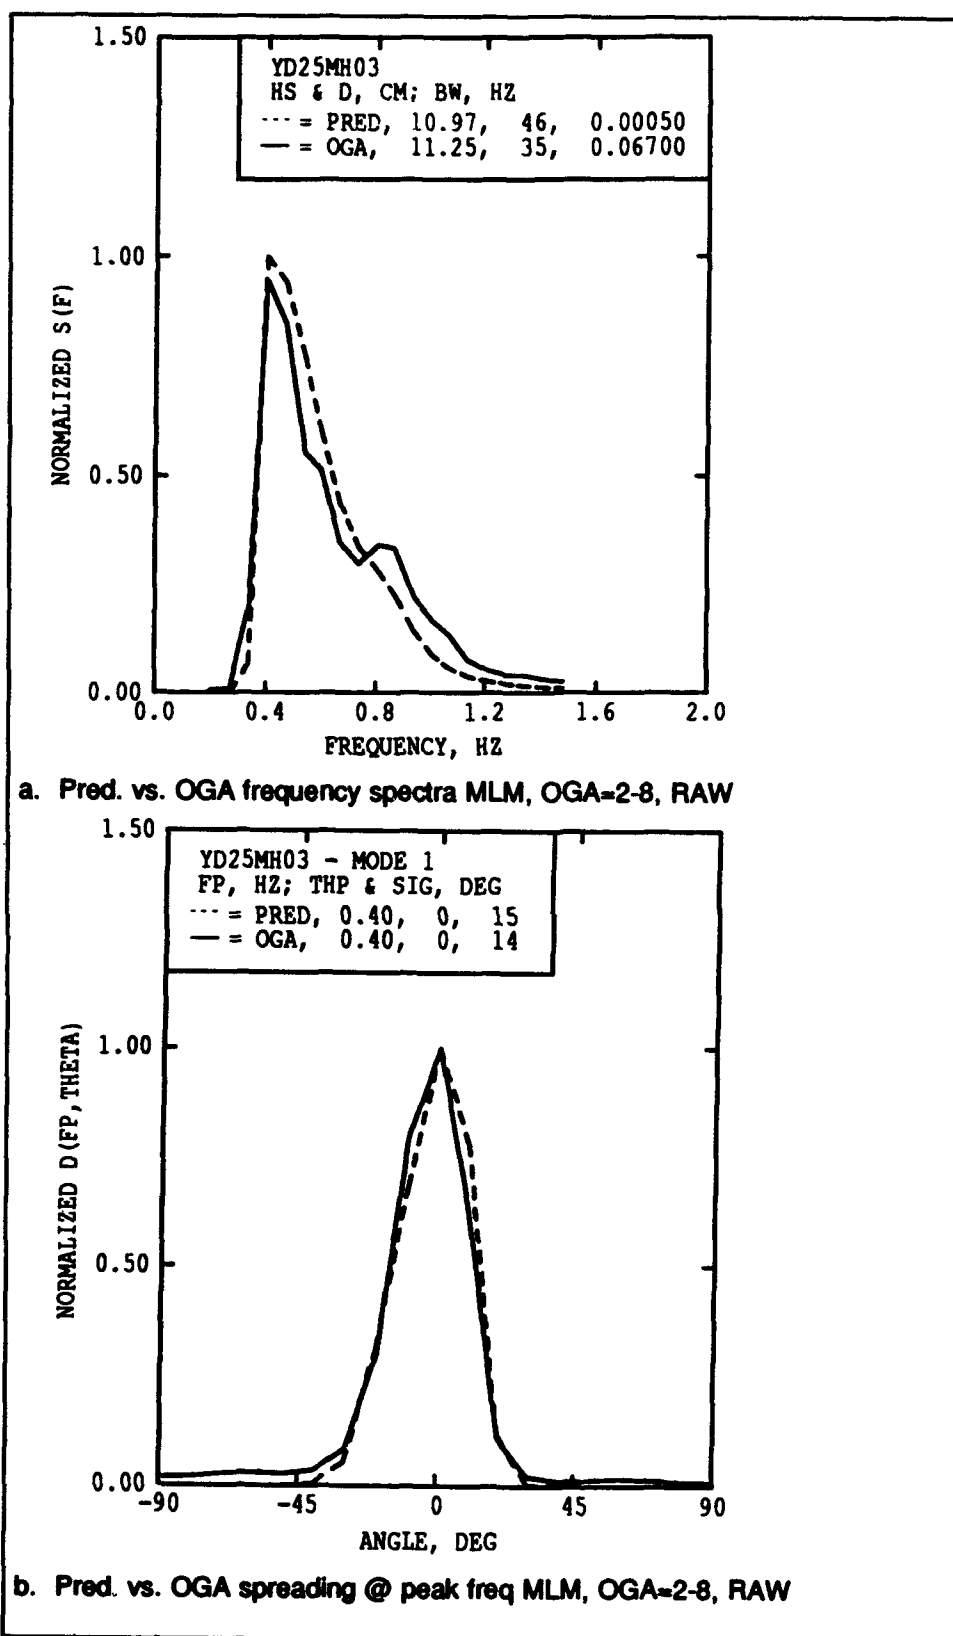
Figure 7. Target and measured normalized directional spectra for case YD25MH

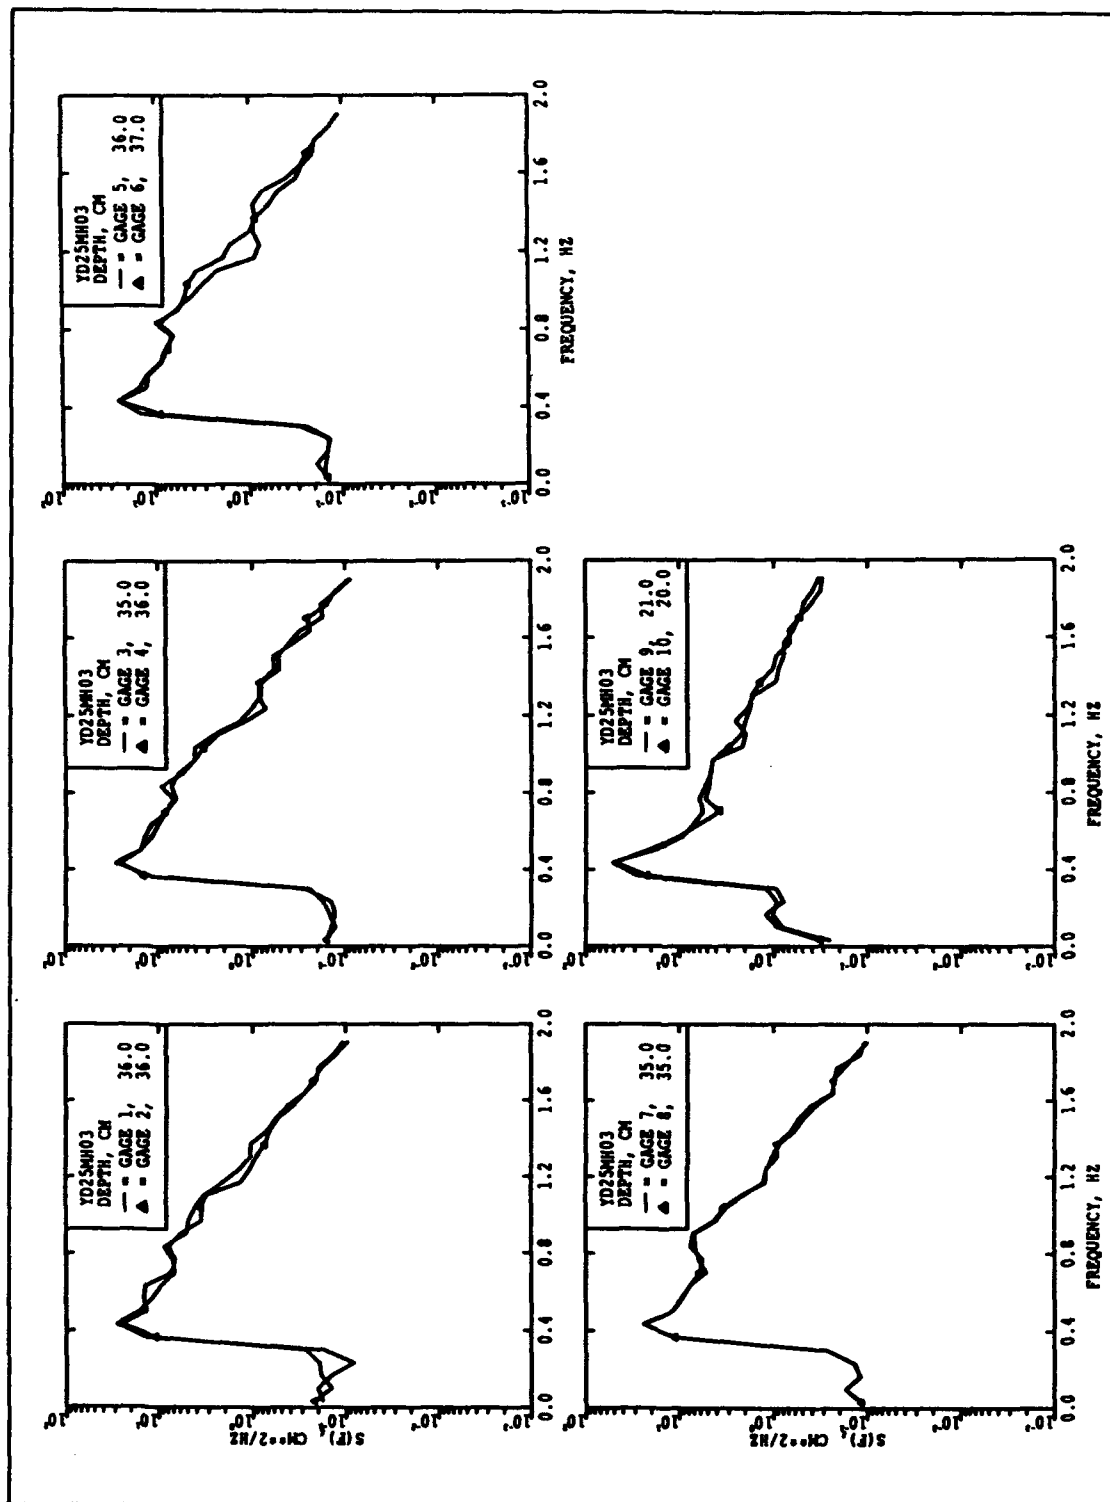
Figure 8. Measured model frequency spectra for all gauges

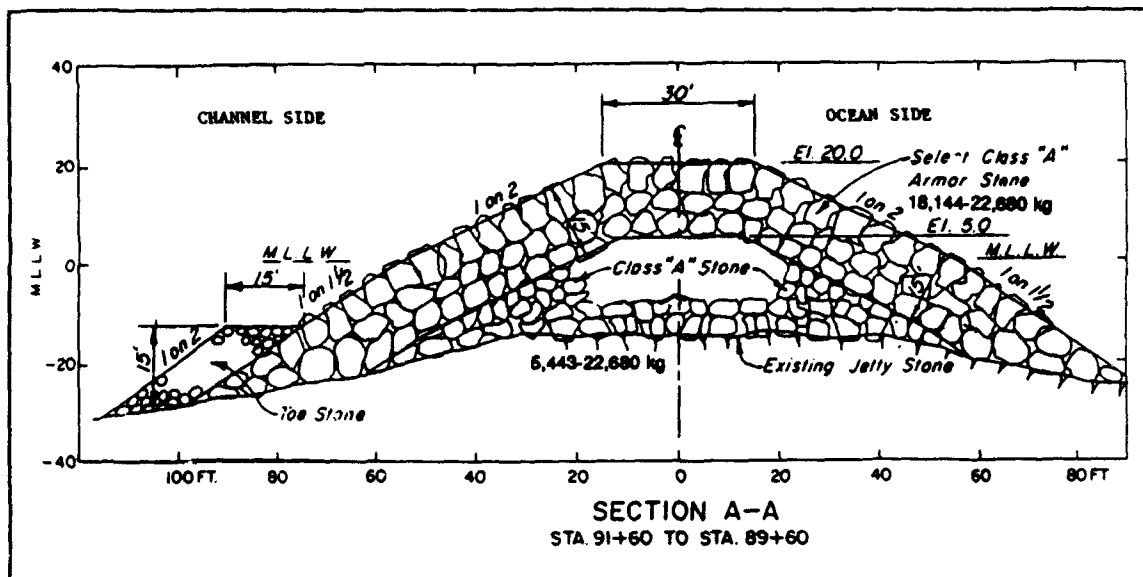
Figure 10. Jetty Section A-A

The jetty profile and cross sections are presented in Figures 9, 10, and 11. The rehabilitation plan was characterized by a crest elevation of +20 ft (6 m) mllw and a crest width of 30 ft (9 m). Armor sections were typically composed of two layers of 6- to 25-ton (5,443- to 22,680-kg) stone (average weight = 10 tons (9,072 kg)). The model structure is shown in Photos 1 and 2.

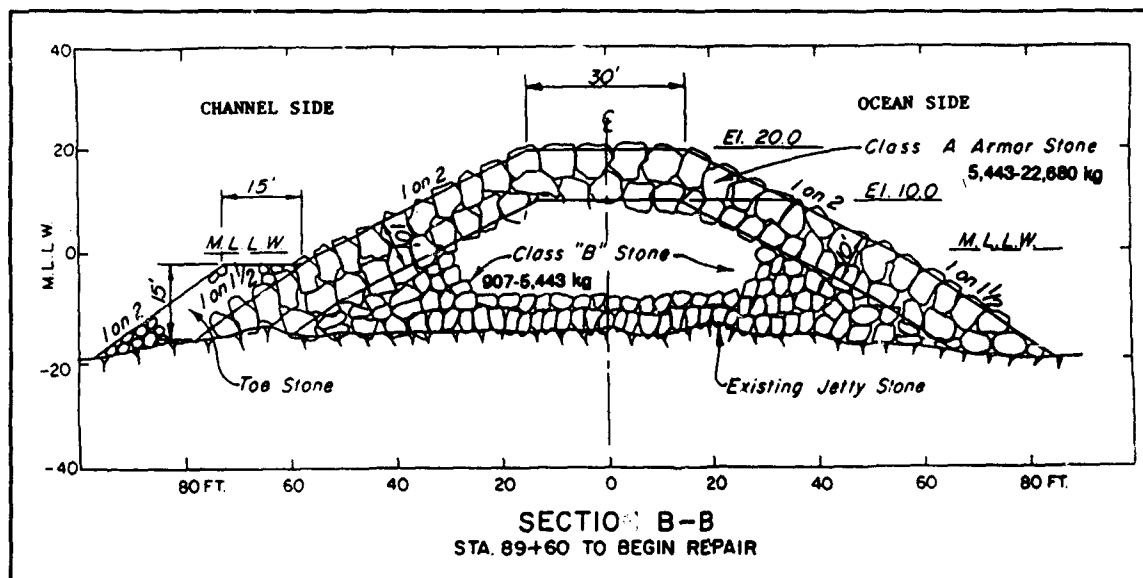
Figure 11. Jetty Section B-B

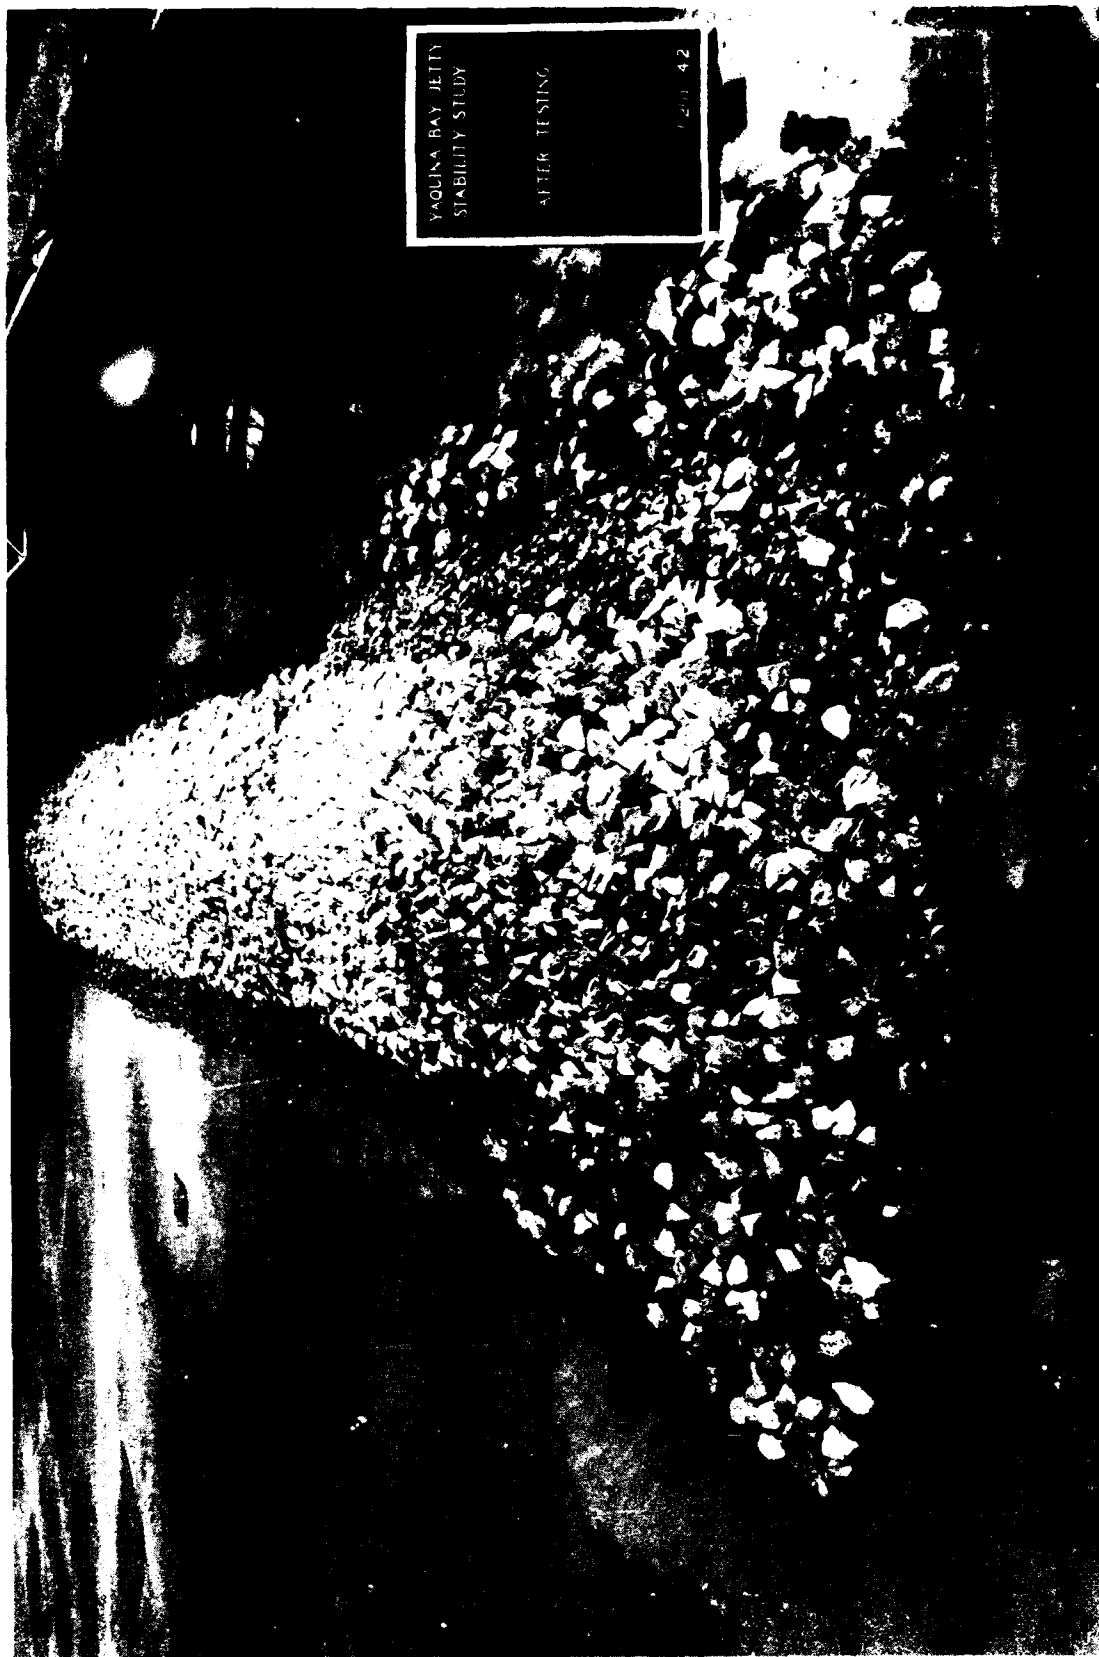
Initiation of the December storm (step 21) caused displacement of one armor stone and rocking of a few others. General loosening of the armor above the swl was observed during steps 22, 23, and 24. Steps 25 and 26 produced minor rocking of 3 or 4 armor stones. The structure emerged from the 26-step test series in good condition. Loosening of the armor observed in steps 22, 23, and 24 abated during steps 25 and 26 and appeared to have no significant impact on overall stability (Photo 3).

Photo 3. Long-axis view of structure following initial stability test

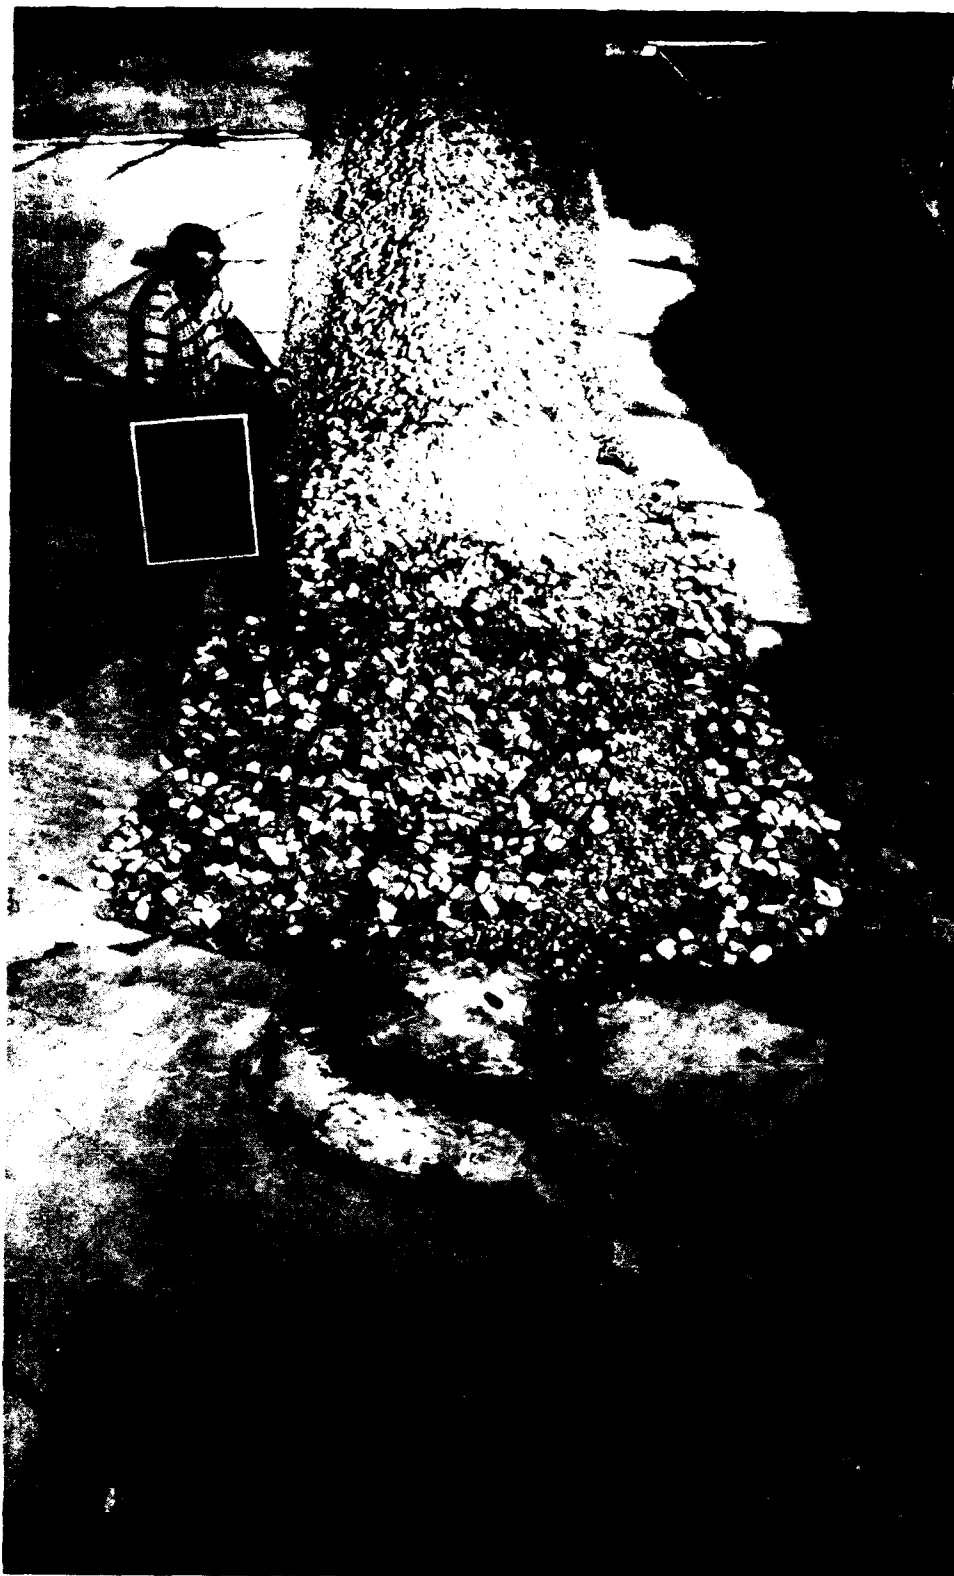
Finally, the model structure was rebuilt to initiate "hot spots" by dislodging and loosening some stones, and retested. Since most of the observed movement during the first test series occurred during the December storm, it was decided to use only the six December storm conditions for this last test series. Test results from this repeat series are summarized in Table 6. Step 1 caused significant loosening of the armor with nine stones being displaced. At the conclusion of step 1 it was anticipated that the repeat test might show a significant increase in damage above that observed for the original test. However, steps 2, 3, and 4 produced only rocking of five or six armor units, with no additional displacement observed. Minor rocking of two or three armor units was observed during steps 5 and 6, with the structure emerging from the six-step simulation in good condition (Photos 4 and 5).

Photo 4. Overhead view of structure following repeat stability test

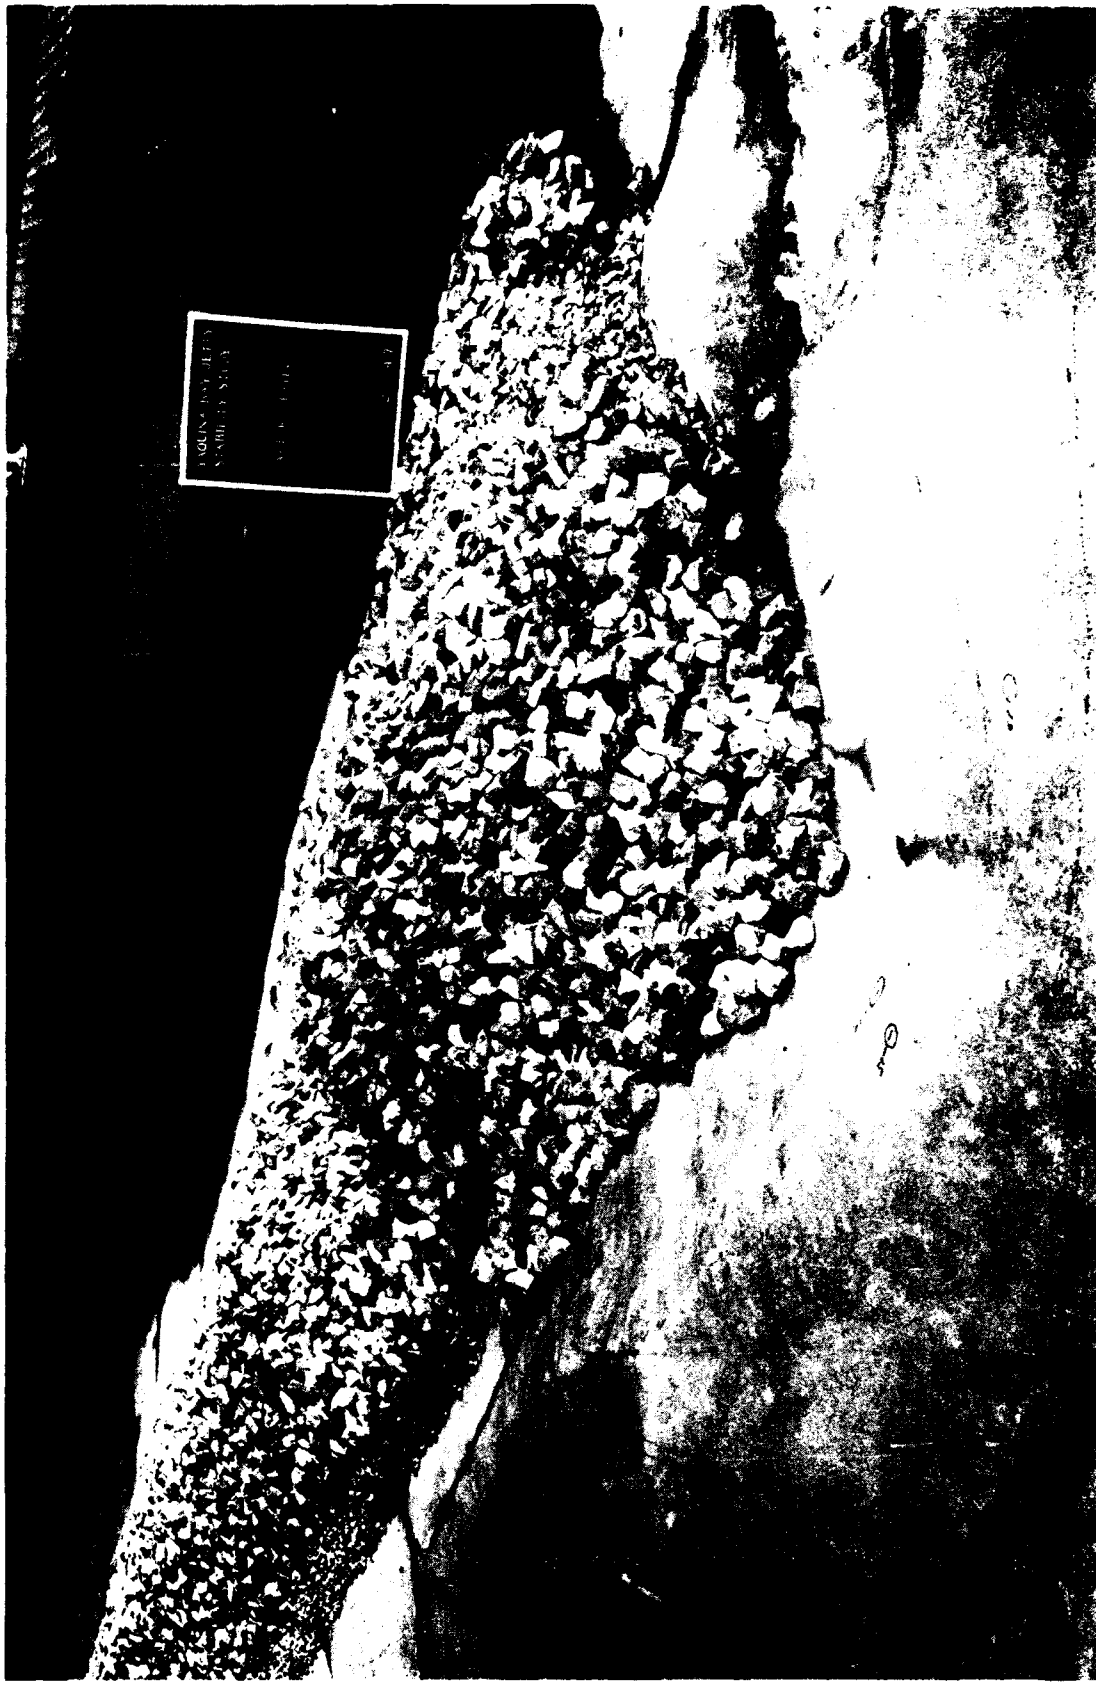
Photo 5. Sea-side view of structure following repeat stability test
