# NAVAL POSTGRADUATE SCHOOL Monterey, California

## THESIS

A TRANSMISSION ELECTRON MICROSCOPE  
CHARACTERIZATION OF SODIUM SULFATE  
HOT CORROSION OF SILICON CARBIDE  
FIBER-REINFORCED LITHIUM  
ALUMINOSILICATE  
GLASS-CERAMIC MATRIX COMPOSITE

September 1994

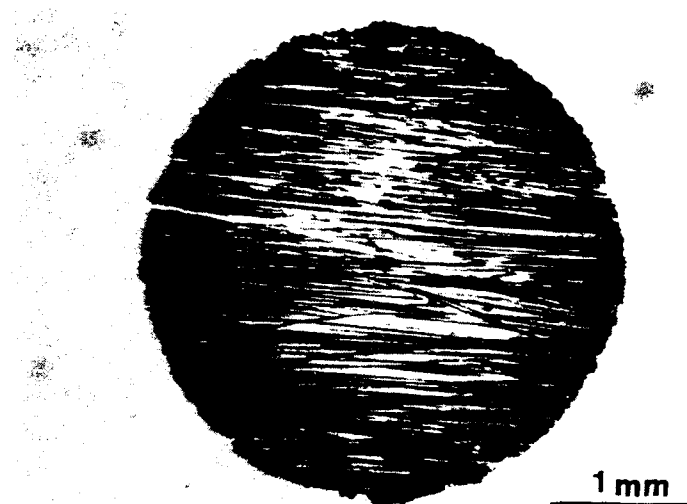
**Figure 15** Optical micrograph of 3 mm diameter disc after thinning to approximately 50  $\mu\text{m}$  showing the orientation of fibers (dark) within the matrix (light).
