RESIDUAL STRENGTH AFTER FATIGUE  
OF UNIDIRECTIONAL AND CROSS-PLY  
METAL MATRIX COMPOSITES  
AT ELEVATED TEMPERATURE

THESIS

Master of Science in Aeronautical Engineering

June, 1996

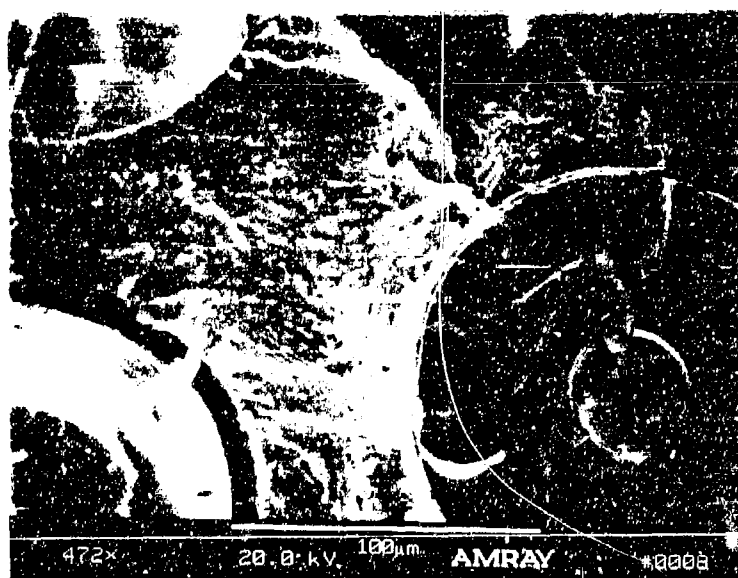
Fracture analysis indicated interface debonding between fiber and the matrix during the tensile testing as the matrix exhibited plastic “necking” between the fibers as shown in Figure 32. Also, it is found that the degradation or the fracture of the fiber coating layer occurred during fatigue.

Figure 33 Crack Initiation & Propagation from Interface of Fiber-Matrix

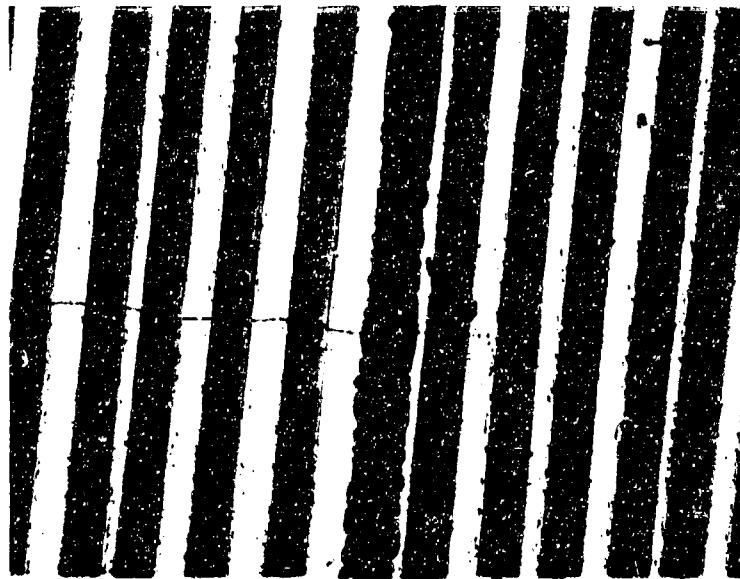
Figure 40. Cracks Propagated Transverse to the Loading Direction

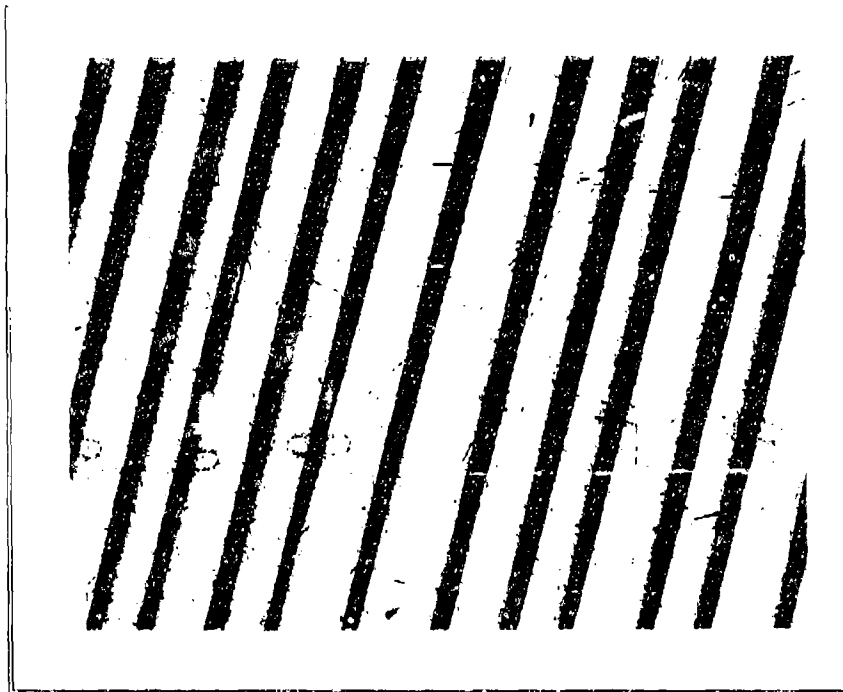
Figure 44. Polishing Observation on 50 %  $N_f$  of  $[0]_s$  Laminate,  $\sigma_{max}=900$  MPa

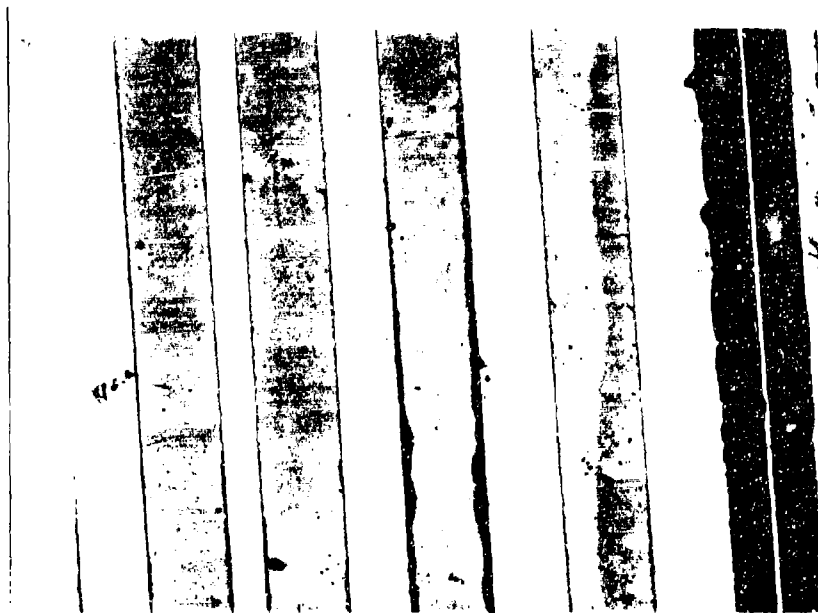
Figure 46. Polishing Observation on 75 % N<sub>2</sub> of [0]<sub>8</sub> Laminate,  $\sigma_{\max}=900$  MPa

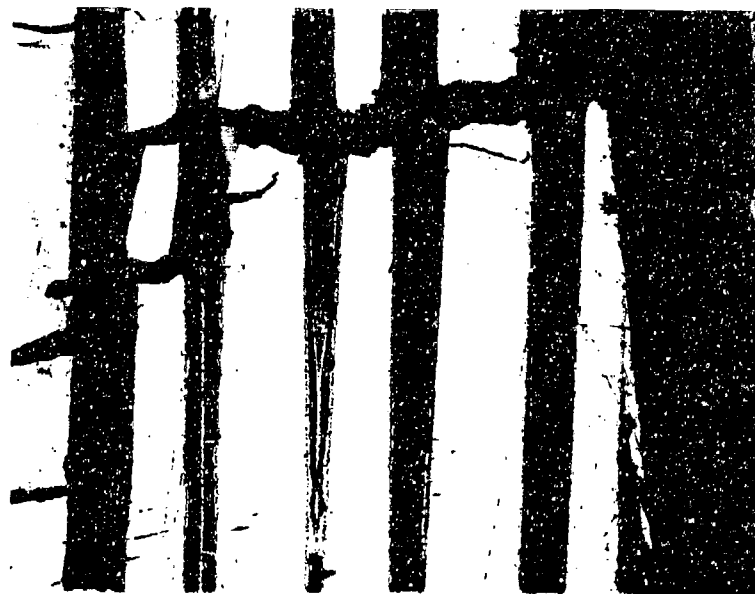
Figure 17 Polishing Observation on 100 %  $N_t$  of  $[0/90]_s$  Laminate.  
 $\sigma_{max} = 300 \text{ MPa}$

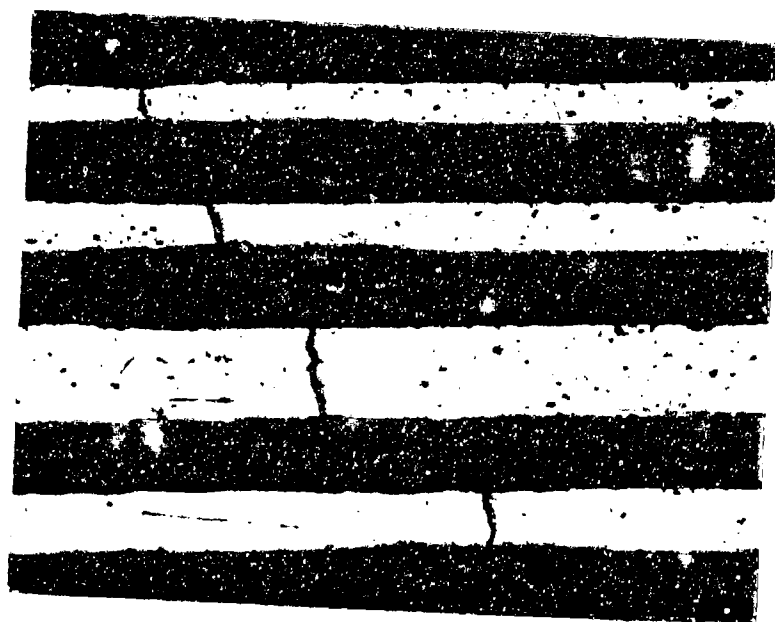
Figure 49. Matrix Cracks Throughout the Width

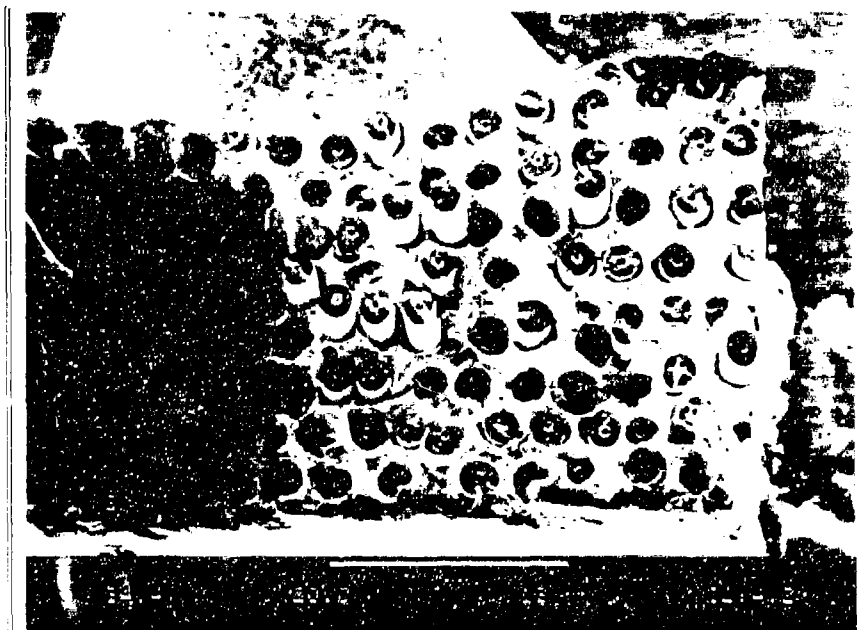
Figure 81: 28%  $N_1$  of the Unidirectional Laminate,  $\sigma_{max} = 900$  MPa
