Technical Report EL-94-15
October 1994

Reliability, Availability, and Maintainability Testing of High Pressure Pumping Units for Mobile Army 600 Reverse Osmosis Water Purification Unit

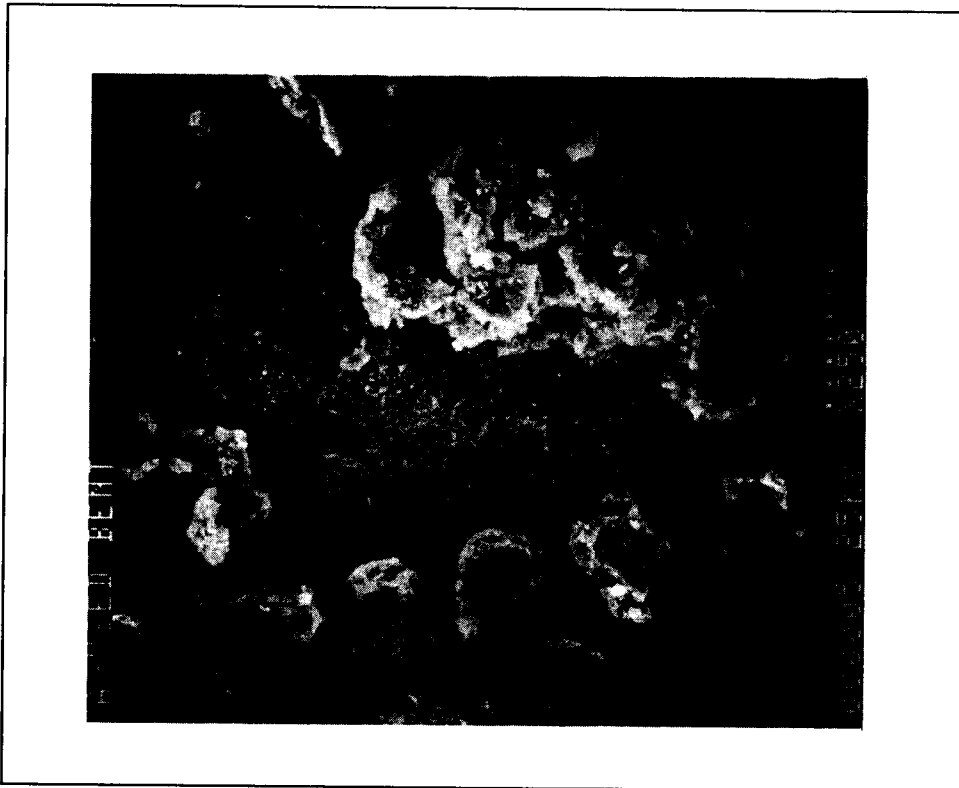
Figure E7. X250. Shows deposits inside elbow. Surface of pipe is also shown. Much of original surface is gone

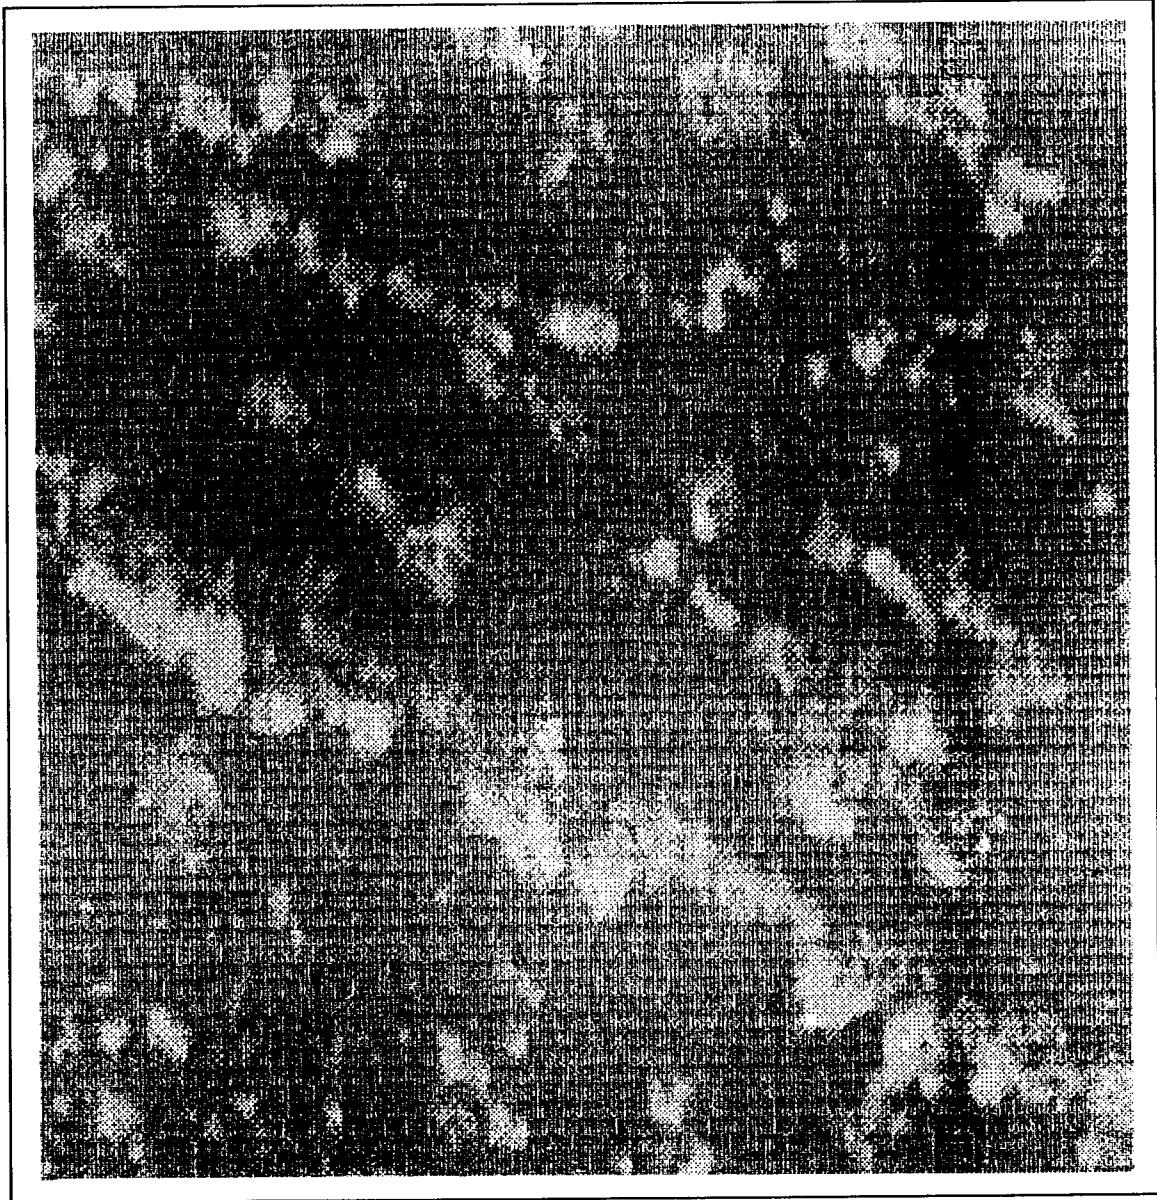
Figure E15. EDX high resolution X-ray map showing distribution of nickel. Light areas indicate concentrations of nickel in some areas
