## Development of Welded Solar Arrays for DMSP and GPS Satellites

15 September 1994

P. C. BRENNAN  
Mechanics and Materials Technology Center  
Technology Operations

6. AUTHOR(S) Brennan, P. C.			
7. PERFORMING ORGANIZATION NAME(S) AND ADDRESS(ES) The Aerospace Corporation Technology Operations El Segundo, CA 90245-4691		8. PERFORMING ORGANIZATION REPORT NUMBER TR-94(4478)-3

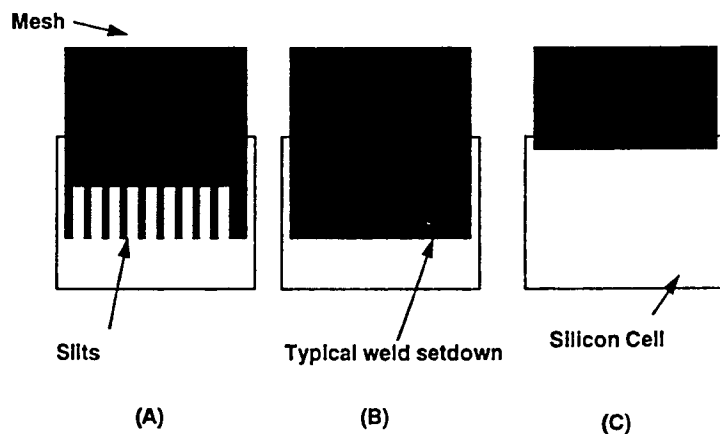
Figure 5. Schematic of basic cell designs tested in this study. (A) P-side sample with slits in mesh; (B) original P-side design with typical weld setdown location delineated; (C) basic design for all N-side welds and P-side edge samples designed to physically resemble N-side welds.

A schematic of the thermal-cycle apparatus is shown in Figure 4. A steel-mesh cage was used to transport the solar cells between a LN<sub>2</sub> bath and a steam chamber. A variable-speed motor was used to lift the cage. The majority of the tests were conducted at a rotation rate of 3.5 min/rev. This allowed for a residence time in the steam of approximately 1 min. The residence time in the LN<sub>2</sub> depended on the liquid level, but was also approximately 1 min. Faster rates did not allow sufficient time to equilibrate the cage and sample temperature with the steam-chamber temperature. Consequently, after an extended period, ice would develop on the cage. By using a slower rotation rate, the samples and cage were resident in the steam chamber long enough to melt any ice and to equilibrate with the surroundings. Modifications to the weld location on the mesh and cell, as well as modifications to the mesh geometry were tested. A schematic of the various cell designs is exhibited in Figure 5.

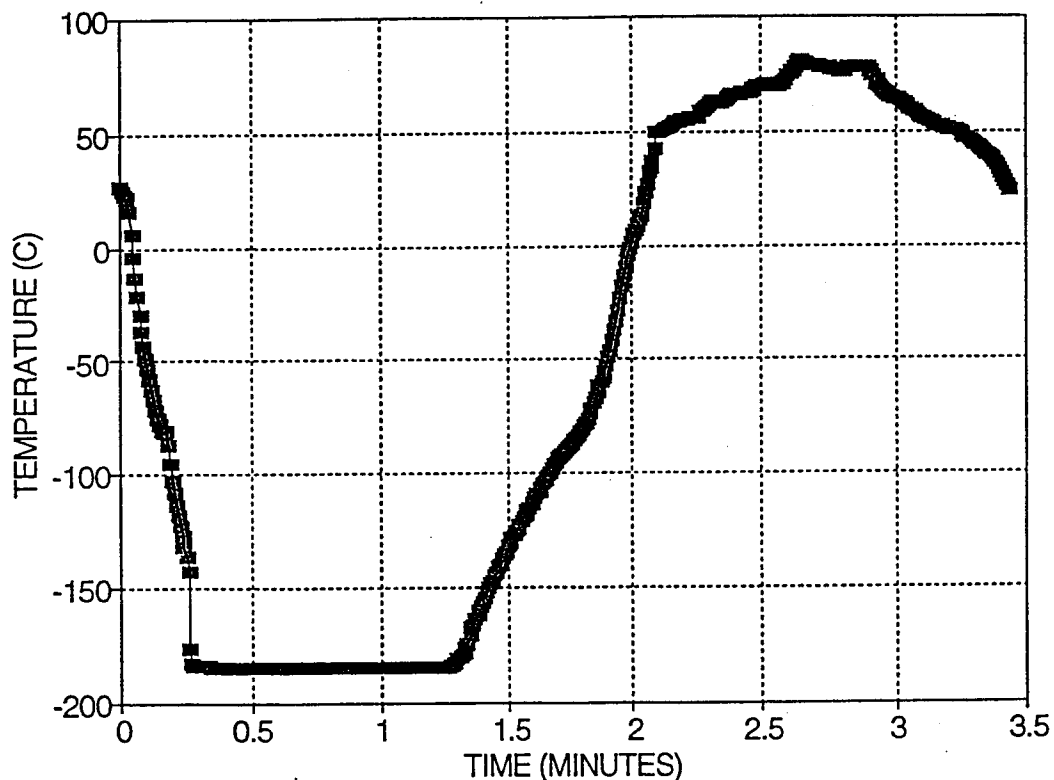
Figure 6. Temperature profile of a 0.010-in.-diam. type-K thermocouple as it cycles through one complete temperature cycle. Cycle time is approximately 3.5 min/rev. Notice uncalibrated thermocouple reads approximately 10°C off at liquid nitrogen temperature (-196°C).

The temperature of the steam chamber was monitored with a type-K thermocouple. The temperature of the chamber would drop 10–15°C from its 85°C average when the chilled sample carrier first entered the chamber. The temperature would return to 85°C before the sample carrier exited the chamber. A temperature plot for an actual thermal cycle experienced by a 0.010"-diameter thermocouple is exhibited in Figure 6. The thermal experience for the solar cell should be similar. The test thermocouple was not calibrated. Consequently, there are errors in the absolute value of the indicated temperatures. Samples were allowed to cycle unattended for several-hour periods before requiring additional LN2 to be added to the bath.

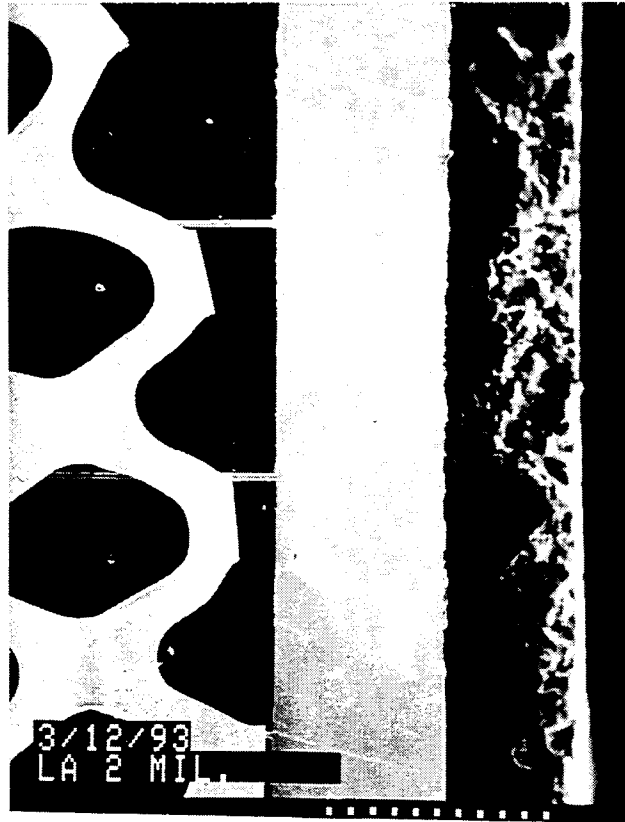
Figure 9. Typical as-fabricated DMSP N-side weld setdown.

A typical, as-fabricated DMSP N-side weld is exhibited in Figure 9. Prior to being thermal cycled, the welds fail, of course, in a ductile manner. Sharp, bright tear ridges are readily visible at low magnifications in the SEM. After thermal cycling, the size of the indications decreases. A typical post-thermal-cycle, P-side setdown is shown at progressively higher magnifications in Figures 10a-c. At low magnification (Figure 10a), the indications appear as bright spots amongst the dull, non-welded Ag and thermally fatigued fracture regions. In Figure 10b, the distinction between regions is much clearer. At a much higher magnification (Figure 10c), the sharp tear ridges and well-defined dimples are readily visible. Organic "crud" from the RTV adhesive typically collects in wide regions on the P side of cells (see Figure 11). This material often made site location more difficult, but not impossible.

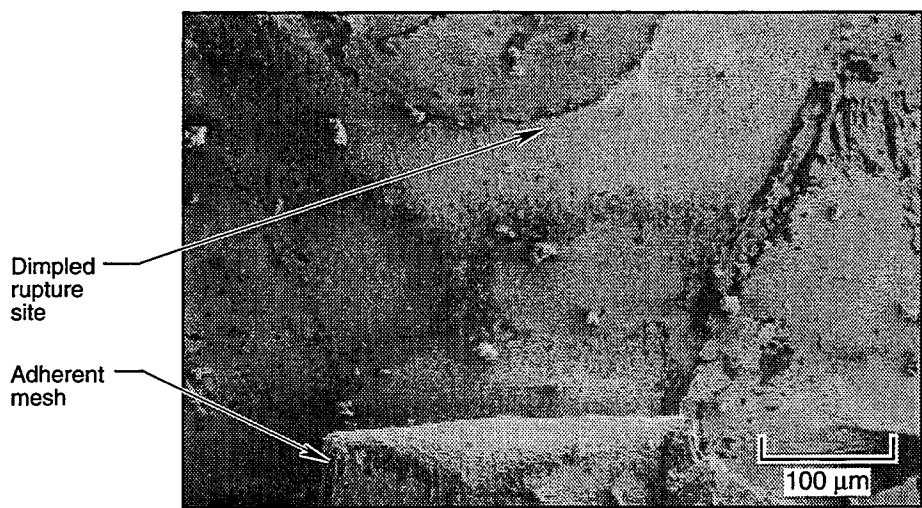
Figure 10. Micrographs exhibiting bright dimpled rupture regions at various magnifications for typical P-side welds.

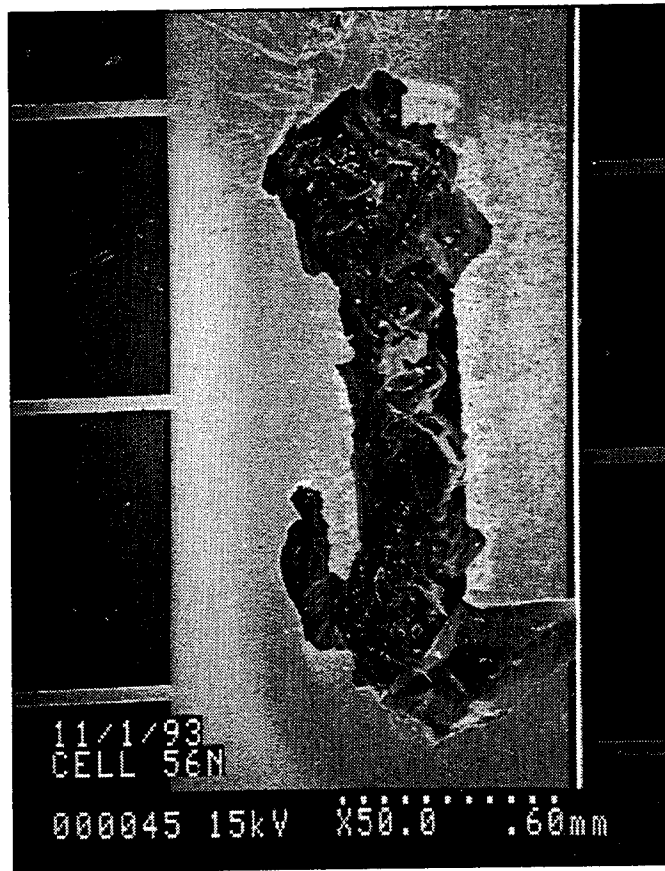
Figure 17. Typical fracture surface of modified N-side weld with Si divot.
