An Enhancement to the NA4 Gear Vibration Diagnostic Parameter

Harry J. Decker and Robert F. Handschuh
Vehicle Propulsion Directorate
U.S. Army Research Laboratory
Lewis Research Center
Cleveland, Ohio

Prepared for the
18th Annual Meeting
sponsored by the Vibration Institute
Hershey, Pennsylvania, June 20-23, 1994

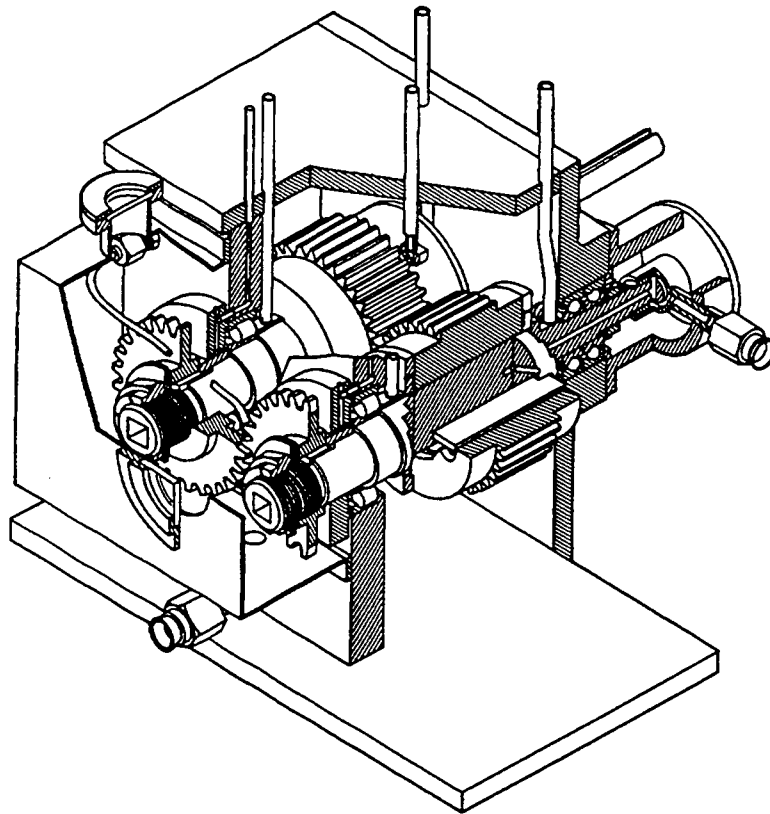
Figure 1.—Spur Gear Fatigue Rig.

The three parameters were tested using data obtained from gear fatigue test rigs at the NASA Lewis Research Center (figures 1 and 2). The purpose of these rigs is to study the effects of gear tooth design, gear materials and lubrication on the fatigue lives of aircraft quality gears. Vibration data from accelerometers mounted on each rig was captured with a personal computer using an analog to digital conversion board and an anti-aliasing filter. Both rigs use the closed loop torque regeneration principle. After the rigs are at operating conditions, the power system only has to supply enough power to overcome the losses in the system.

The spur gear test rig uses a pair of spur gears having 28 teeth, a pitch diameter of 88.9 mm

(3.50 in), and a face width of 6.35 mm (0.25 in). The gear faces are offset by 2.79 mm (0.11 in) to allow a higher surface stress without a corresponding increase in the bending stress. This, coupled with the ability to run on both sides of the profile, allows up to four fatigue failures per pair of gears. The pair transmits 143 kW (192 hp) as the gears rotate at 10,000 revolutions per minute.

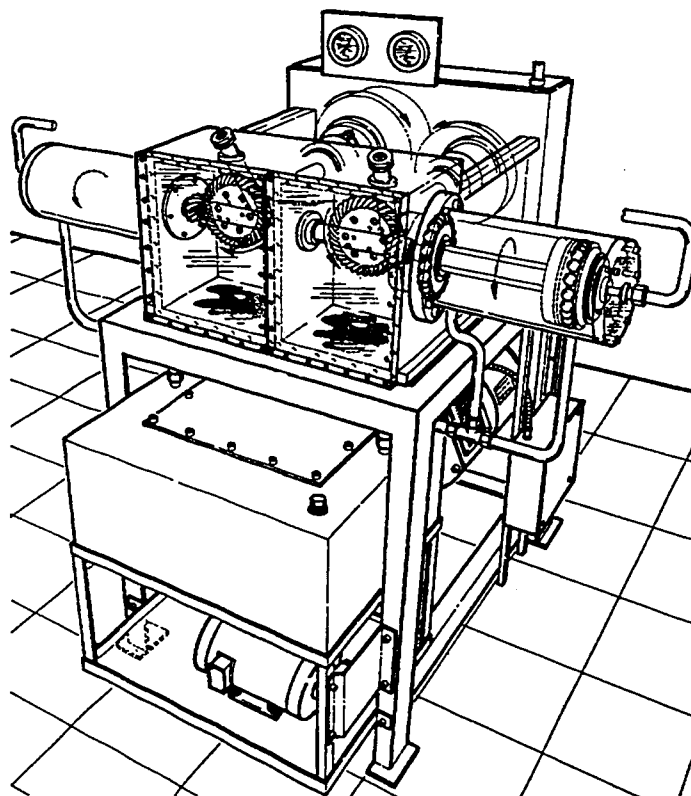
Figure 2.—Spiral Bevel Rig.

The spiral bevel gear test rig uses a 12 tooth test pinion and a 36 tooth gear both having a 35 degree spiral angle, a 25.4 mm (1 in) face width, 90 degree shaft angle, and a 22.5 degree pressure angle. The pair transmits 537 kW (720 hp) as the pinion rotates at 14,400 revolutions per minute.

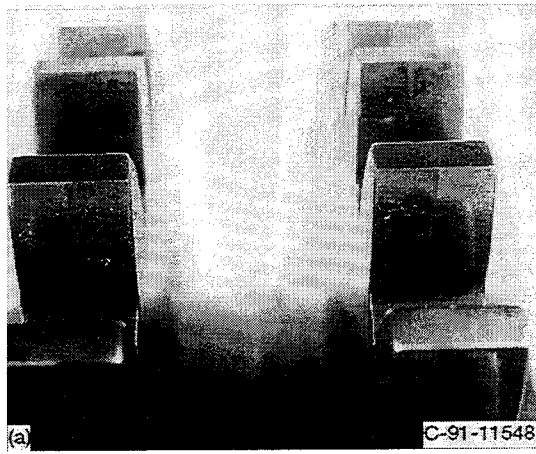
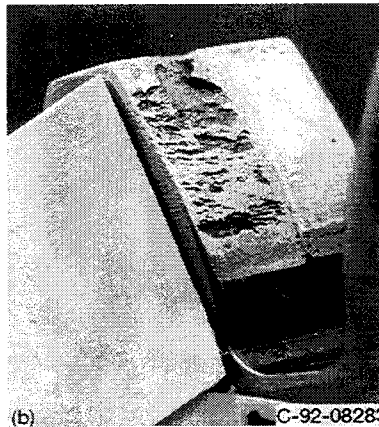
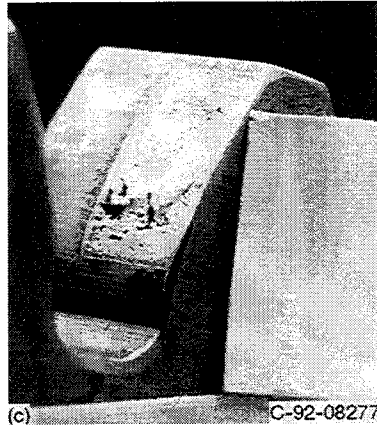
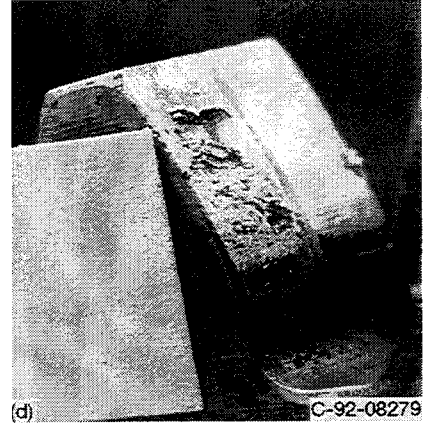
Figure 3.—(a) Heavy pitting on two teeth in Run 1 at 131 hr into run. (b) Example of spalling at end of Run 1. (c) Example of Run 2 moderate pitting. (d) Example of Run 3 heavy pitting.

At 131 hours into run 1, damage was found on two teeth on the driver gear (one heavy and one moderate pitting). Both mating teeth on the driven gear were also found to be damaged (both heavy pitting). Figure 3a illustrates the heavy pitting damage on the driver and driven gears at 131 hours. Figure 3b illustrates the spalling and heavy pitting damage found on roughly one third of the teeth on both the driver and driven gears at the end of the run.

At the end of run 2, damage was found on four consecutive teeth on the driver gear (one heavy and two moderate pitting). Two of the three mating teeth on the driven gear were also

found to be damaged (both moderate pitting). This damage is shown in figure 3c.

Figure 3d shows the damage that was found at the end of run 3. After 74 hours, four consecutive teeth on the driver gear had damage. One was spalled, with two teeth having heavy and one tooth having moderate pitting. One of the four mating teeth on the driven gear was also found to be damaged (moderate pitting).

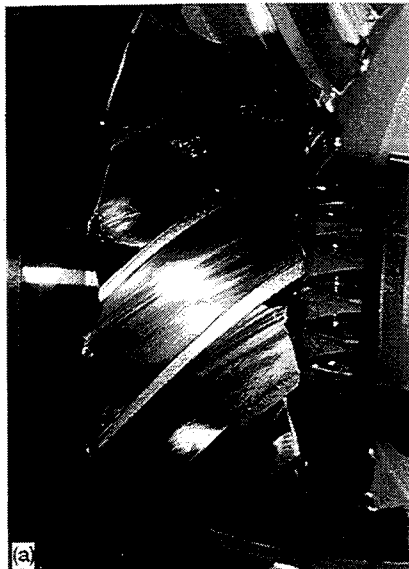
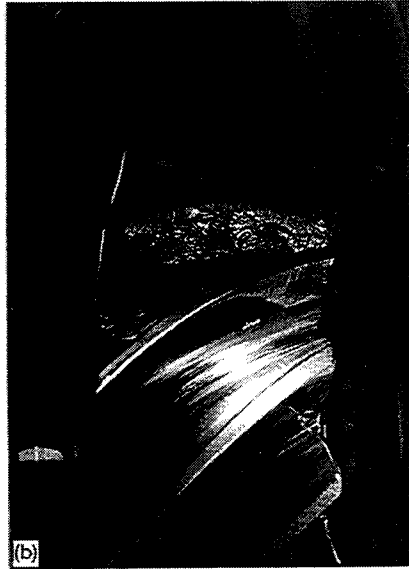
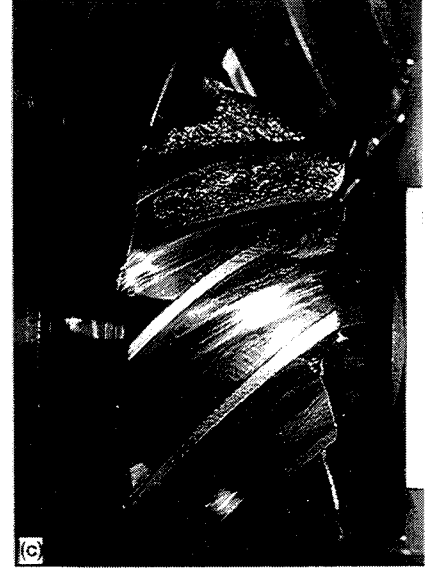
Figure 4.—Damage to Spiral Bevel pinion. (a) At 5.05 hr. (b) At 12.03 hr. (c) At end of run.

Data from one spiral bevel test were obtained. Pictures of tooth damage on the pinion at various stages in the test are illustrated in figures 4a, 4b, and 4c. The rig was shut down a total of eight times to observe and document the damage as it progressed during the run. Only the results of three of these shutdowns will be discussed. At the first shutdown, at about five and one half hours into the test, a small pit was observed on one of the teeth on the test pinion as illustrated in figure 4a. At approximately twelve hours into the run, pitting started to appear on adjacent teeth, as seen in figure 4b. The pitting on the adjacent teeth continued to grow until it covered a majority of the face of three adjacent teeth on the pinion, and part of the face of another adjacent tooth. The run was stopped when one of the three heavily pitted pinion teeth was found to have fractured, losing one-third of the tooth, as illustrated in figure 4c. The fracture occurred between 16.16 and 17.79 hours into the test.

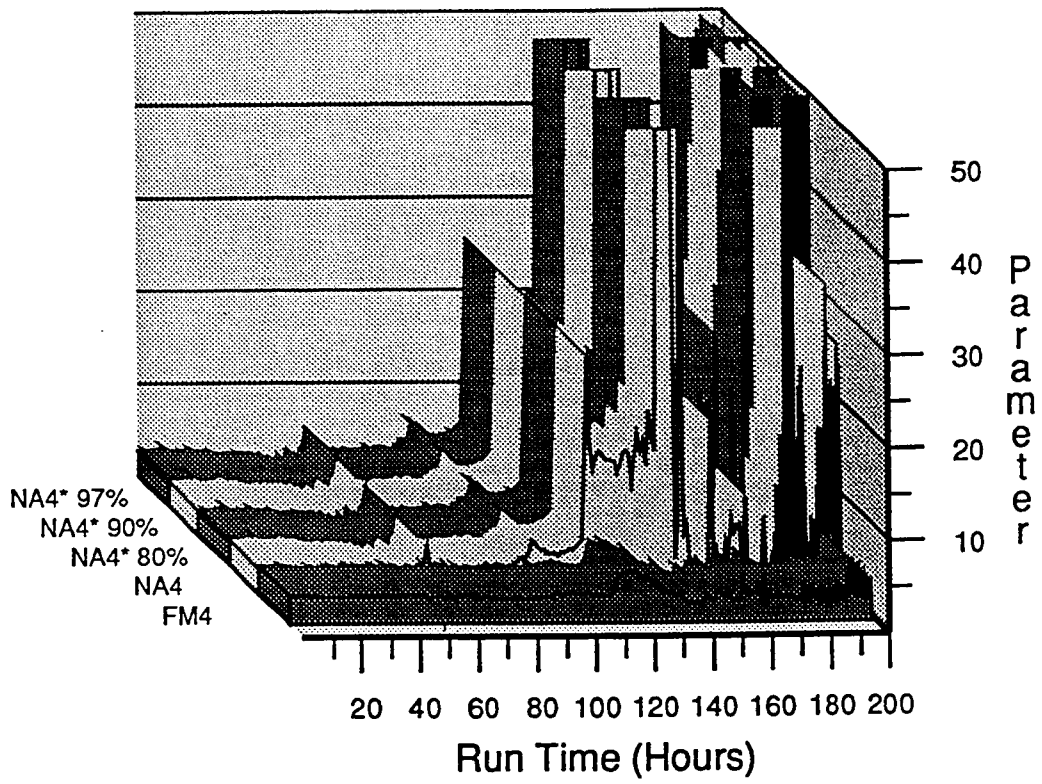
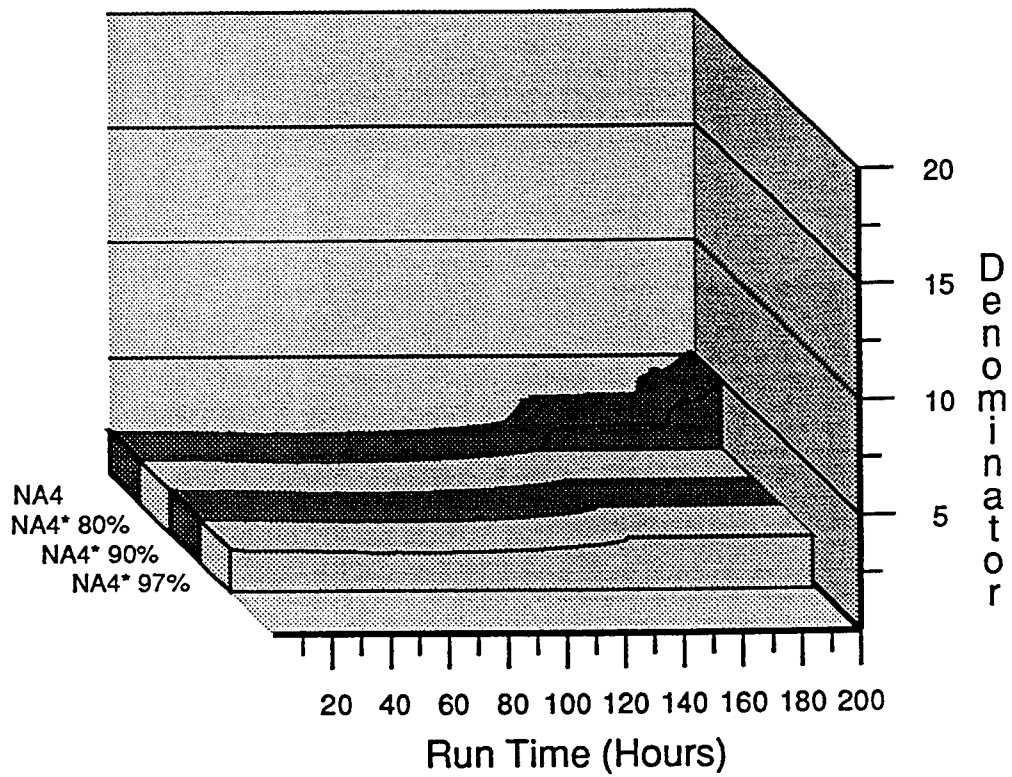
Figure 5.—Parameters for Spur Gear Run 1.

The comparisons between FM4, NA4 and a version of NA4* for test runs 1, 2, and 3 are shown in figures 5, 6, and 7, respectively. Due to limitations in the testing procedure, it is difficult and time consuming to correlate the actual condition of the gears with the vibration parameters that are calculated. Experience determines what an appropriate value for facility shutdown should be. At that time, if significant damage is present, the test is suspended, otherwise the test is restarted.

At 131 hours into test 1, the value of the NA4 parameter was very high, the rig was shut down, the gears removed, inspected and photographed. The gears were then re-installed and the test continued. From figure 5, it is assumed that a large amount of damage occurred around 112 hours into the test. NA4 and NA4* both react well to the damage by increasing to a value of 25 and only reducing to a value of 15 as localized damage progressed. FM4, however, peaked to a value of 5.4, then produced a Type I error when it dropped to its nominal value around 3. It is interesting to note that the NA4* parameter does not come

back down to the NA4 level and that the shapes of the curves are nearly identical. This implies that the irregularities of the curve is a function of just the numerator and not both the numerator and denominator. The drastic irregularities that occur after 170 hours are unique to this test and have not been observed in any other test.

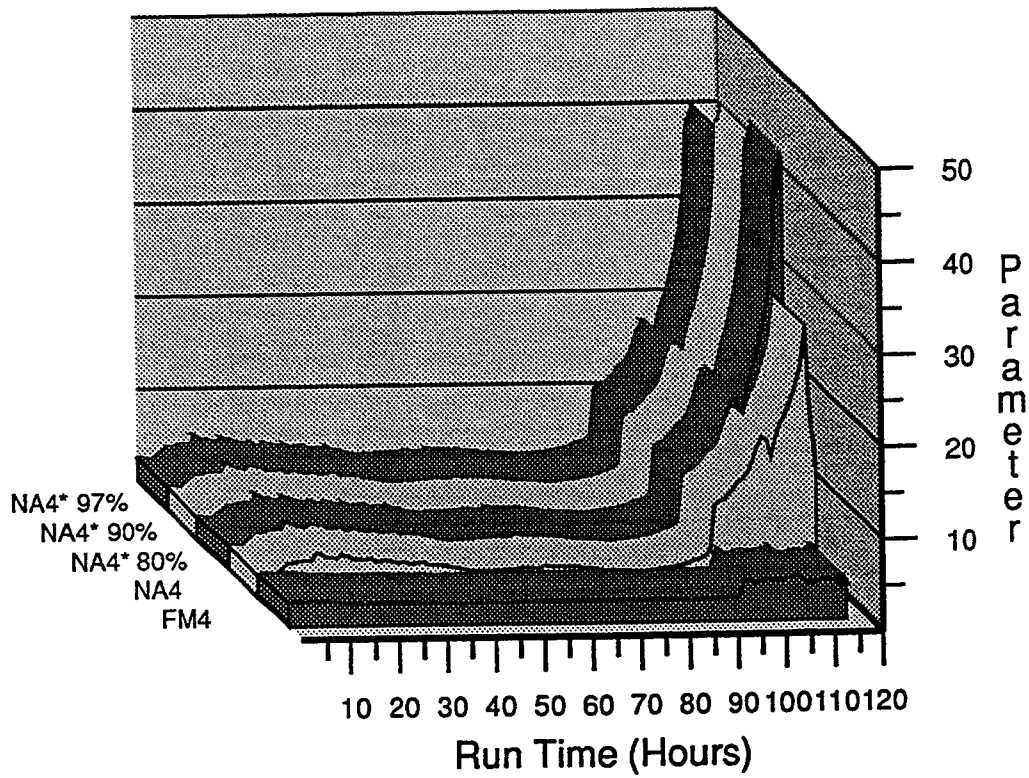
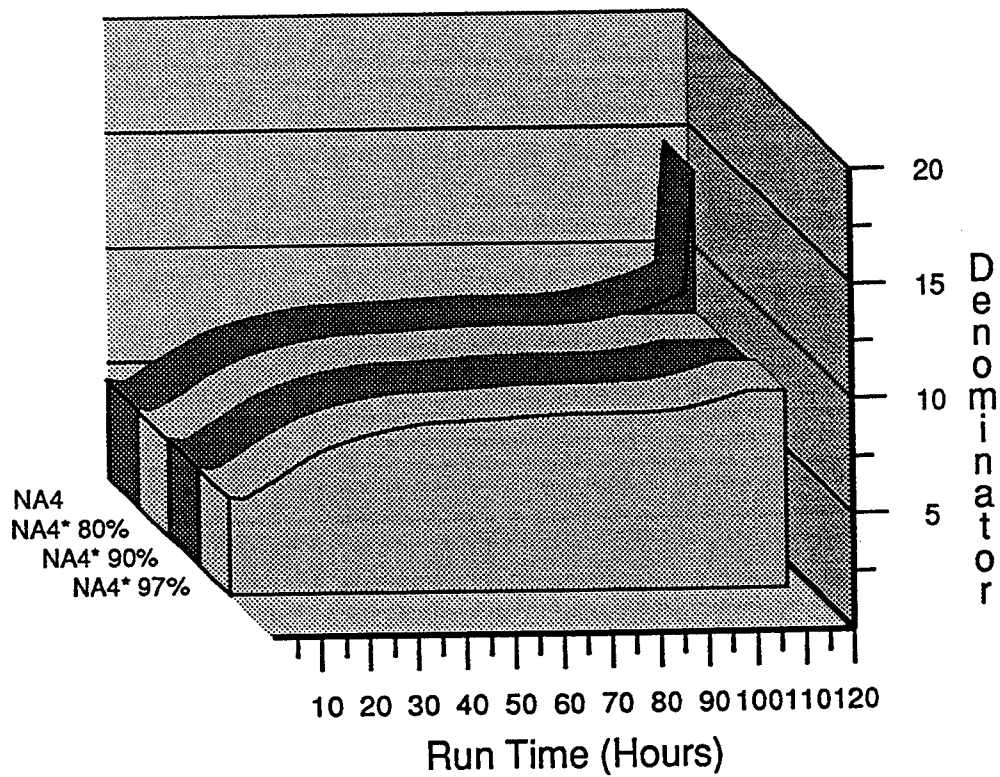
Figure 6.—Parameters for Spur Gear Run 2.

The results from run 2 (figure 6) give the best example of the desired effect of using NA4* versus NA4. The most striking attributes of the curves are the difference in magnitudes and that the NA4* parameter did not give a Type I error. Again, notice that the overall shape of the curve is primarily a function of the numerator. It is interesting to note that the NA4 and FM4 parameters react at the same point in time, although with different sensitivities.

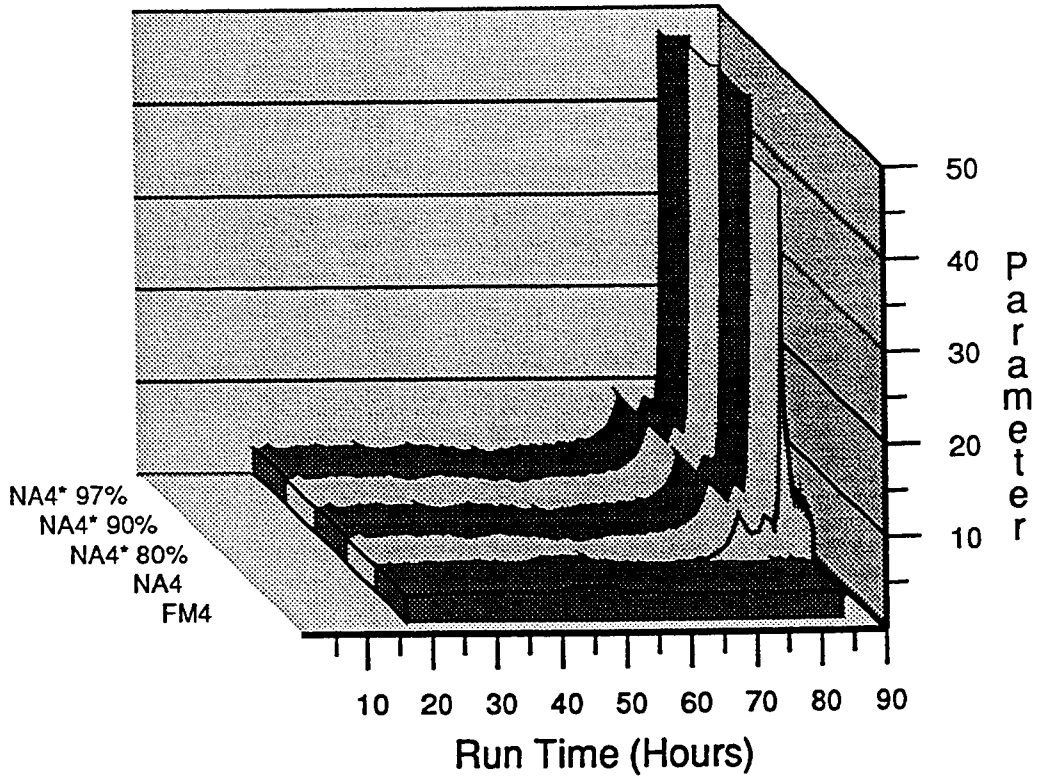
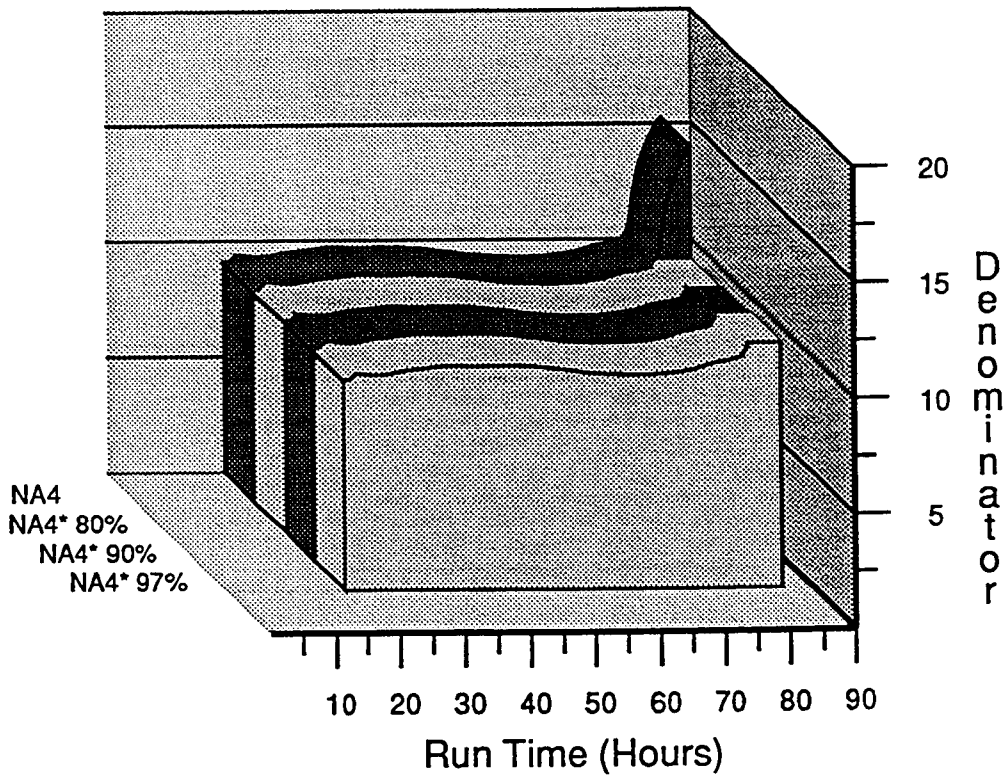
Figure 7.—Parameters for Spur Gear Run 3.

The results from run 3 (figure 7) show the same effect, although not as drastically. The important characteristic to note is that the NA4* parameter is most robust at indicating damage for both the initiation of damage as well as when damage progresses. On the other hand, the FM4 and NA4 parameters may return to levels indicating no damage when actually localized damage is progressing. As with the other runs, FM4 still shows the damage occurring, but it is more susceptible to misinterpretation than NA4 and NA4*.

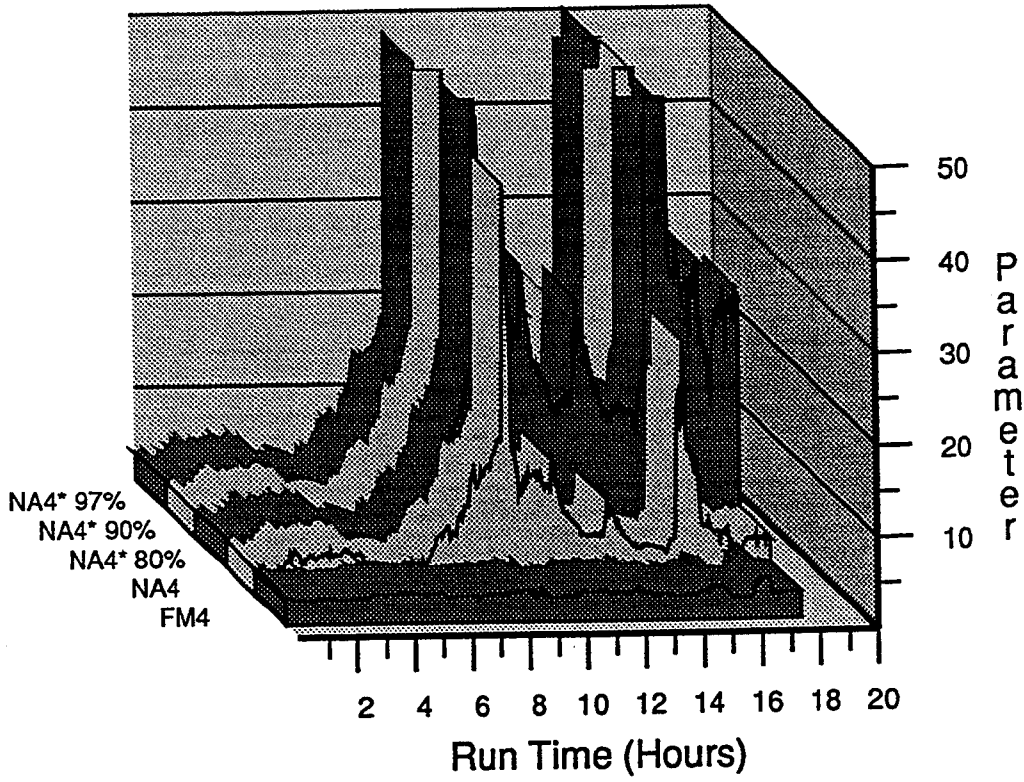
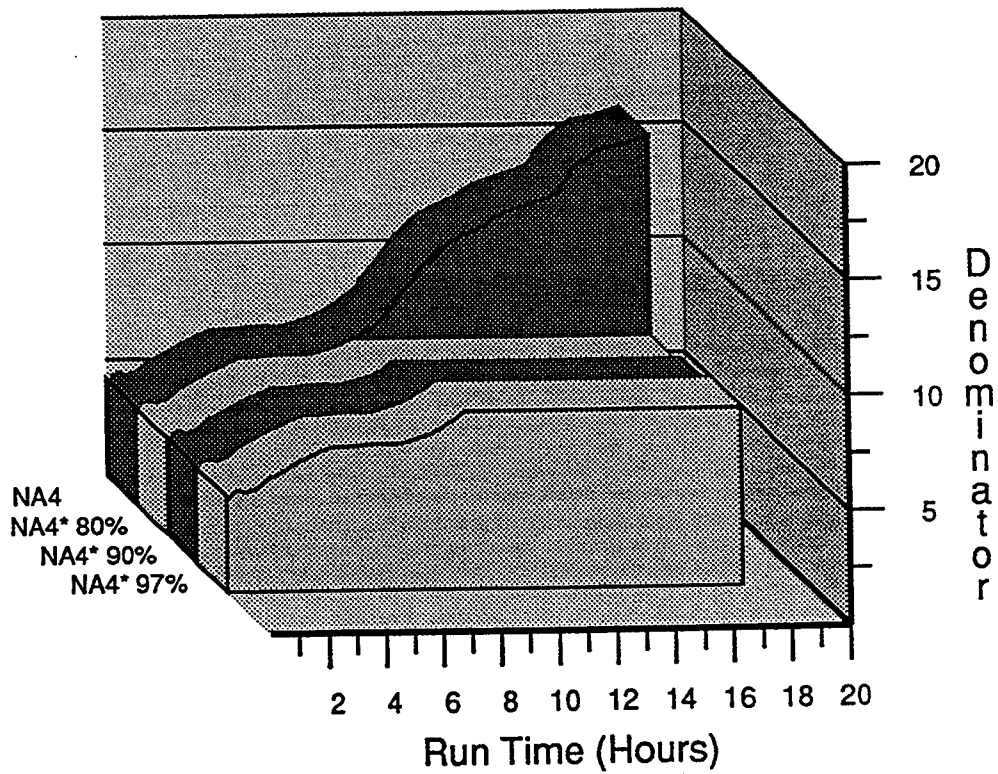
Figure 8.—Parameters for Spiral Bevel Run.

In the results of the spiral bevel test (figure 8), the FM4 parameter did not respond well, only hinting at some damage at about 16 hours. This was well after severe pitting and spalling was documented. For most of the run FM4 was producing a Type I error. The NA4 and NA4* curves give an early and robust indication that damage has occurred. In figure 8, the

effect of using different confidence intervals is best illustrated. In fact, it is suspected that damage started about 1.5 hours into the test when the NA4 and NA4* parameters have a value of near 5 for about 2 hours.

There were some differences in the versions of NA4* corresponding to the selected coefficients. Although a confidence coefficient of 80% is suggested, more experience is needed to determine which produces the best result.
