# INTERFACIAL STUDIES OF COATED FIBER REINFORCED GLASS- CERAMIC MATRIX COMPOSITES

FINAL REPORT

Contract F49620-92-C-0001

UNITED  
TECHNOLOGIES  
RESEARCH  
CENTER

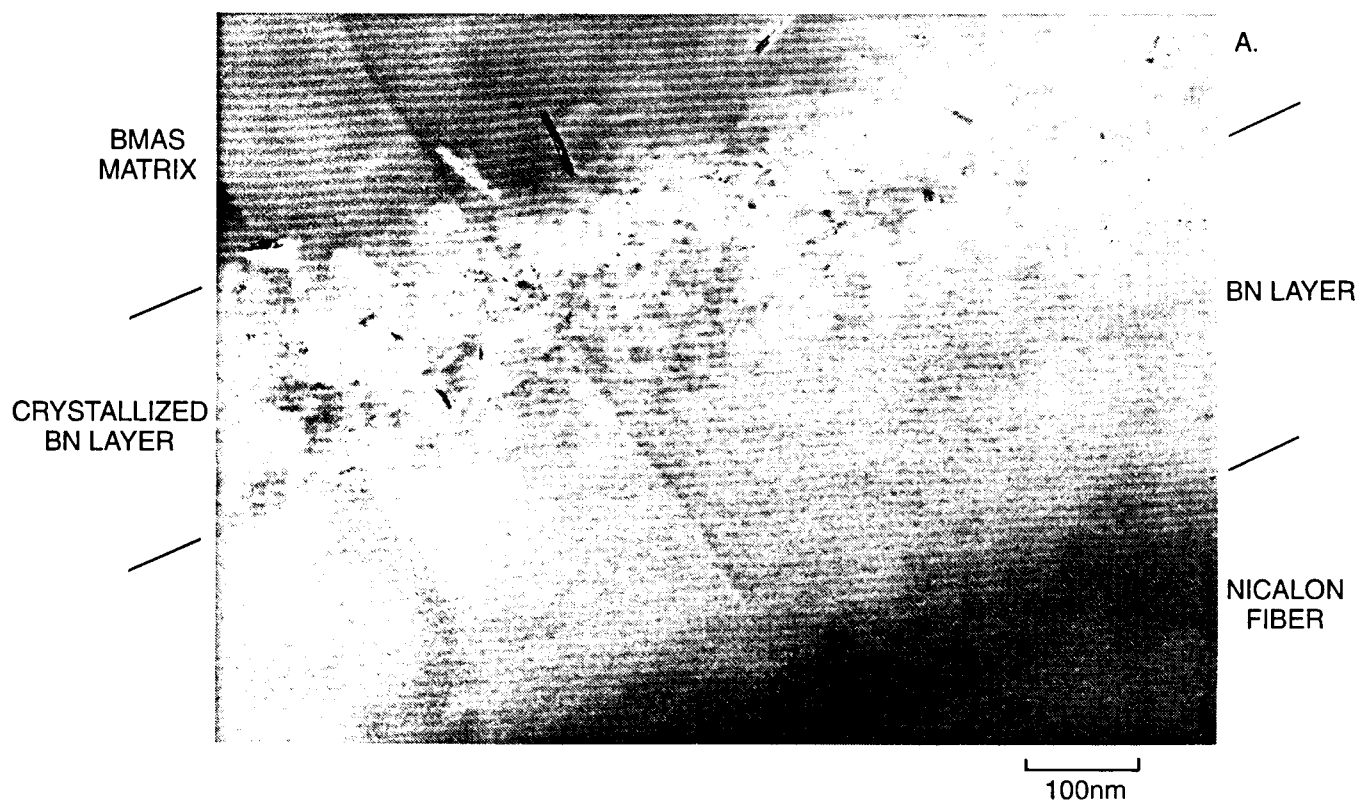
**Figure 18 TEM Thin Foil Analysis of Interfacial Region in BMAS Matrix/ $\text{Si}_3\text{N}_4$ /BN Coated Nicalon Fiber Composite #363-92 (As-Pressed)**

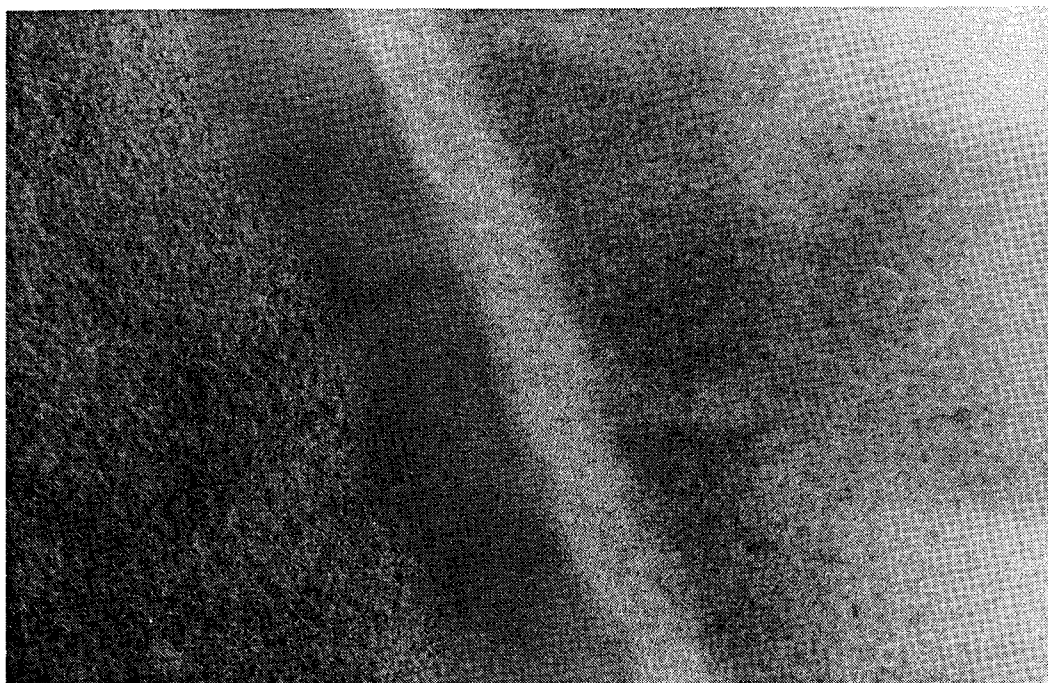
**Figure 23 TEM Thin Foil Analysis of Interfacial Region in BMAS Matrix/BN Coated Nicalon Fiber Composite #253-93 (Ceramed)**
