Environmental Effects of Dredging Technical Notes

EQUIPMENT MOBILITY IN CONFINED DREDGED MATERIAL DISPOSAL AREAS; FIELD EVALUATIONS

PURPOSE: This technical note describes recently completed equipment evaluations and presents data on mobility of this equipment in confined dredged material containment areas. The equipment evaluation included newly developed four- and six-wheeled low-ground-pressure vehicles. This equipment is typically used to tow a rotary ditching device to create surface trenches to enhance drainage and dewatering of confined dredged material disposal sites.

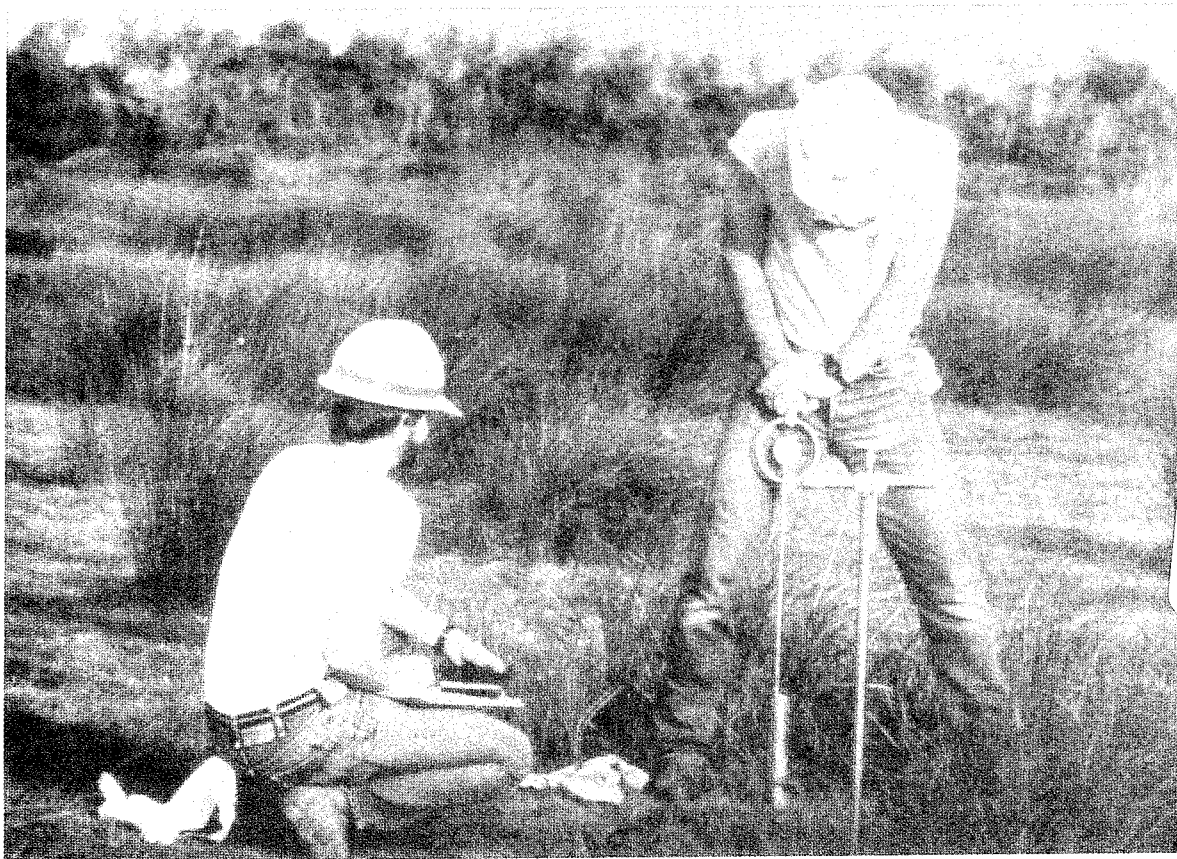
Figure 1. Field soil testing for vehicle mobility determination using the cone penetrometer

During field evaluations, data on the equipment, the equipment operation and performance, and the soils were collected. Pertinent data on the equipment included weight, horsepower, number of tires, and vehicle ground contact pressure. Operation and performance data included speed of movement across the disposal site, linear feet of ditching accomplished per hour, and size of the trench formed (which indicates rate of production in quantity of material removed per hour). Soils data collected included soil strength as recorded by the hand-held cone penetrometer, shown in operation in Figure 1. Results of the field evaluations are discussed in following sections.

To evaluate the potential for equipment mobility in a dredged material disposal site, field data on soil strength must be collected. These data included the cone index (CI) and remolding index (RI), from which the rating

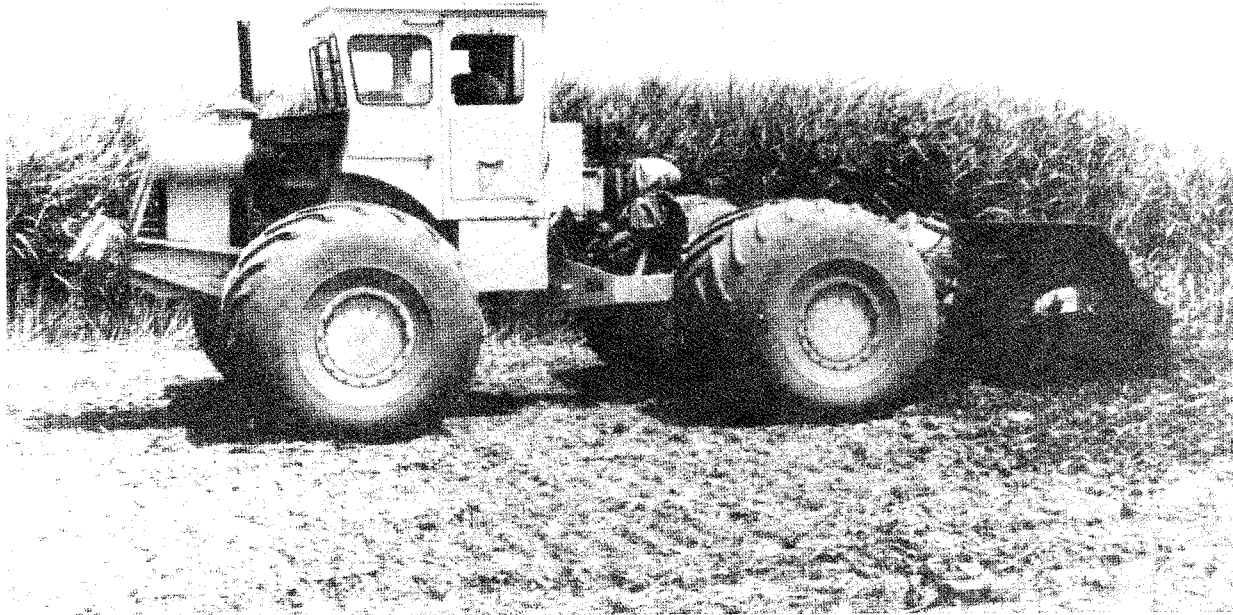
Figure 7. GEMCO vehicle with Dondi ditcher being lowered into position for trenching

The Artificial Island disposal area was the location of field equipment evaluations on June 15-17, 1987. The disposal site, located approximately 60 miles southwest of Philadelphia, is compartmentalized into three separate cells by interior dikes. Figure 6 is a map of the Artificial Island site. Each cell has one weir for water drainage. The dredged material in Artificial Island is predominantly sandy clay. No specific information was available on the thickness of the dredged material deposit in this site. All three cells were covered with a thick growth of *Phragmites* which had to be removed by bulldozing before trenching could begin to prevent entanglement of the vegetation in the rotary ditching device (Figure 7).

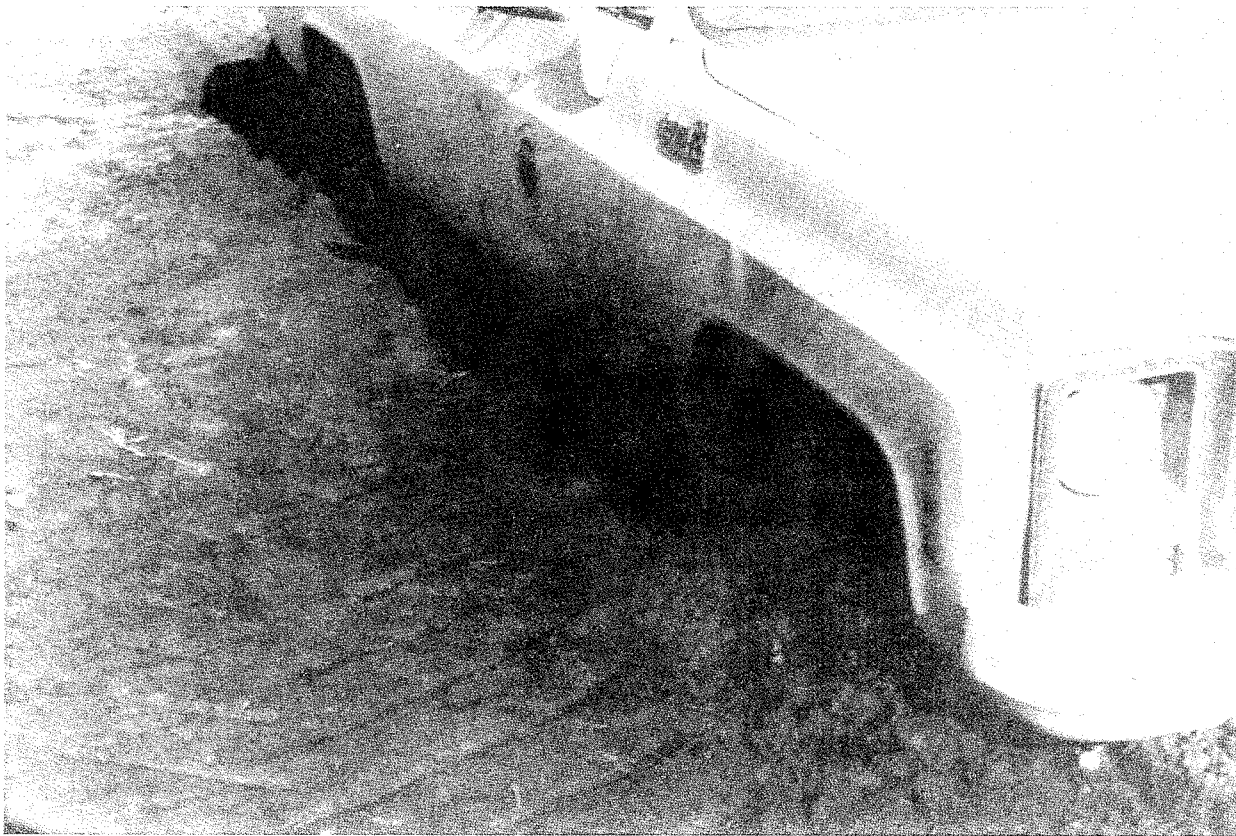
Figure 10. Corps of Engineers 4x4 vehicle immobilized where GEMCO pulling ditcher had no problem; note GEMCO trademarks beside vehicle

through the hardened crust and the soft material below cakes between the tire treads causing a loss of traction.
