# Metallurgical Examination of M61A1 Breech Bolt Assembly Components

ARL-TR-684

The Naval Air Warfare Center (NAWC) requested the Army Research Laboratory (ARL) to perform a metallurgical investigation on 20mm M61A1 Gatling gun system breech bolt assembly components. An unused breech bolt assembly, and an individual locking block (a component of the breech bolt assembly) were both examined. Each part was taken from inventory at NAWCAD, Patuxent River. The Navy had experienced numerous failures of this system in practice gun mount testing and in service. Failures have coincided with the use of a recently developed more potent replacement for the 20mm M50 Series ammunition. This new ammunition is designated as 20mm PGU Series ammunition. The investigation performed by ARL concentrated on determining the conformance of each component to the governing specifications. The examination included high-voltage testing, visual examination, surface finish measurement, dimensional analysis, magnetic particle inspection, metallography, mechanical testing, chemical analysis, and coating measurements. Findings included a nonconforming surface finish upon the individual locking block, a complete

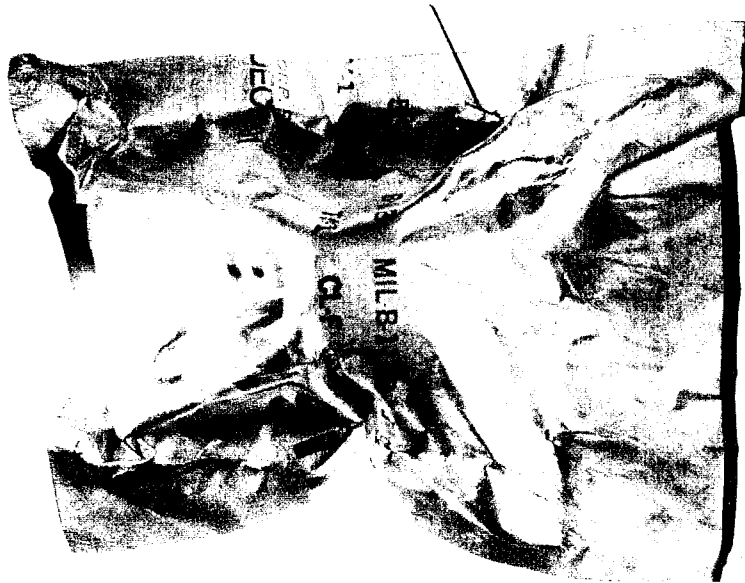
FIGURE 1 Breech bolt assembly in the as-received condition. Note puncture in protective packing, exposing part to environment. Reduced 20%.

The breech bolt assembly was received in the packing shown in Figure 1. Although the packing was punctured (see figure), visual inspection of the well lubricated component showed no sign of corrosion. Figures 2 through 4 show the top, side and end view of the breech bolt after being removed from its original package.

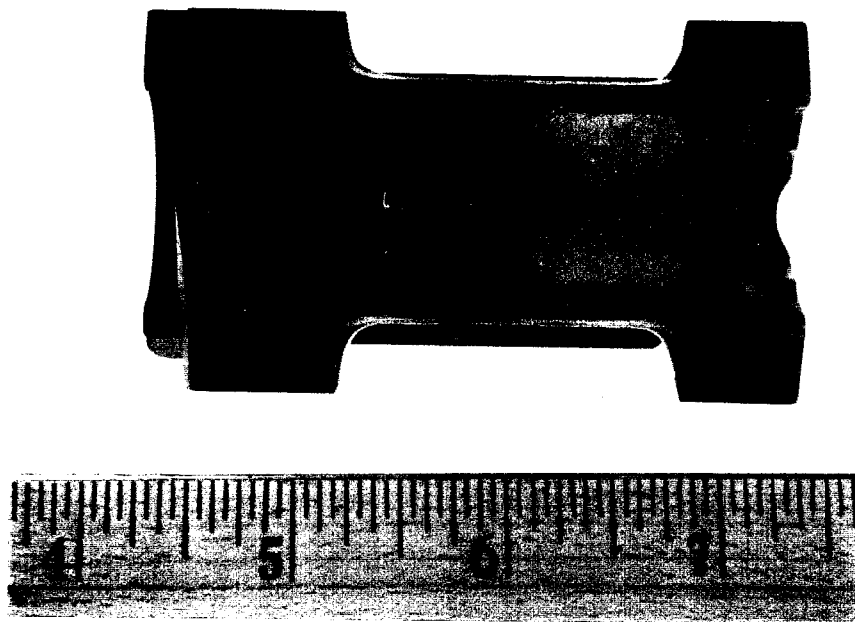
FIGURE 2 Top view of the as-received breech bolt assembly. Mag. 1x.

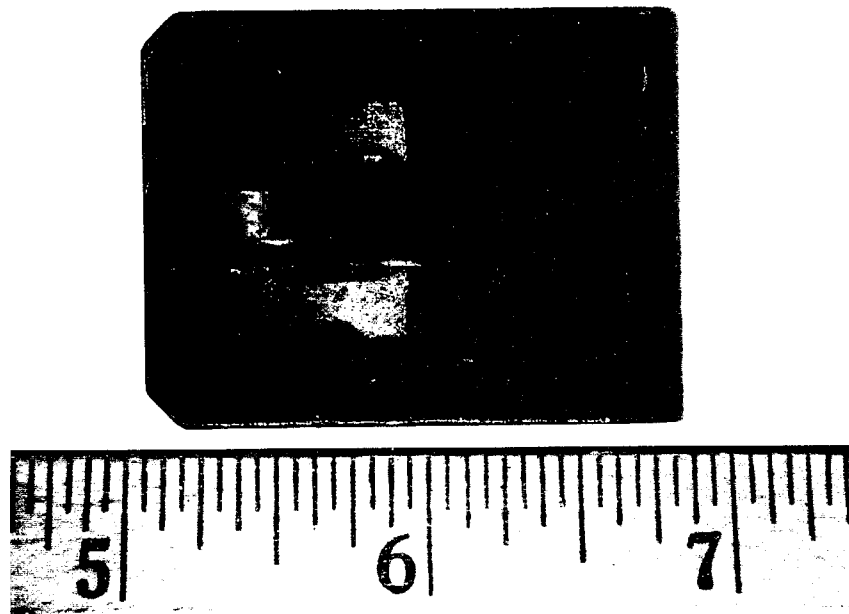
FIGURE 10 Top view of the individual locking block showing excessive machine marks. Surface finish was determined to be out of specification. Mag. 1.5x.

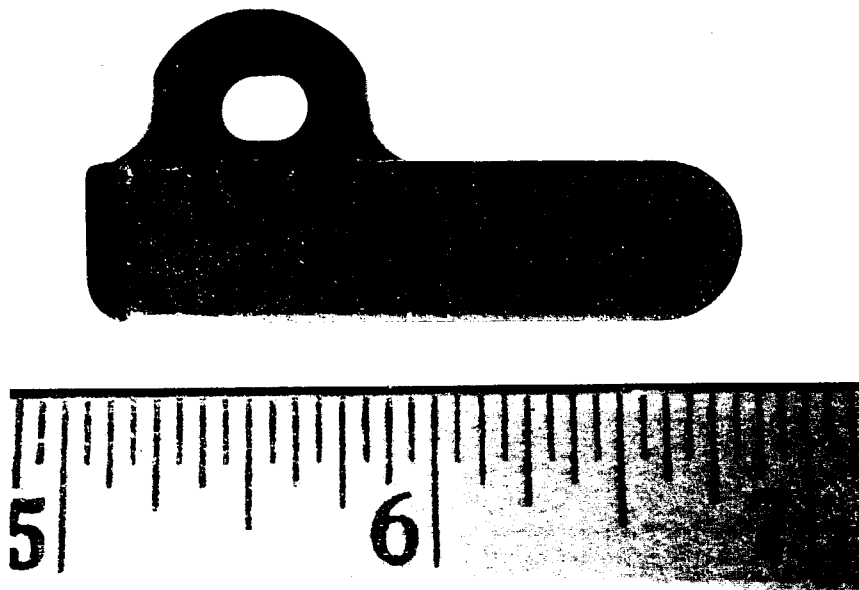
FIGURE 11 Side view of the individual locking block showing excessive machine marks. Surface finish was determined to be out of specification. Mag. 1.5x.

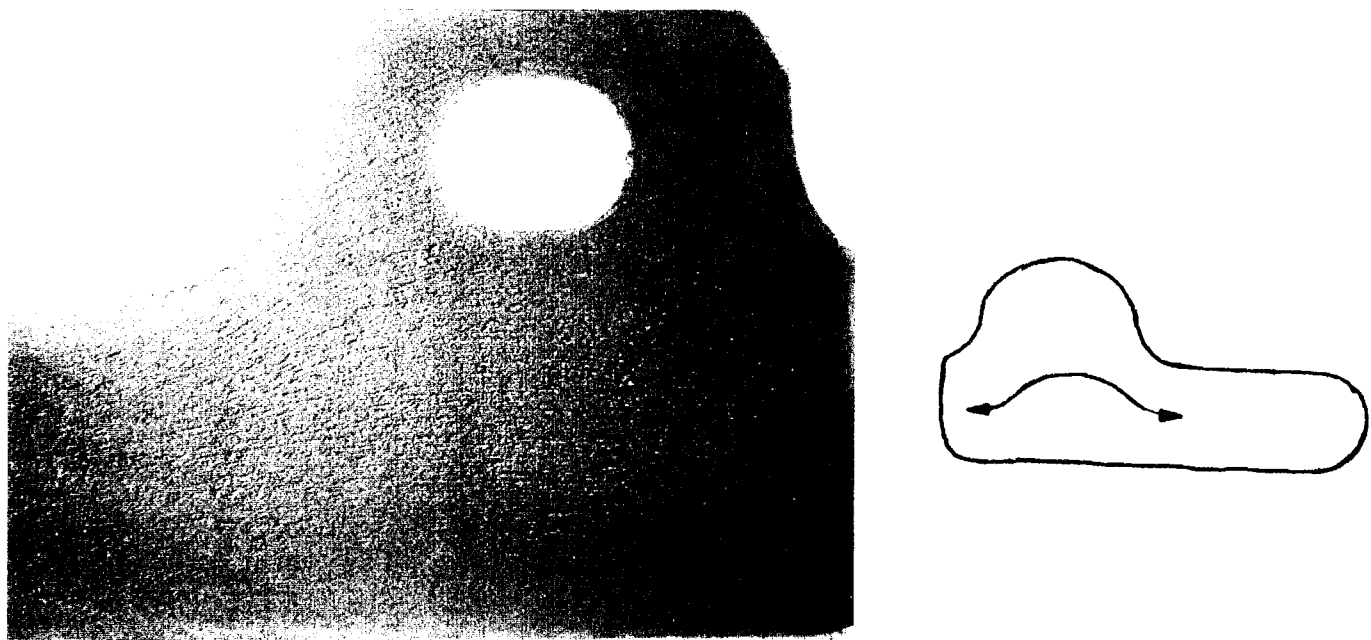
FIGURE 12 Etched (50% HCl and 50% distilled H<sub>2</sub>O, @ 180°F) section of the individual locking block showing grain flow in conformance to Eng. Dwg. 11691480. Mag. 4x.

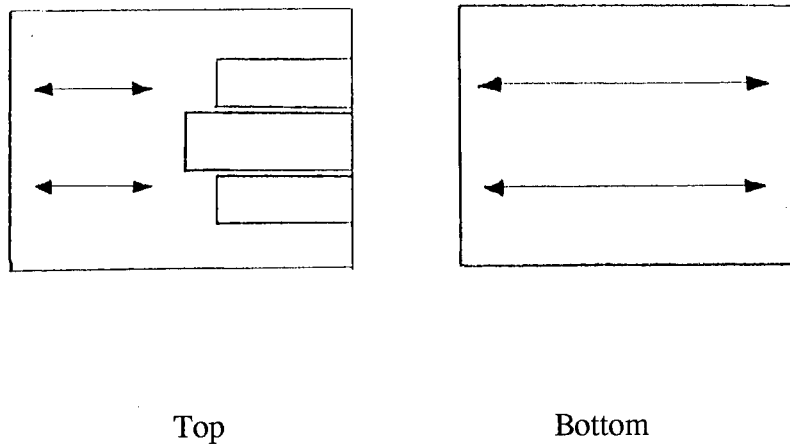
The surface roughness of the locking block was measured with the Mitutoyo Surftest 401 Analyzer. Readings were taken across the top and bottom of the part (see schematic in Figure 32). These were the regions of the component which exhibited machining marks, although not as severe as the machining marks noted on the locking block shipped separately (Figures 33 and 34). The required average surface roughness of the top and bottom of this component was 125  $\mu$ in RMS (Eng. Dwg. 11691480). The top surface registered an average of 58.4  $\mu$ in

FIGURE 32 A schematic showing directions of surface finish measurement on the locking block.

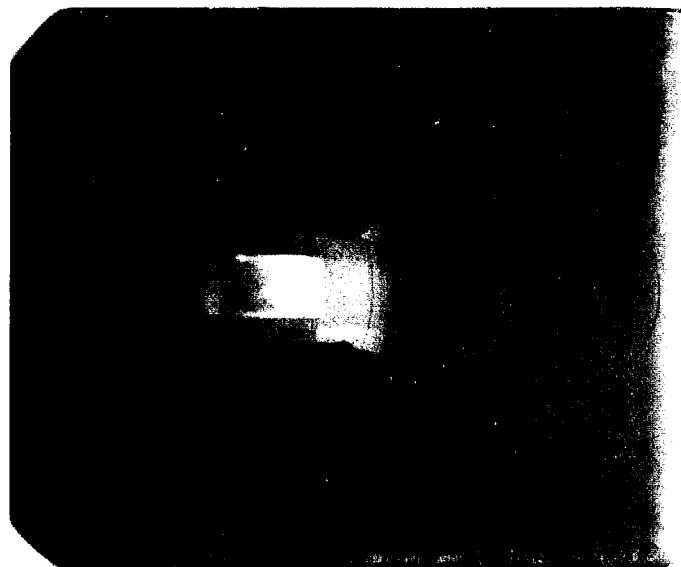
FIGURE 33 Top view of the assembly locking block showing machining marks. Surface finish was determined to be within specification. Mag. 1.5x.

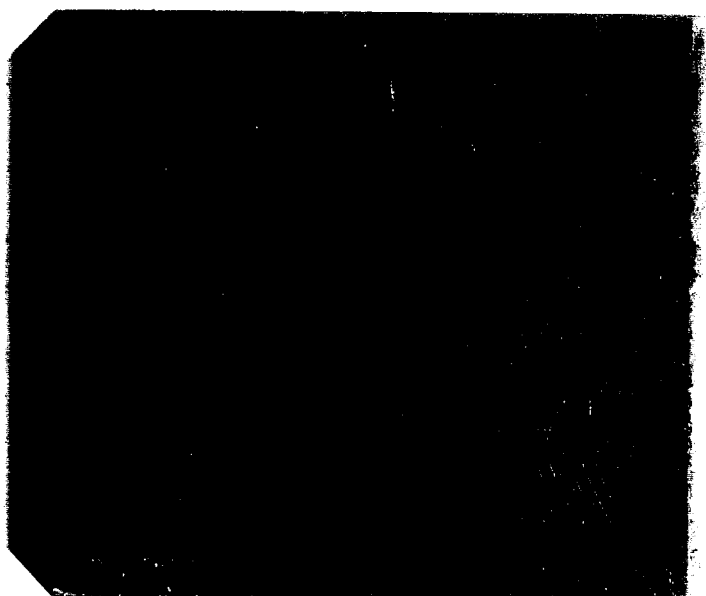
FIGURE 34 Bottom view of the assembly locking block showing machining marks. Surface finish was determined to be within specification. Mag. 1.5x.

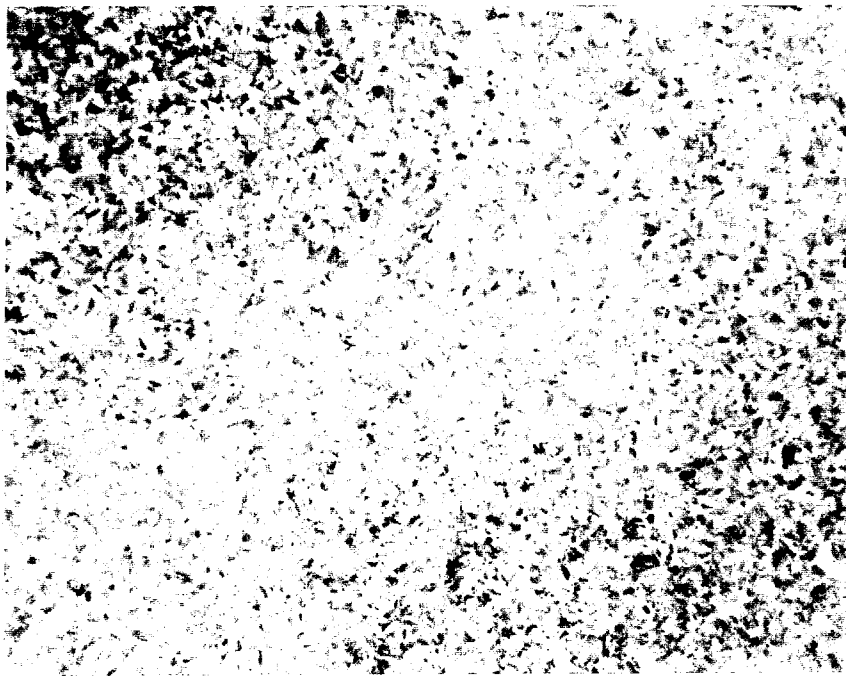
FIGURE 39 Spiral spring ("Top") microstructure consisting of a fine tempered martensite consistent with the required heat treatment. Fry's reagent. Mag. 500x

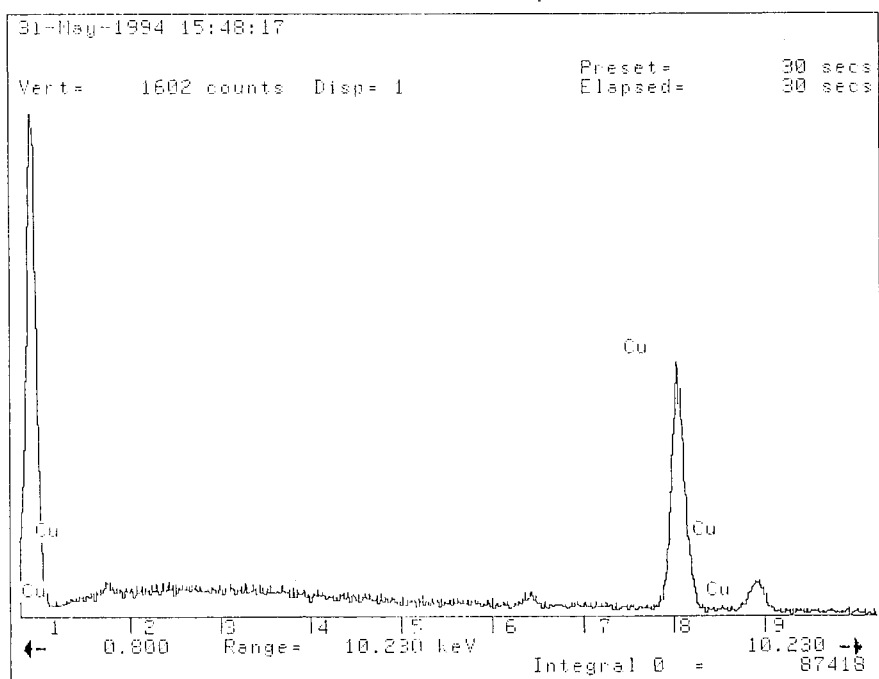
EDS of the coating on the "Top" spring, confirmed that copper plating was utilized. The iron peak represents the base metal, while the silicon and cobalt peaks represent elements found within the chemistry of the base material. EDS of the coating of the "Bottom" spring also confirmed the presence of copper plating, as shown in Figure 42.

FIGURE 42 Representative EDS spectrum of the plating on the spiral spring pins, verifying that copper was utilized, as represented by the copper peaks.
