DOT/FAA/CT-94/116

Vertical Drop Test of a Narrow-Body Fuselage Section with Overhead Stowage Bins and Auxiliary Fuel Tank on Board

April 1995

Final Report

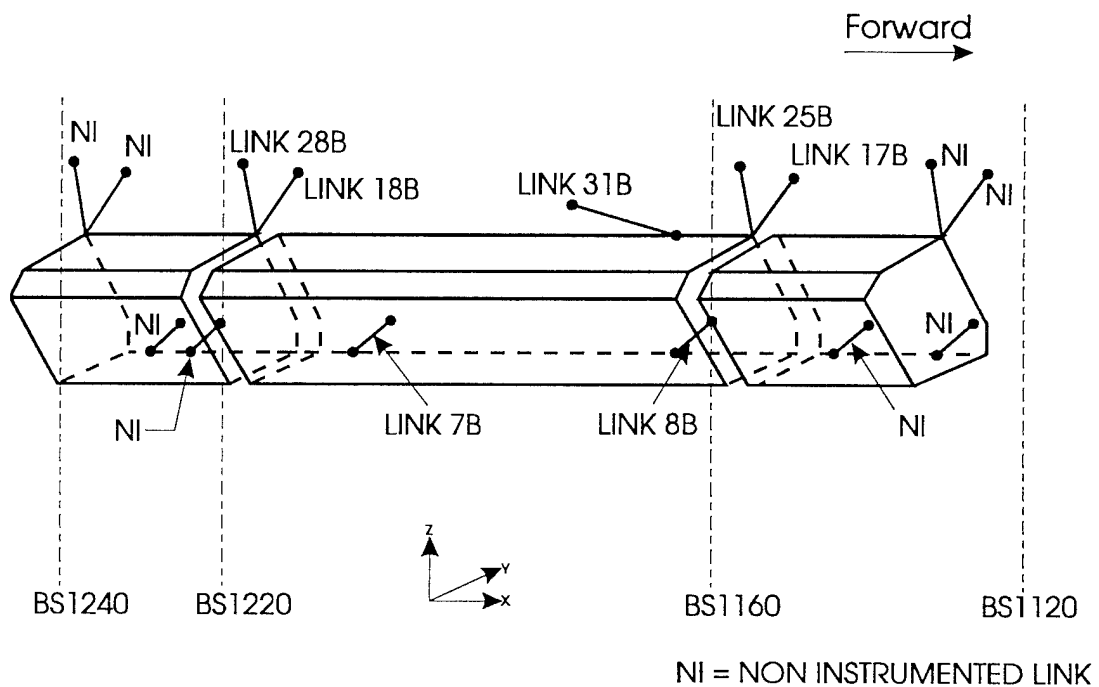
FIGURE 7. BOEING OVERHEAD STOWAGE BIN

The Boeing overhead stowage bin (figure 7) had strain gages bonded to its support links, as shown in figure 8. The C&D overhead stowage bin (figure 9) had strain gages attached to its upper brackets and lower fittings, as shown in figures 10 and 11, respectively. Figures 7 and 9 show the layout of the fixtures on the Boeing and C&D bins, respectively. There were 7 channels recorded in full-bridge configuration for the Boeing bin, and 12 channels were recorded for axial and bending loads for the C&D bin (refer to table 3).

NUMBERED LINKS ARE INSTRUMENTED WITH STRAIN GAGES

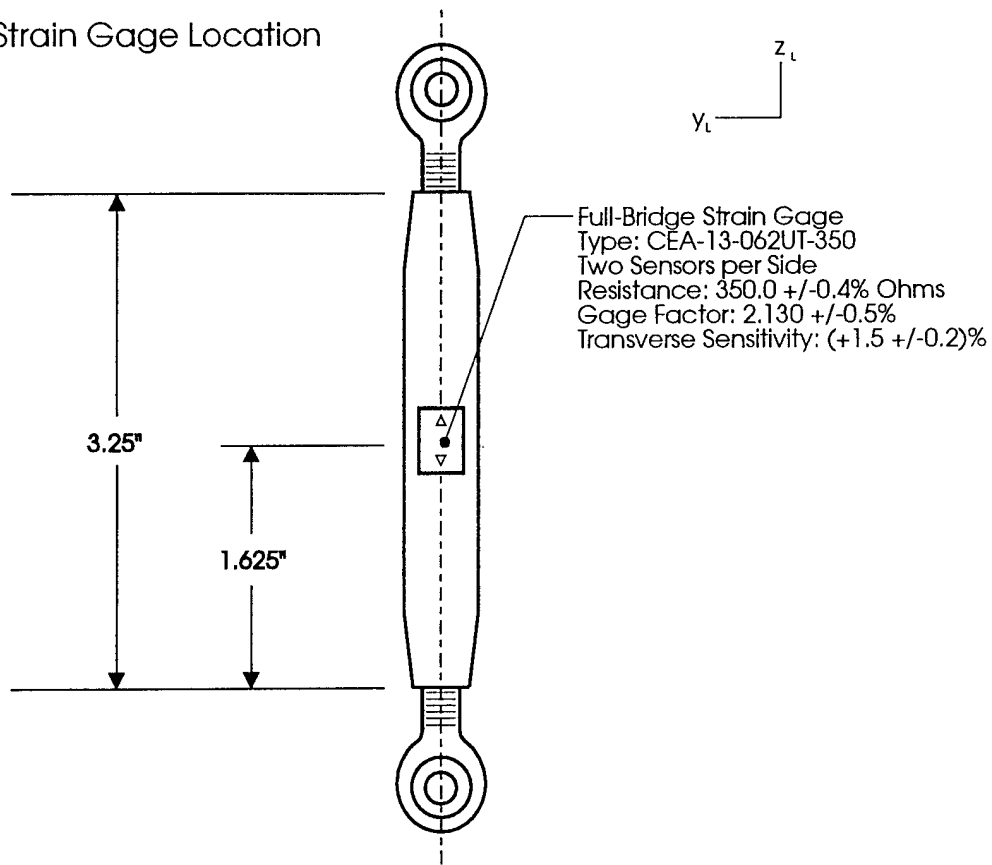
FIGURE 8. BOEING LINK: SENSOR LOCATION AND DIAGRAM

A. Strain Gage Location

B. Full-Bridge Diagram (Axial)

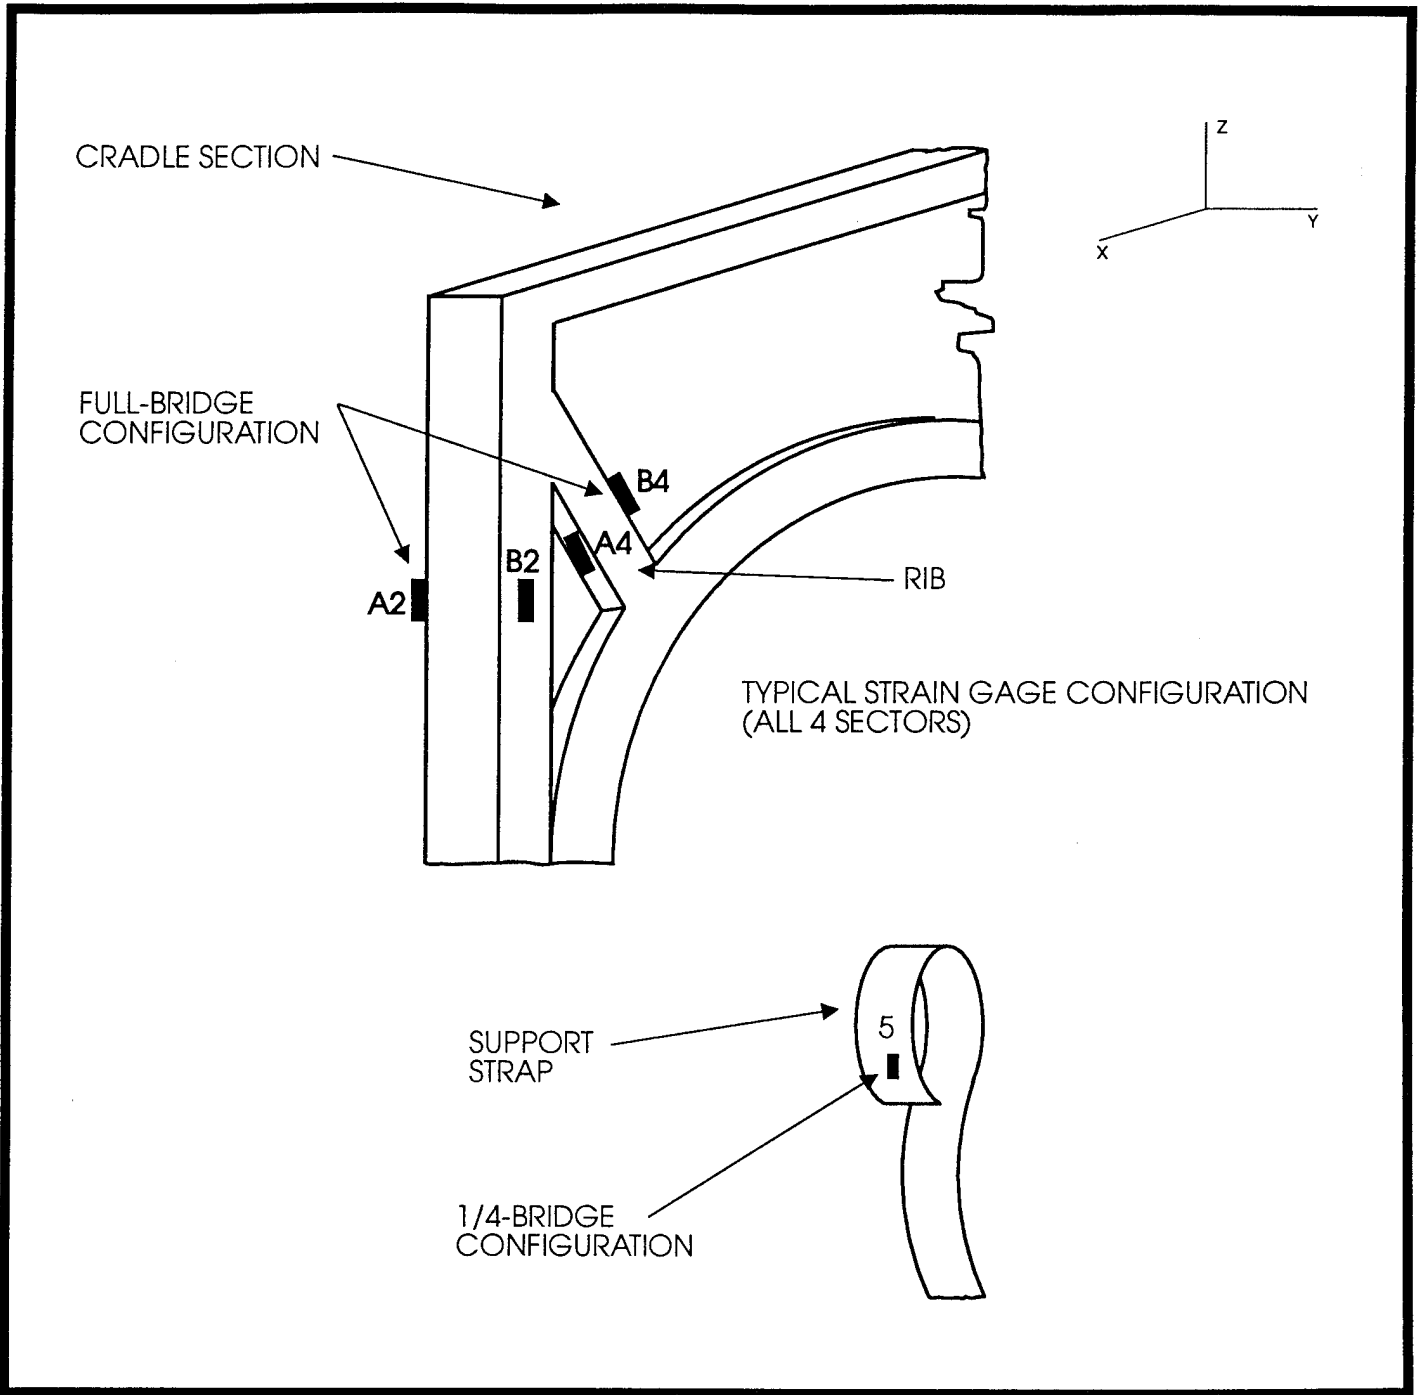
FIGURE 12. AUXILIARY FUEL TANK CRADLE: INSTRUMENTATION LOCATIONS

The auxiliary fuel tank's four upper cradle corners were strain gaged on the vertical and diagonal supports, along with the support strap, as shown in figure 12, for a total of 12 channels. All data were recorded on channels 101 to 112. Four accelerometers were attached to the cradle and recorded data in the Z-direction. Six accelerometers were attached to the tank, with four recording in the Z-direction and two in the X-direction.

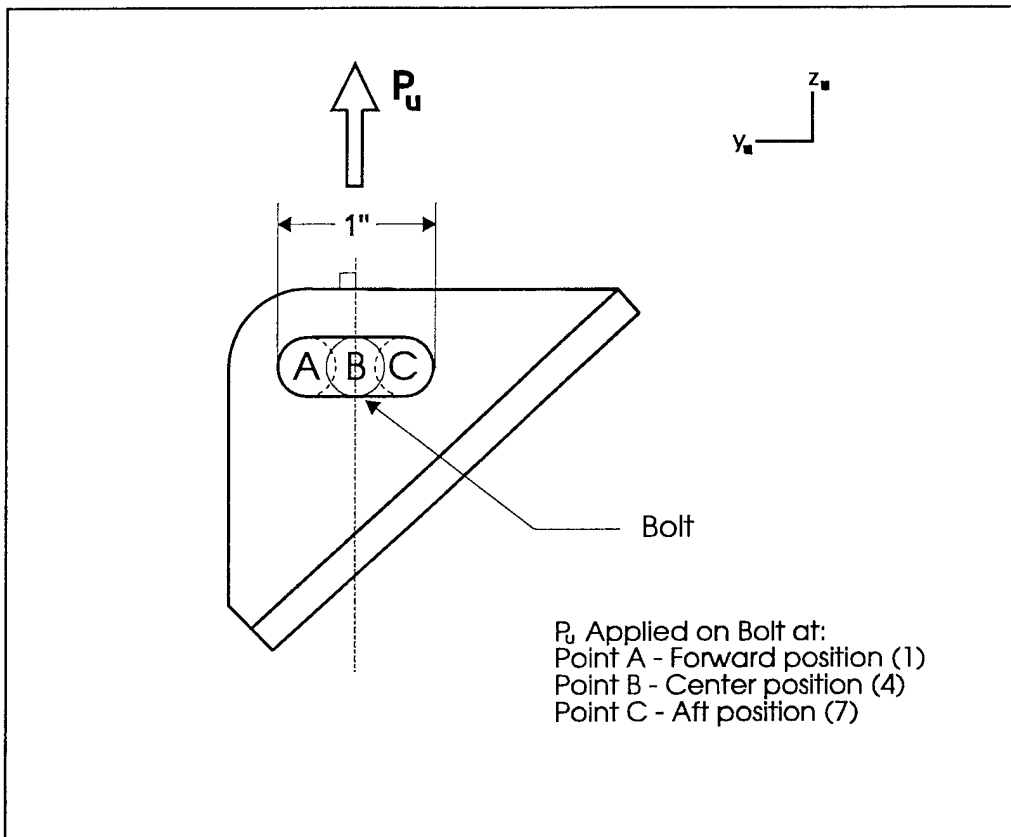
FIGURE 17 . BOLT LOCATION IDENTIFIERS (UPPER BRACKET)

Before the calibrations were done, the exact location of the bolt, in the one-inch slot of the upper bracket, was determined (figure 17). In addition, the installation angles were measured. These measurements were repeated after each weight increment.

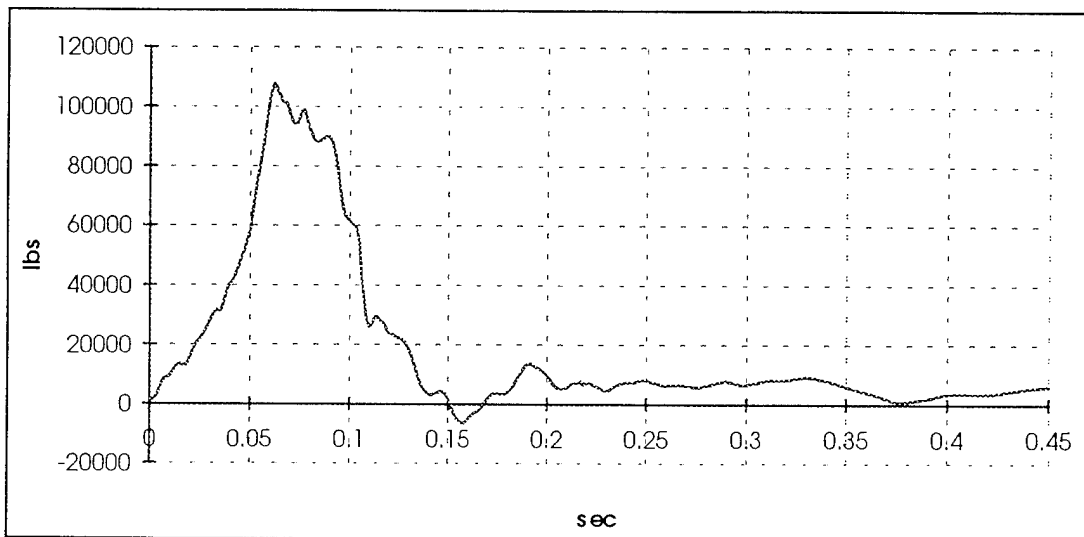
FIGURE 22. PLATFORM TOTAL LOAD

The platform was supported by 12 load cells to measure the impact load. One platform load cell located at the mid-aft left side exceeded the full-scale load limit (33,500 lbs) at 57 milliseconds after impact. One load cell located at the mid-forward right side failed. Comparing the measured loads based on locations and sides, which are symmetric, it is reasonable to assume that a load cell on the left side measured the equivalent load as one on the opposite side (right side) at a same longitudinal location, i.e., forward or aft. In this case, the maximum platform total load during the primary impact was approximately 107,000 lbs. The platform load data is presented in figure 22.

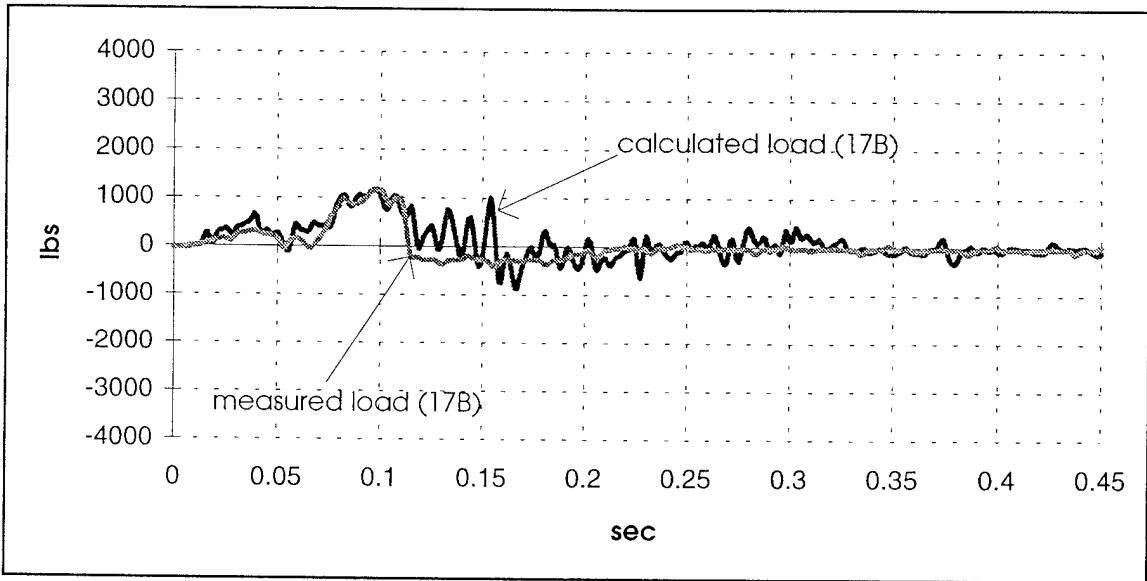
FIGURE 23: BOEING LINK 17B LOAD COMPARISON

The maximum measured loads on each link during the initial impact, the primary impact, and after the primary impact are shown in table 28. These loads were not the cause of the link fractures. Some links failed due to bending and shearing forces which occurred when the bins shifted fore and aft after the impact, due to fuselage section pitching, as evidenced from film analysis.
