# NAVAL POSTGRADUATE SCHOOL MONTEREY, CALIFORNIA

## THESIS

**SODIUM SULFATE HOT CORROSION OF SILICON  
CARBIDE FIBER-REINFORCED CALCIUM  
ALUMINOSILICATE**

**March 1995**

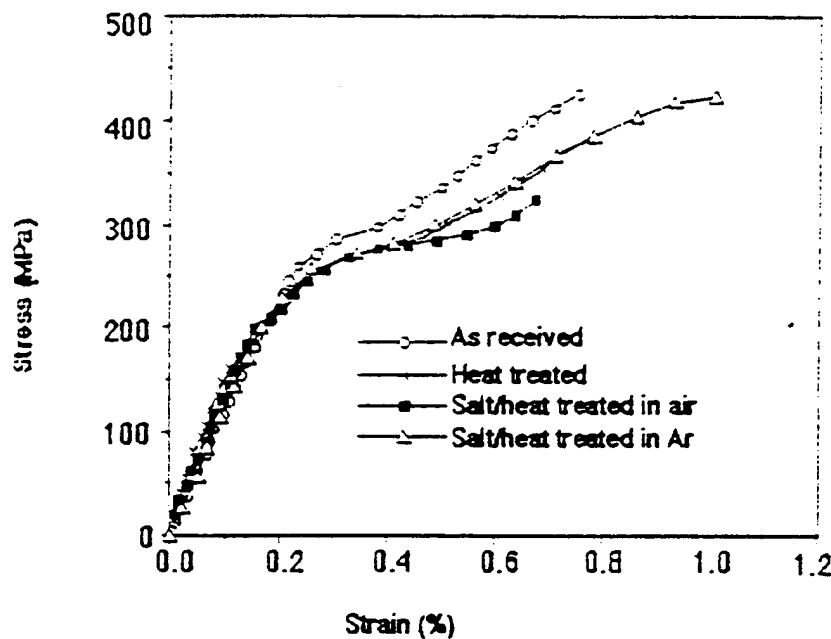
Figure 6. Stress Strain Curves of SiC/CAS Tensile Specimen Exposed to Various Environments [Ref. 17]

Material property degradation due to sodium sulfate corrosion of SiC/CAS CMC has been demonstrated by Wang, Kowalik, and Sands (see Figure 6). They found a reduction in tensile strength of about 25% in SiC/CAS when coated with Na<sub>2</sub>SO<sub>4</sub> salt and heat treated in air at 900°C while heat treatment in an argon atmosphere led to less than 10% reduction.

- We find good correlation between our results and the properties and proposed mechanisms reported by Wang, Kowalik and Sands [Ref. 1]. The degradation of material properties corresponds to the extent of corrosion. The sample exposed to the air environment experienced greater corrosion and showed the most degradation of material properties (see Figure 6).

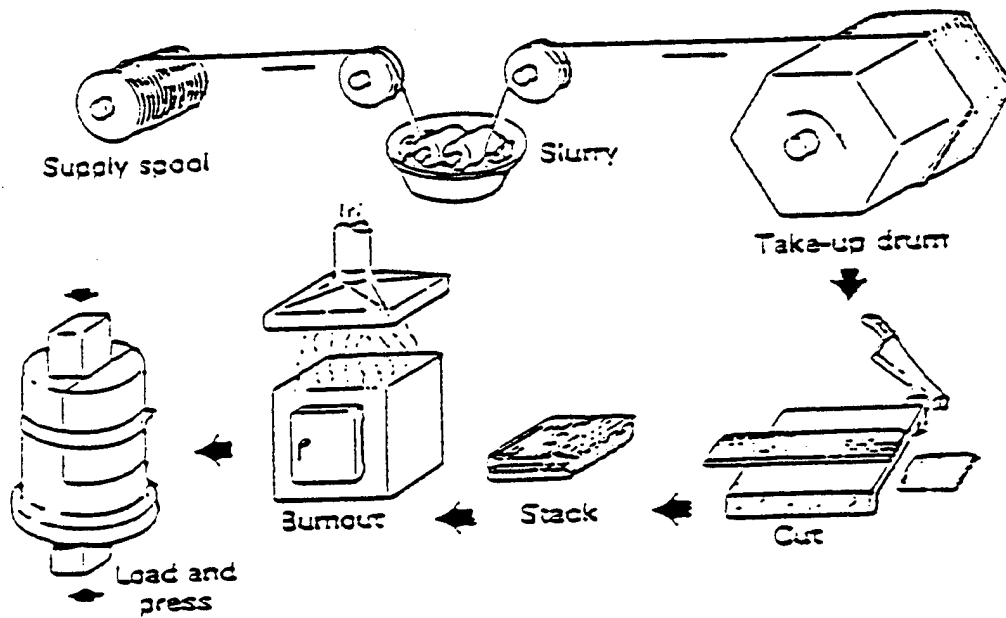
Figure 7. SiC/CAS Fabrication Process Schematic [Ref. 12]

The cerammed SiC/CAS composite was fabricated by Corning Incorporated. The manufacturing process is depicted in Figure 7.
