AL/CF-TR-1994-0183

**ANTHROPOMORPHIC CUTANEOUS TACTILE SENSING  
ON DEXTEROUS MECHANICAL HANDS**

**BONNEVILLE SCIENTIFIC, INC.  
1849 W. NO. TEMPLE, BLDG. E  
SALT LAKE CITY, UT 84116**

**FINAL REPORT FOR THE PERIOD JANUARY 1991 TO JUNE 1994**

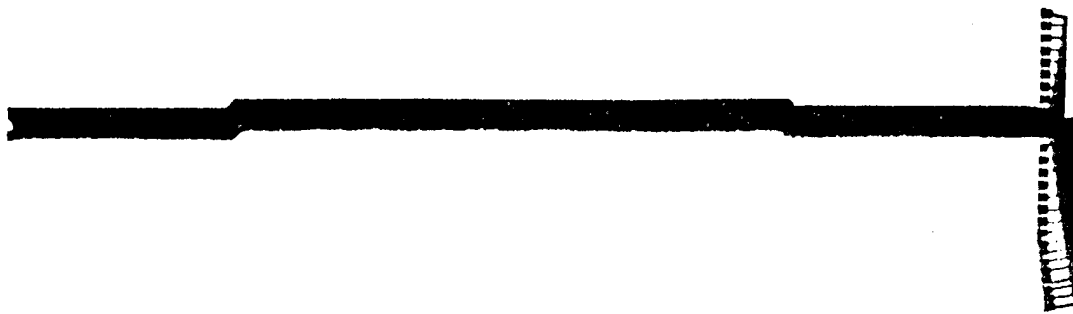
Figure 10. Cables for the three finger segments.  
(Only receiving leads shown)

We developed one double-sided cable for the arrays on each digit segment. Leads for the transmitting elements were on one side, and the receiving leads on the other side. Figure 10 shows the receiving leads on one side of these cables for the three segments. A similar arrangement was used for the transmitting leads that are on the opposite side of the cables.
