Technical Report REMR-CS-49
June 1995

Repair, Evaluation, Maintenance, and Rehabilitation Research Program

Applications of Precast Concrete in Repair and Replacement of Civil Works Structures

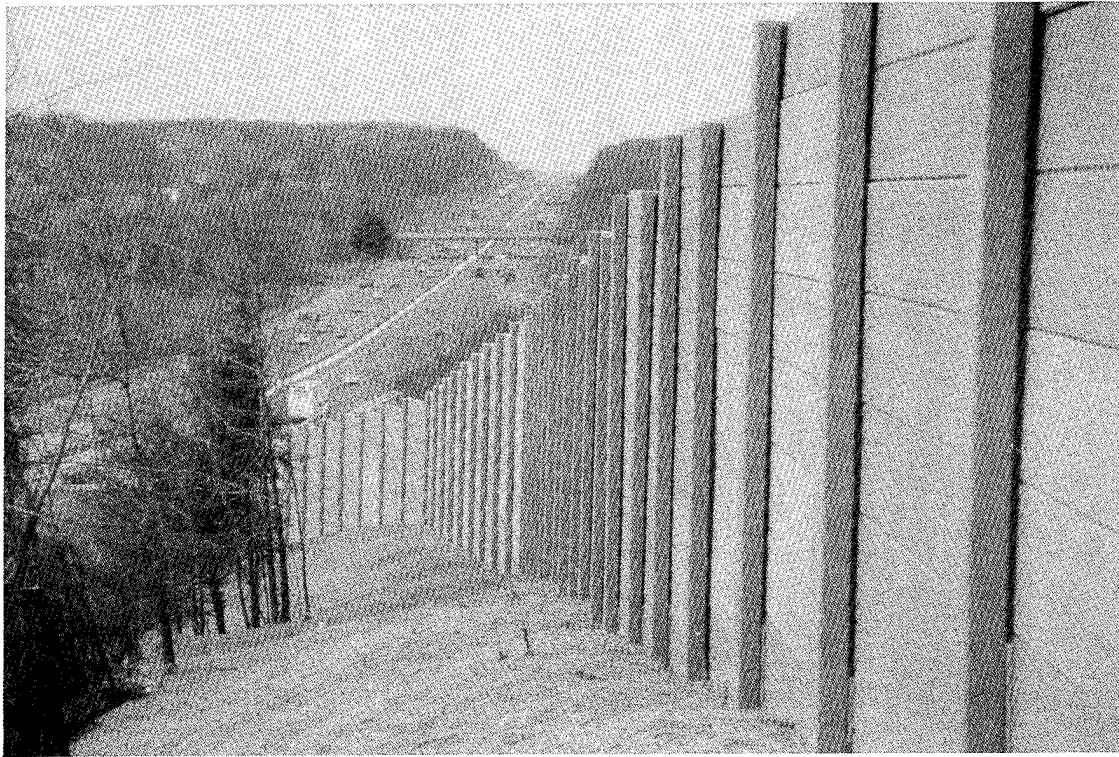
Figure 211. Section of precast concrete post and panel noise barrier wall installed along Interstate Route 80, New Jersey (from Guzaltan 1992)
