EVALUATION OF RETROREFLECTIVE AIRFIELD PAVEMENT MARKINGS

ELLSWORTH AFB,
SOUTH DAKOTA
and
TYNDALL AFB
FLORIDA

April 1995

RETROREFLECTIVE AIRFIELD MARKINGS

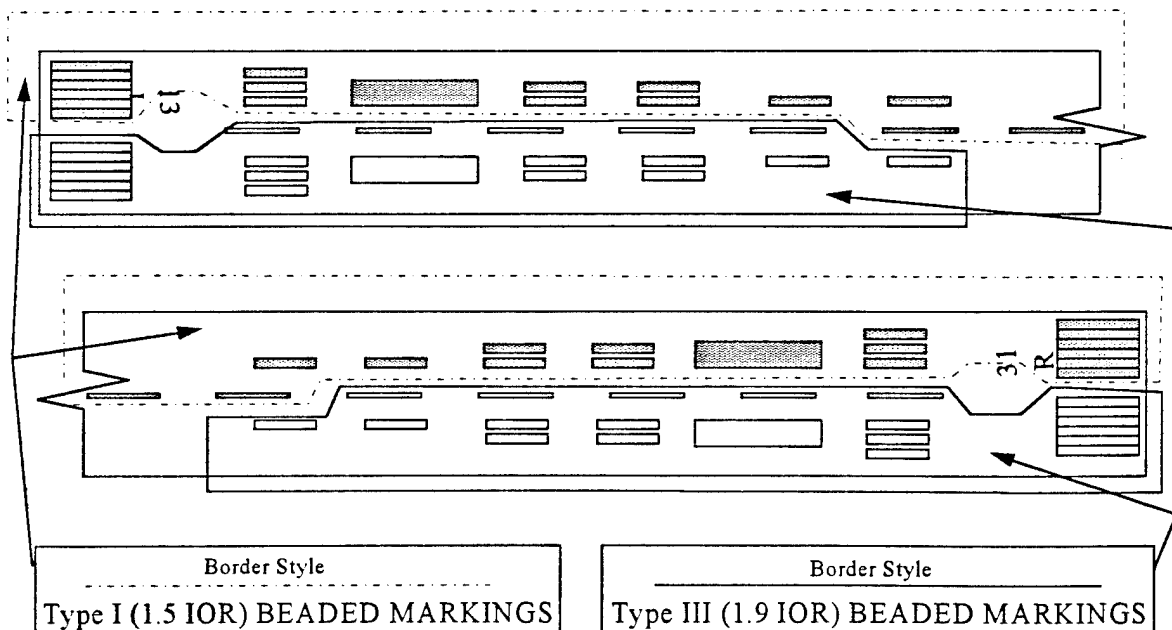
Figure 4

i. Type I (1.5 IOR) beads; all threshold, touchdown zone, and fixed distance markings to the left of centerline on runway 13L (north side) for the entire length of the runway, and all centerline stripes from the 7,000 feet Runway Distance Marker (distance remaining) to the 3,000 feet Runway Distance Marker (see Figure 4).

ii. Type III (1.9 IOR) beads; all threshold, touchdown zone, and fixed distance markings to the left of centerline on runway 31R (south side) for the entire length of the runway, and the first and last 3,000 feet of centerline stripes for both approach headings (see Figure 4).
