**ENHANCED PRELIMINARY ASSESSMENT REPORT  
FOR TOOEELE ARMY DEPOT - NORTH AREA  
TOOELE, UTAH**

**USAEC Contract DAAA15-93-D-0006  
Delivery Order 001**

FINAL ENHANCED PRELIMINARY ASSESSMENT REPORT  
FOR TOOEELE ARMY DEPOT - NORTH AREA  
TOOELE, UTAH

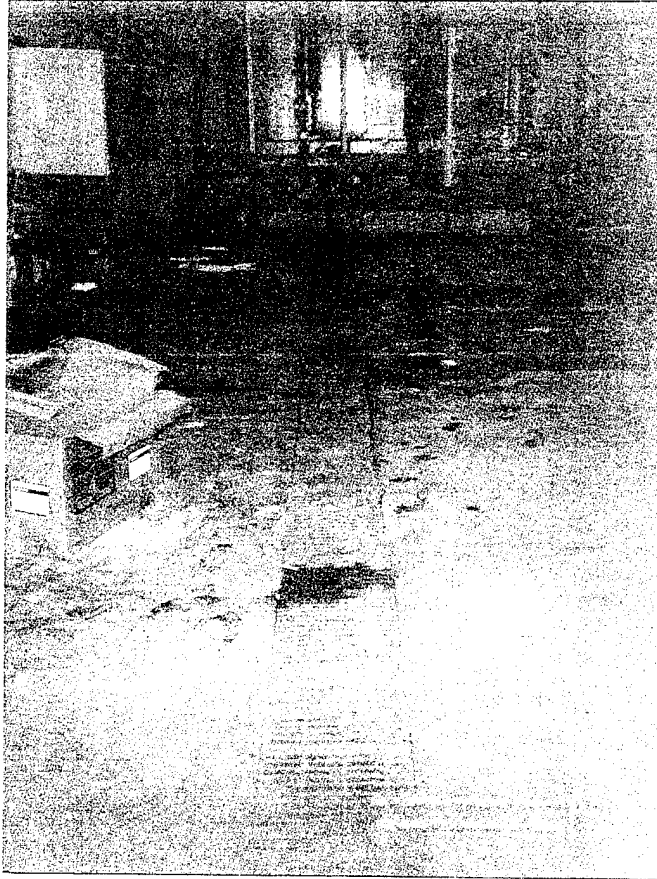
Photograph 3. (AREE 2 - SWMU 47: Boiler Plant Blowdown Water). View of Boiler Blowdown Sump in Building 637.

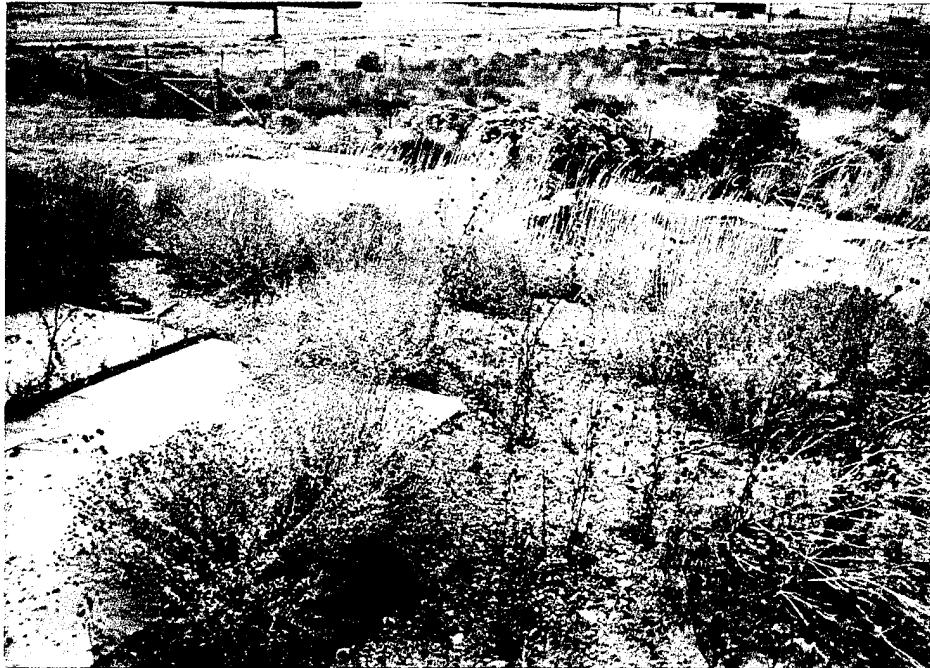
Photograph 5. (AREE 4 - SWMU 51: Chromic Acid/Alodine Drying Beds). View Northwest of Chromic Acid/Alodine Drying Beds Marked as Building 623.

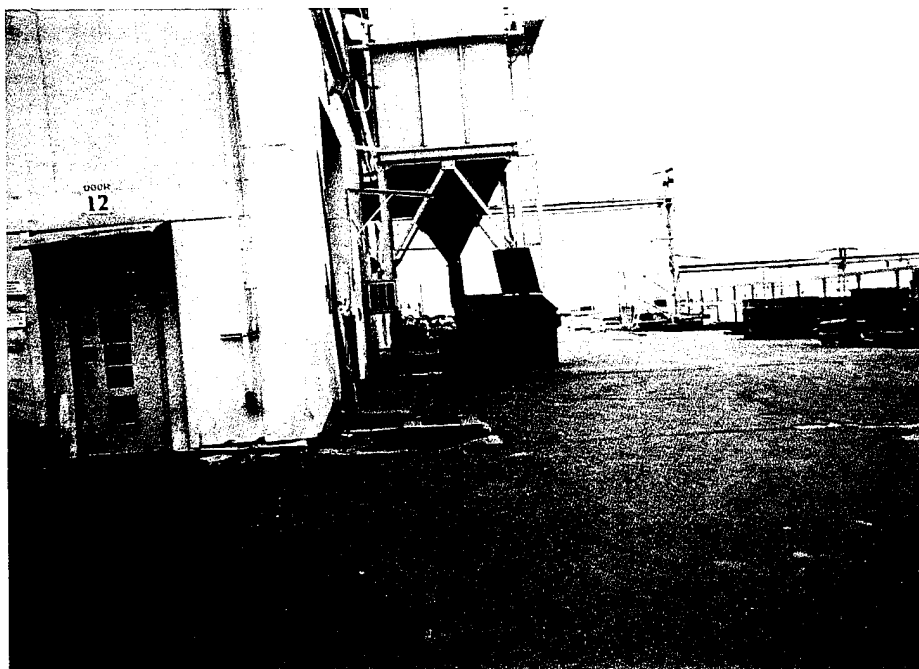
Photograph 6. (AREE 6 - SWMU 4: Sand Blast Areas). View South of Building 615 Sand Blast Grit Collection Area.
