NASA Technical Paper 1081

Mechanical Behavior  
and Fracture Characteristics  
of Off-Axis Fiber Composites  
I - Experimental Investigation

John H. Sinclair and Christos C. Chamis

DECEMBER 1977

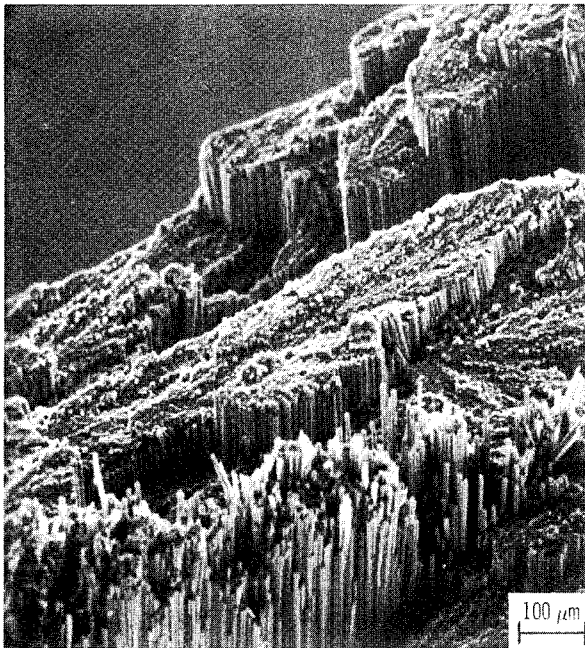
(a) General view.

(b) Detailed view.

(c) Enlargement of detail to show fracture mode.

Figure 16. - Scanning electron photomicrographs of fractured surface of Mod I/E composite tested parallel to fiber direction.

The fracture surface of the  $0^\circ$  specimen is shown in figure 16(a), where it can be observed that the fracture surface is irregular. An area replete with pulled-out fibers that broke off at varying lengths can be observed in the left foreground of the figure. This type of fracture suggests poor bonding between matrix and fibers. The remaining areas of figure 16(a) show irregularly shaped tiered or stepped surfaces that are typical of most of the fracture surface of specimens tested in longitudinal tension. At some regions fibers over relatively large areas fractured at approximately the same level, and they show little fiber pull-out. This type of surface is enlarged in figures 16(b) and (c). There was strong bonding between the fibers and matrix in these areas. The fracture mode of the resin was cleavage (fig. 16(c)). Lateral fiber surfaces of these stepped zones show some evidence of sheared resin lying between the fibers as seen in the upper left of figure 16(c).

The fracture surface in figure 16(c) reveals several distinct features. These features and some significant implications following therefrom are as follows:

- (1) The fiber fracture surface is irregular but appears to be symmetric from the perimeter towards the center. This type of fiber fracture surface morphology will be considered to be typical of tensile fracture.
- (2) The matrix fracture surface between fibers at the same level is smooth, indicating tensile brittle fracture by cleavage.
- (3) The matrix fracture surface between fibers at different levels is lacerated, indicating fracture by tear, which will be considered to be fracture by intralaminar shear.
- (4) The surface of fibers that pulled out appears to be clear of matrix residue, in general. This indicates weak interfacial bonding which may be construed to imply that the interfacial bond is predominantly mechanical.
- (5) The transverse split in the left foreground is probably caused by the elastic energy release after fracture backlash.

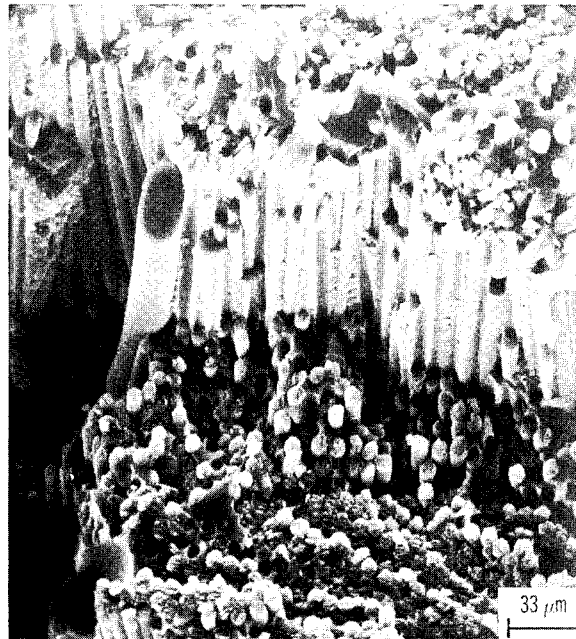
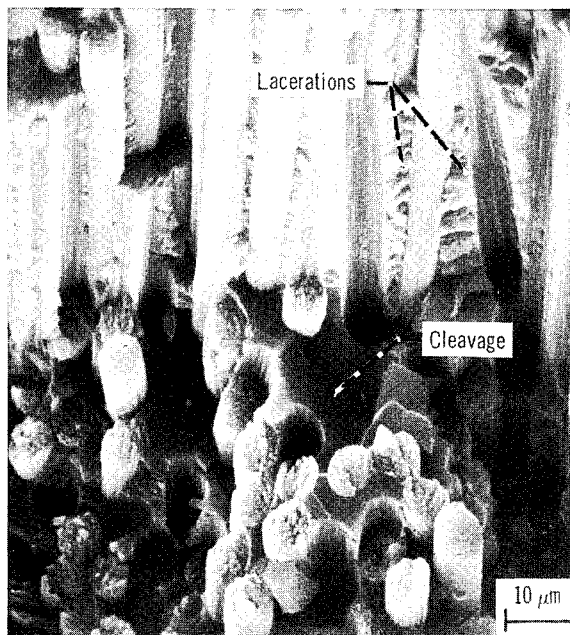
(a) General view.

(b) Detailed view.

(c) Enlargement of detail to show fracture mode.

Figure 17. - Scanning electron photomicrographs of fractured surface of Mod I/E composite tested at 5° to fiber direction.

The fracture surface of the  $5^\circ$  off-axis tensile specimen (fig. 17) reveals the following features:

- (1) Surface tiering (fig. 17(b)) and matrix cleavage (fig. 17(c)) both of which are indicative of tensile fracture
- (2) Extensive matrix surface lacerations, indicating substantial fracture by intralaminar shear
- (3) Fiber pull-out and fiber surfaces free of matrix residue, indicating weak interfacial bonding.

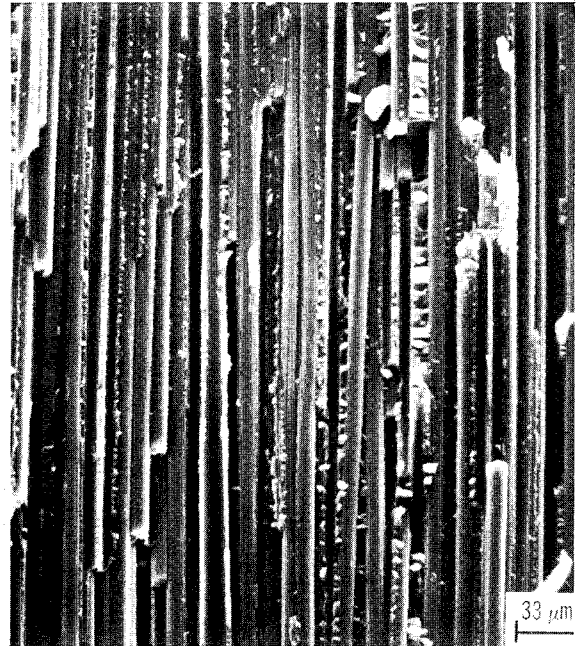
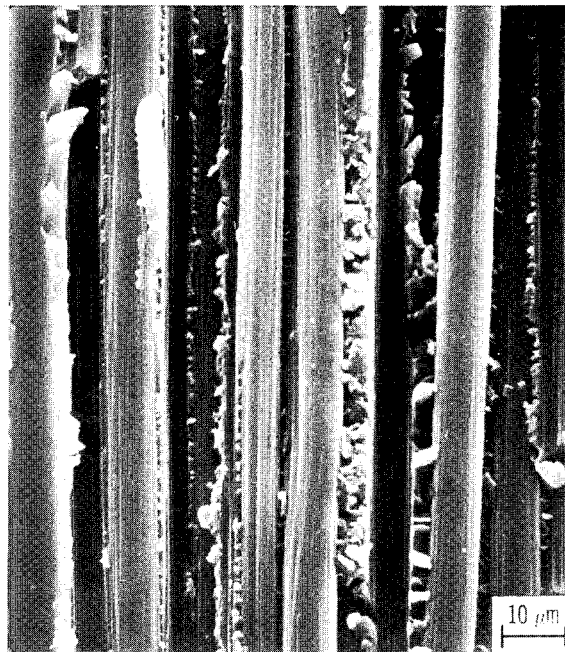
(a) General view.

(b) Detailed view.

(c) Enlargement of detail to show fracture mode.

Figure 18. - Scanning electron photomicrographs of fractured surface of Mod I/E composite tested at  $10^\circ$  to fiber direction.

The fracture of the  $10^{\circ}$  off-axis tensile specimen (fig. 18) reveals (1) matrix surface lacerations and (2) fiber surfaces free of matrix residue. Both of these features indicate that a different fracture mode became active. We will consider this mode to be induced by intralaminar shear stress. It is this observation and the theoretical considerations to be described in Part II that led to the recommendation that the  $10^{\circ}$  off-axis tensile specimen is suitable for intralaminar shear characterization of unidirectional fiber composites.

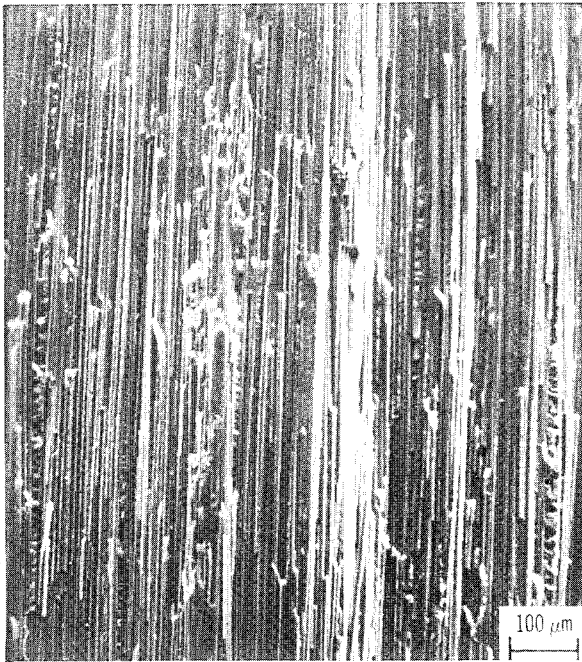
(a) General view.

(b) Detailed view.

(c) Enlargement of detail to show fracture mode.

Figure 19. - Scanning electron photomicrographs of fractured surface of Mod I/E composite tested at 15° to fiber direction.

The fracture surfaces of the  $15^{\circ}$  and  $30^{\circ}$  off-axis tensile specimens (figs. 19 and 20) reveal similar features to those of the  $10^{\circ}$  off-axis tensile specimen. These surfaces, too, indicate that fracture was induced mainly by intralaminar shear stress.

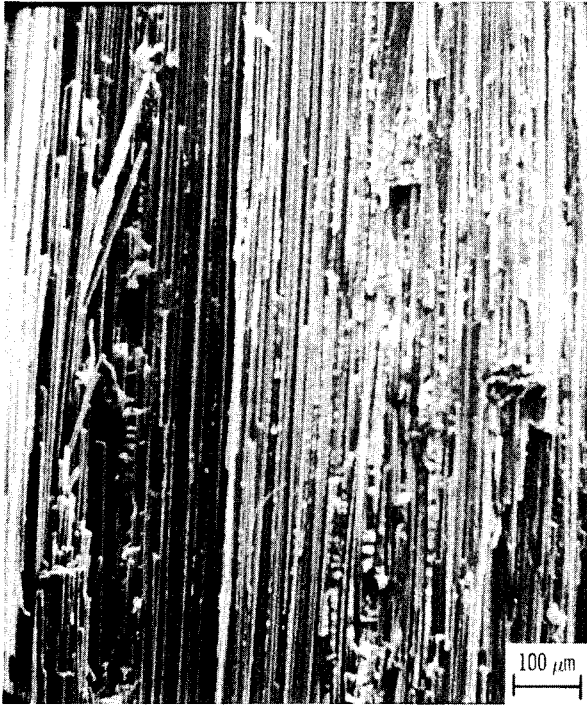
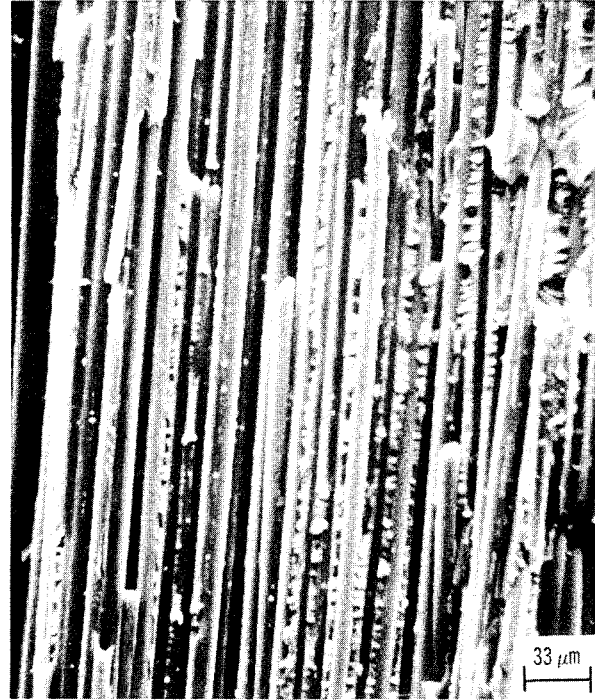
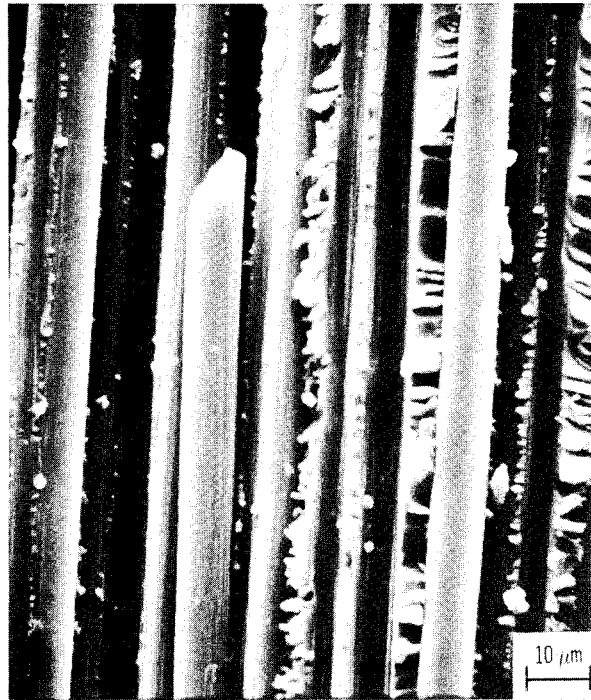
(a) General view.

(b) Detailed view.

(c) Enlargement of detail to show fracture mode.

Figure 20. - Scanning electron photomicrographs of fractured surface of Mod I/E composite tested at 30° to fiber direction.

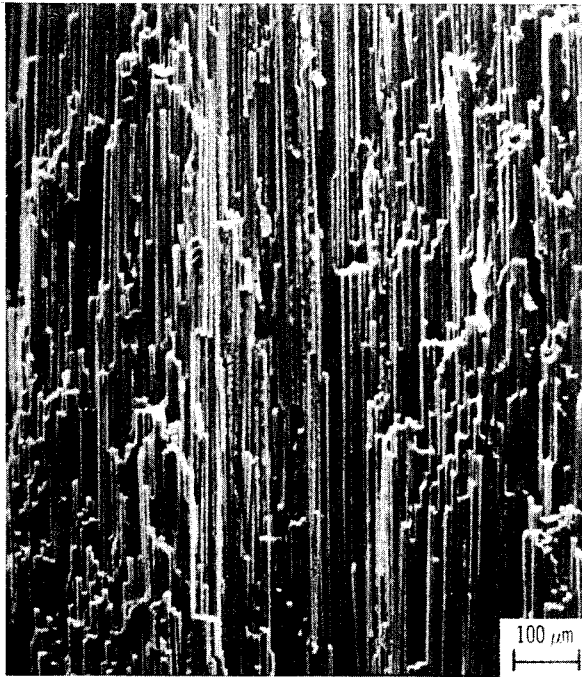
(a) General view.

(b) Detailed view.

(c) Enlargement of detail to show fracture mode.

Figure 21. - Scanning electron photomicrographs of fractured surface of Mod I/E composite tested at 45° to fiber direction.

The fracture surface of the  $45^{\circ}$  off-axis specimen (fig. 21) reveals the following features:

- (1) Matrix cleavage with irregular boundary, indicating some transverse tensile fracture
- (2) Matrix debris resulting probably from tensile matrix fracture
- (3) Some matrix lacerations, indicating some intralaminar shear stress fracture.

These surface fracture features show that another fracture mode becomes active somewhere between a load angle of  $30^{\circ}$  and  $45^{\circ}$ . This mode is construed to have been induced by the transverse tensile stress.

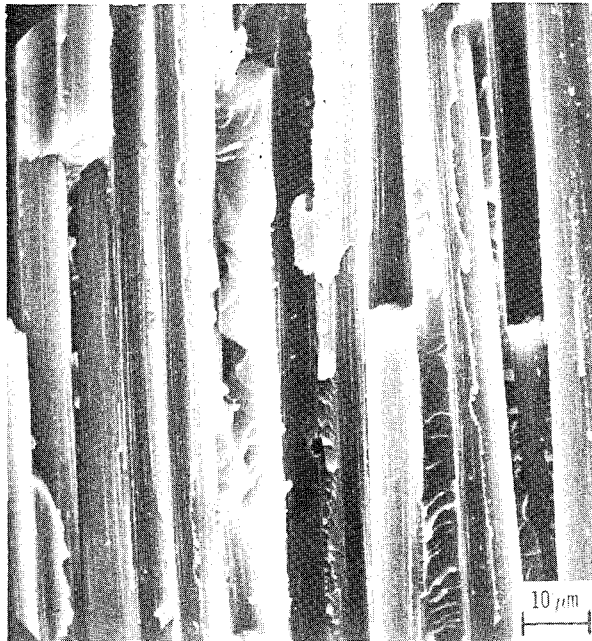
(a) General view.

(b) Detailed view.

(c) Enlargement of detail to show fracture mode.

Figure 22. - Scanning electron photomicrographs of fractured surface of Mod I/E composite tested at 60° to fiber direction.

The fracture surfaces of the  $60^{\circ}$  off-axis tensile specimen (fig. 22) and the  $75^{\circ}$  specimen (fig. 23) reveal mainly matrix cleavage and some fiber surface free of matrix residue; both of these features indicate that fracture was induced by transverse tensile stress.

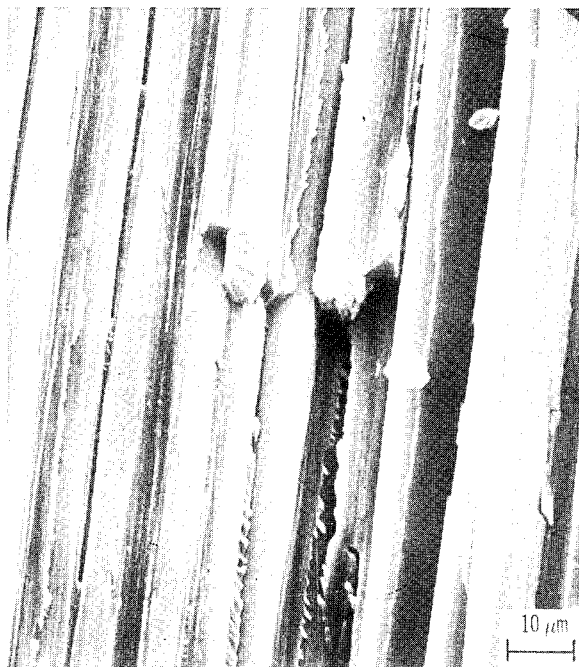
(a) General view.

(b) Detailed view.

(c) Enlargement of detail to show fracture mode.

Figure 23. - Scanning electron photomicrographs of fractured surface of Mod I/E composite tested at 75° to fiber direction.

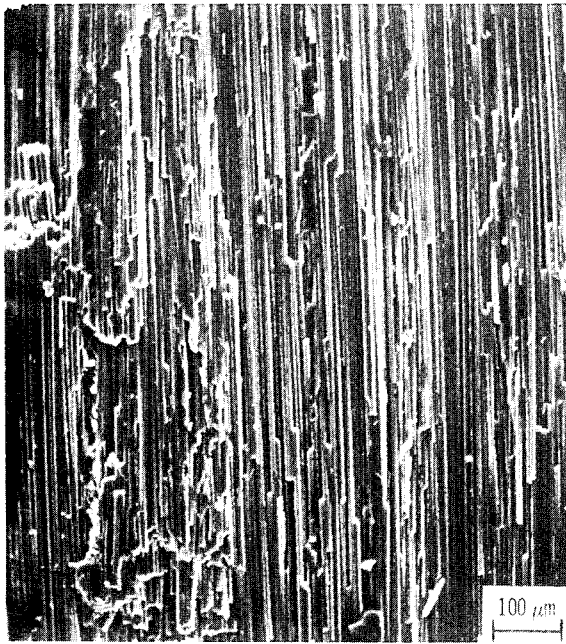
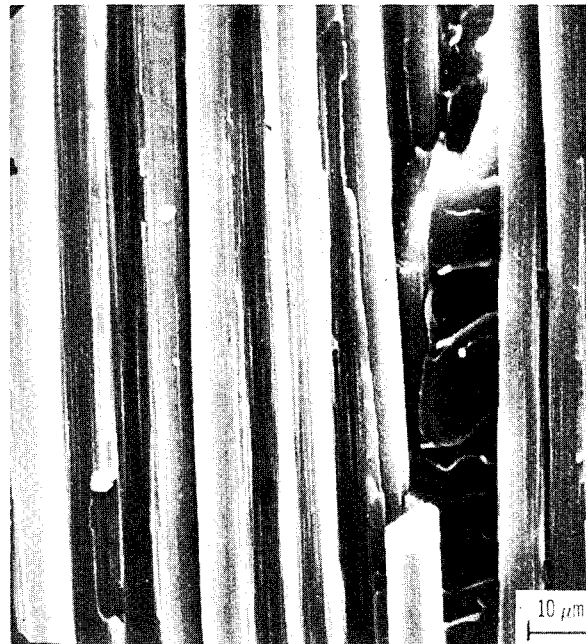
(a) General view.

(b) Detailed view.

(c) Enlargement of detail to show fracture mode.

Figure 24. - Scanning electron photomicrographs of fractured surface of Mod I/E composite tested transverse to fiber direction.

The fracture surface of the  $90^{\circ}$  tensile specimen (fig. 24) reveals the following features:

- (1) Matrix cleavage, indicative of tensile fracture of brittle materials
- (2) Fiber surfaces free of matrix residue, indicative of weak interfacial bond, as was already mentioned
- (3) Some matrix lacerations, indicating shear fracture at surfaces connecting two different levels.

These features indicate that transverse tensile stress produces fracture surfaces characterized by (1) matrix cleavage and (2) fiber surfaces clear of matrix residue.
